## **Town Docks Inspection, Assessment & Asset Management Study**

**Town of Wolfeboro  
Wolfeboro, New Hampshire**

September 14, 2017

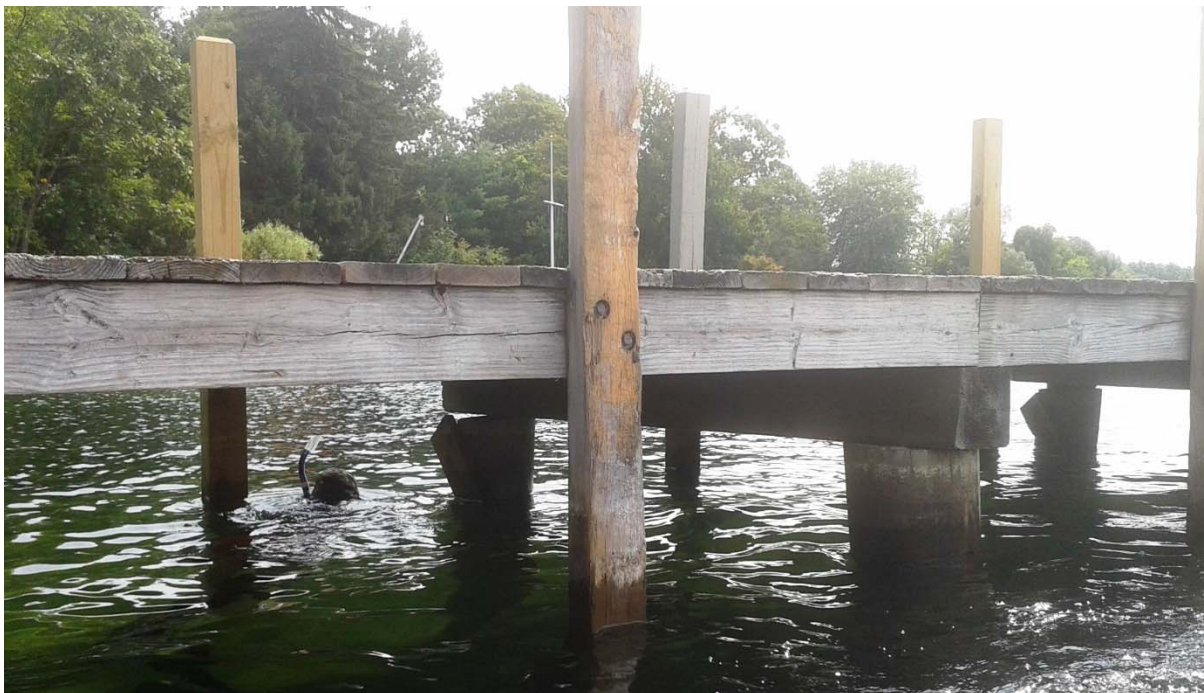
These 8 foot wide docks share generally similar timber construction with 2"x8" decking, 4"x8" rangers (deck edge stringers), 2"x8" interior stringers (approximately 2 feet apart), 8"x8" pile caps and pairs of timber piles about 6 feet apart with pile bents 10 feet oc center average. Based on observations at displaced piles, there appear to be 3/8" diameter drift pins (landscape spikes) driven through the pile caps and into the pile tops. The piles also typically have 1/8" thick x 3" wide plain steel straps fastened to each pile and the pile cap above. Some of these steel straps have been bent with a few pile heads displaced, perhaps by ice movement. Cross bracing on the docks was primarily under water and did vary from 2x timber bracing to stainless steel cables with steel turnbuckles. Much of the cross bracing is deteriorated or failed with split or broken timbers or corroded turnbuckles.

Photo 1 Typical finger dock construction

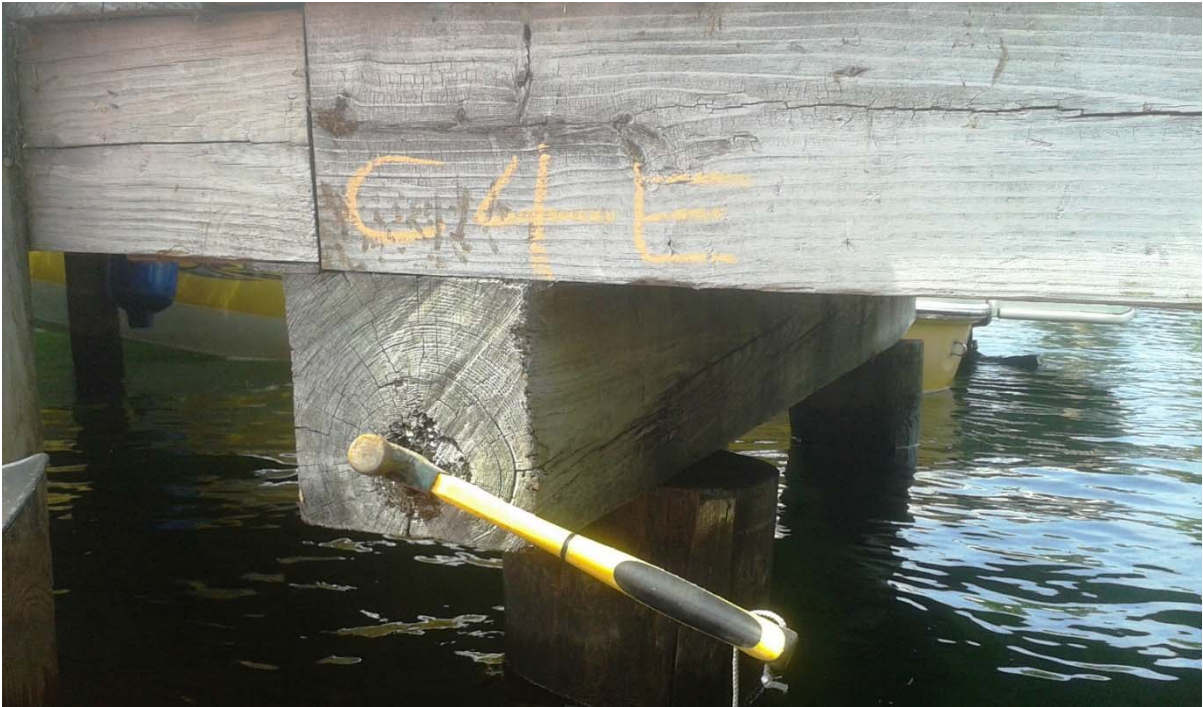
Photo 2 Heartwood decay in pile cap, Dock C, bent 4 east end, note left ranger with minimal bearing on the pile cap

Later when funding is secured, the entire dock superstructure should be redesigned to meet the 100 psf live load requirement and rebuilt accordingly. If the docks are posted with a reduced live load capacity, this can be put off for up to 5 years while plans, permits and funding are secured. During the superstructure replacement, the 4"x6" fenders should also be replaced as needed when they fail or reach the end of remaining service life.

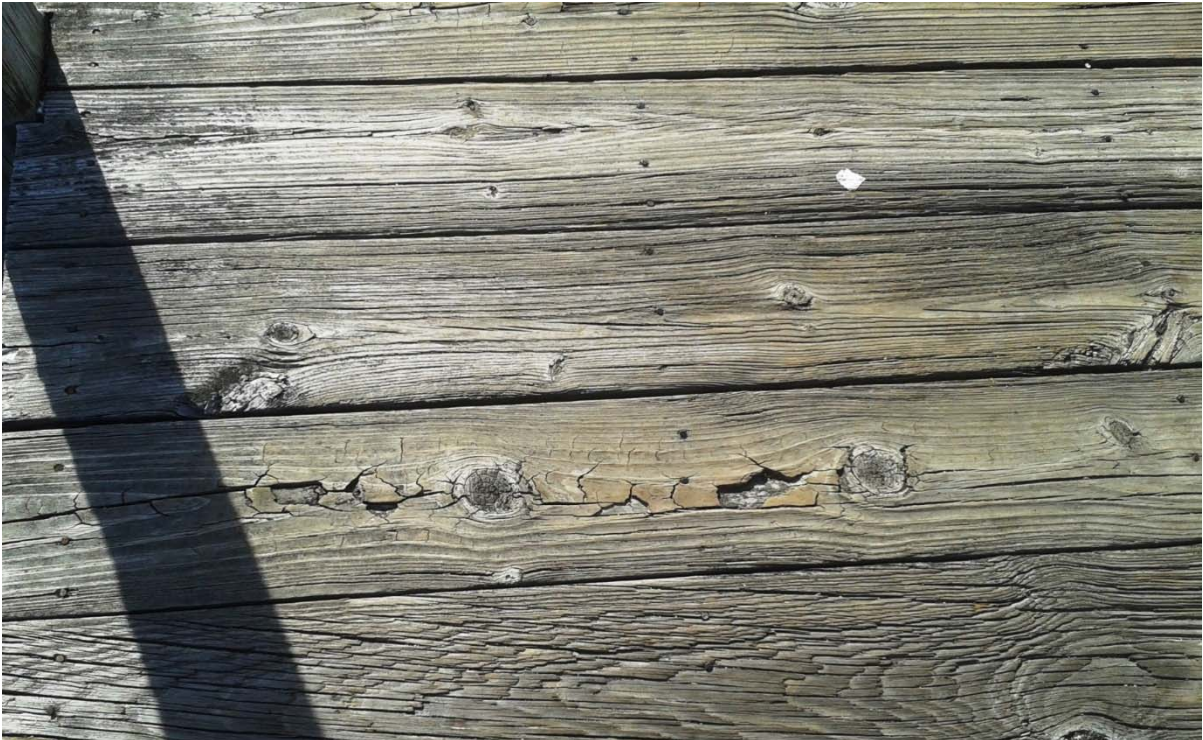
Photo 3 Typical weathered decking

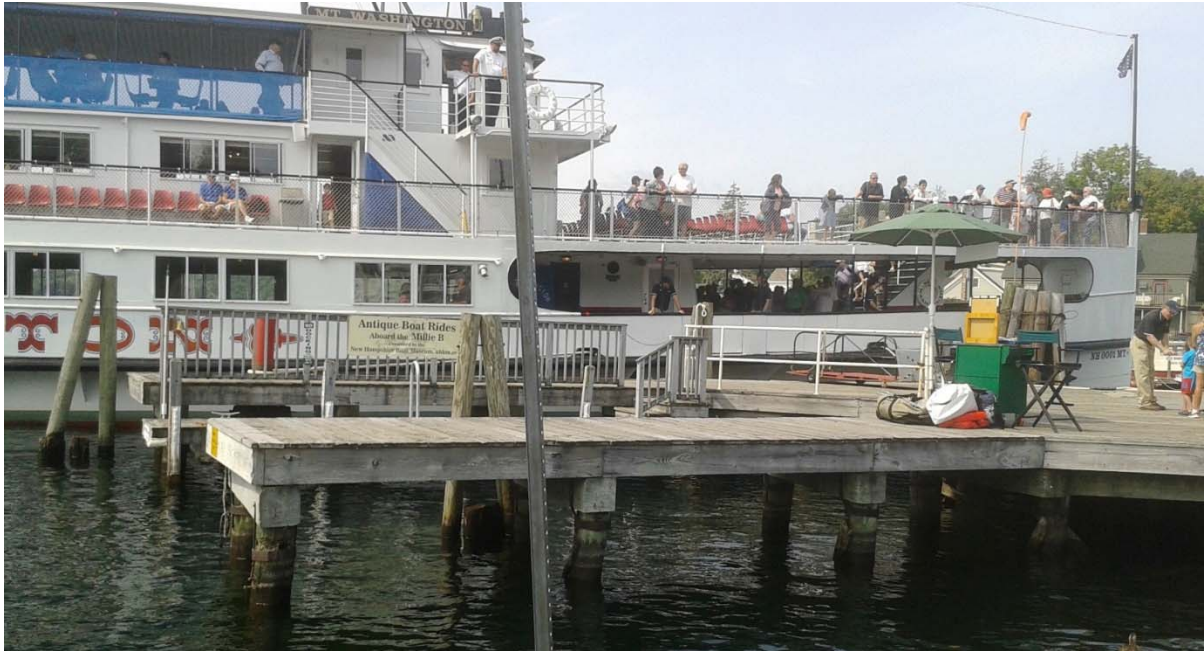
The Main Docks appears to be used primarily for commercial uses including overnight docking of the *Millie B* and visiting docking of the *Winnepesaukee Belle* and *Mount Washington*. The Main Dock is timber construction with 2x8 decking, 4x12 stringers (approximately 2 feet apart), 12x12 pile caps and pairs of timber pile bents about 10 feet apart. The piles typically have 1/8" thick x 3" wide plain steel straps fastened to each pile and the pile cap above. Some of these steel straps have been bent with a few pile heads displaced, perhaps by ice movement. Cross bracing on the docks was primarily under water and was 2x timber bracing. Much of the cross bracing is deteriorated or failed with mostly split or broken timbers. The bollard located on the timber dock consisted of a length of steel pipe over a vertical oak timber pile with above water decay, plus one decayed oak batter pile and three pressure treated pine piles, two of which had loose connection bolts. The pipe bollard did appear to move sideways when under load during *Mt Washington* docking.

Photo 4 Main Dock

The main commercial dock, being of heavier construction, meets the full 100 psf live load requirement. We recommend immediate replacement of the broken cross-bracing and the replacement of the decking since there is advanced weathering and some surface decay. Additionally, there is a pile on the east side of the dock that should be pushed back into place. We anticipate a remaining service life of 10 years, due to the stringers and pile caps. Like the finger docks, the piles are in good condition and we expect a remaining service life of 25 years for the piles.

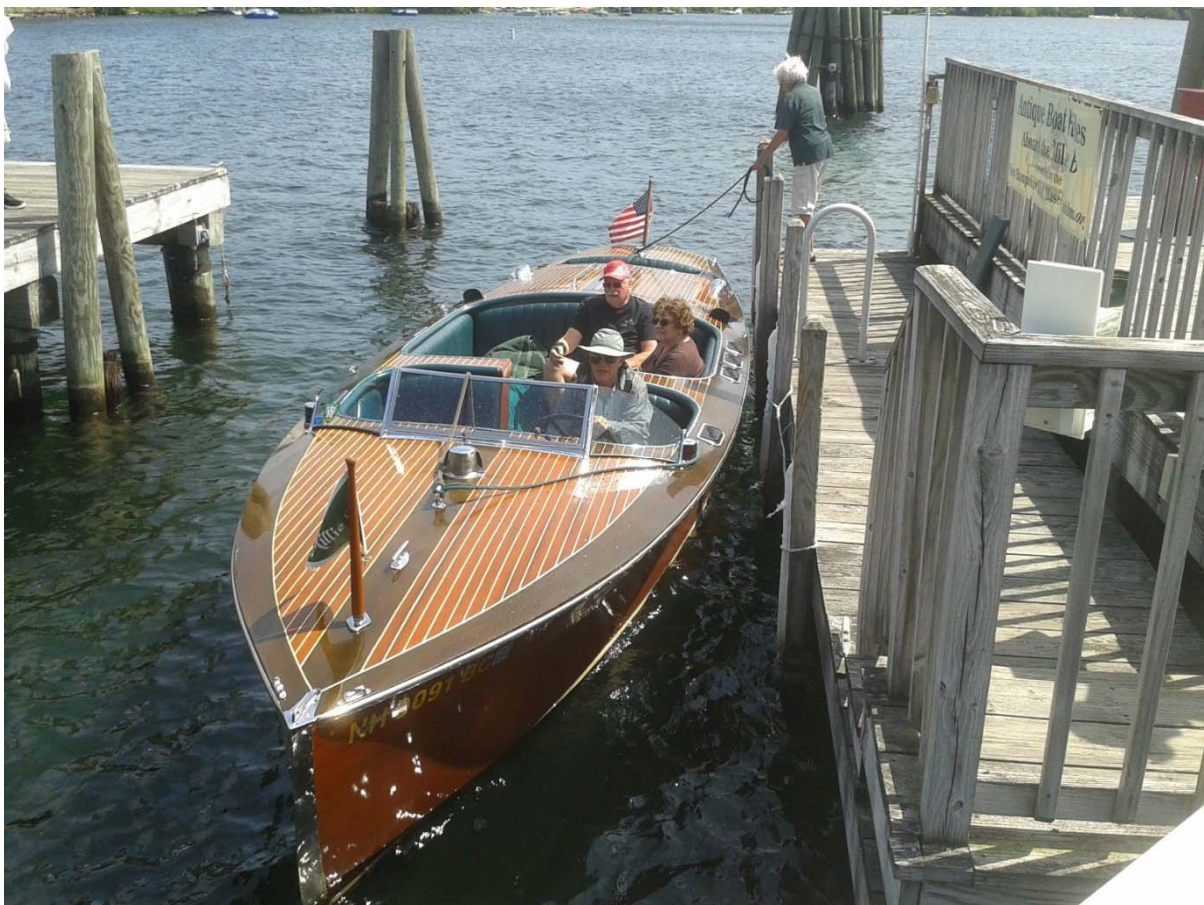
There is a lower level cantilevered deck used for boarding onto the *Millie B*. These cantilevered pile caps are fastened with single 3/4" diameter threaded rod, reducing this deck capacity. – See load rating summary in Section 3.2.

Photo 5 Cantilevered lower deck for *Millie B*

The 4' wide cantilevered dock that services the *Millie B* is the only exception. This dock is lower than the main dock and is cantilevered on (4) 2"x12"s sistered together. The 2x12s are fastened to the main piles by  $\frac{3}{4}$ " bolts, one on each pile. Based on calculations, this results in a uniform live load capacity of 19 psf, or 10 people total. We recommend this be clearly load limit posted immediately and that the cantilevers be strengthened, or additional piles are added to eliminate the cantilever.

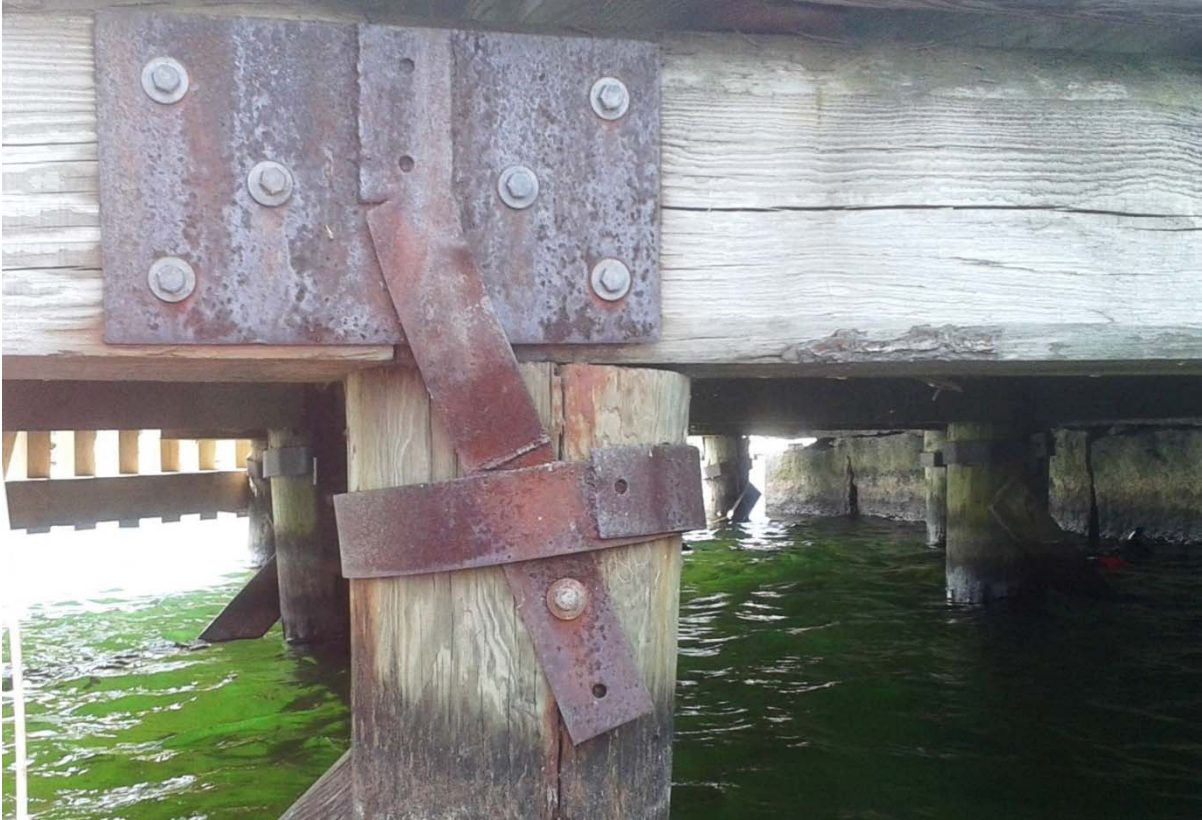
Photo 6 Laterally displaced pile head, left pile cap with minimal bearing

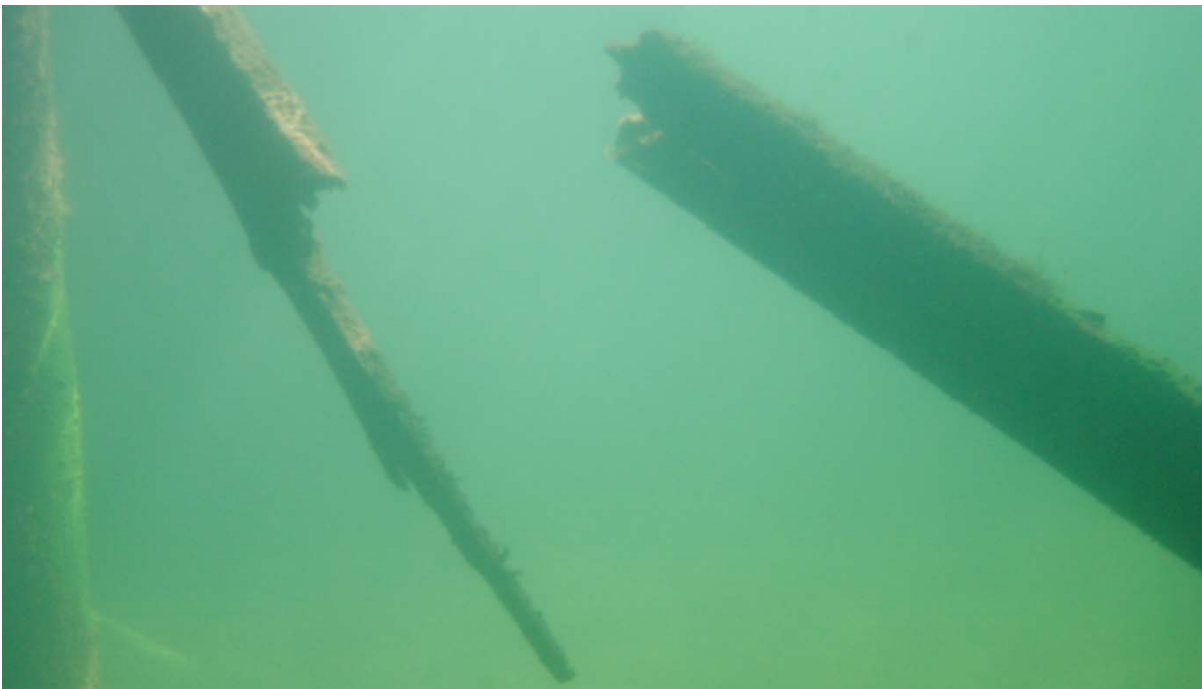
Photo 7 Broken cross bracing underwater

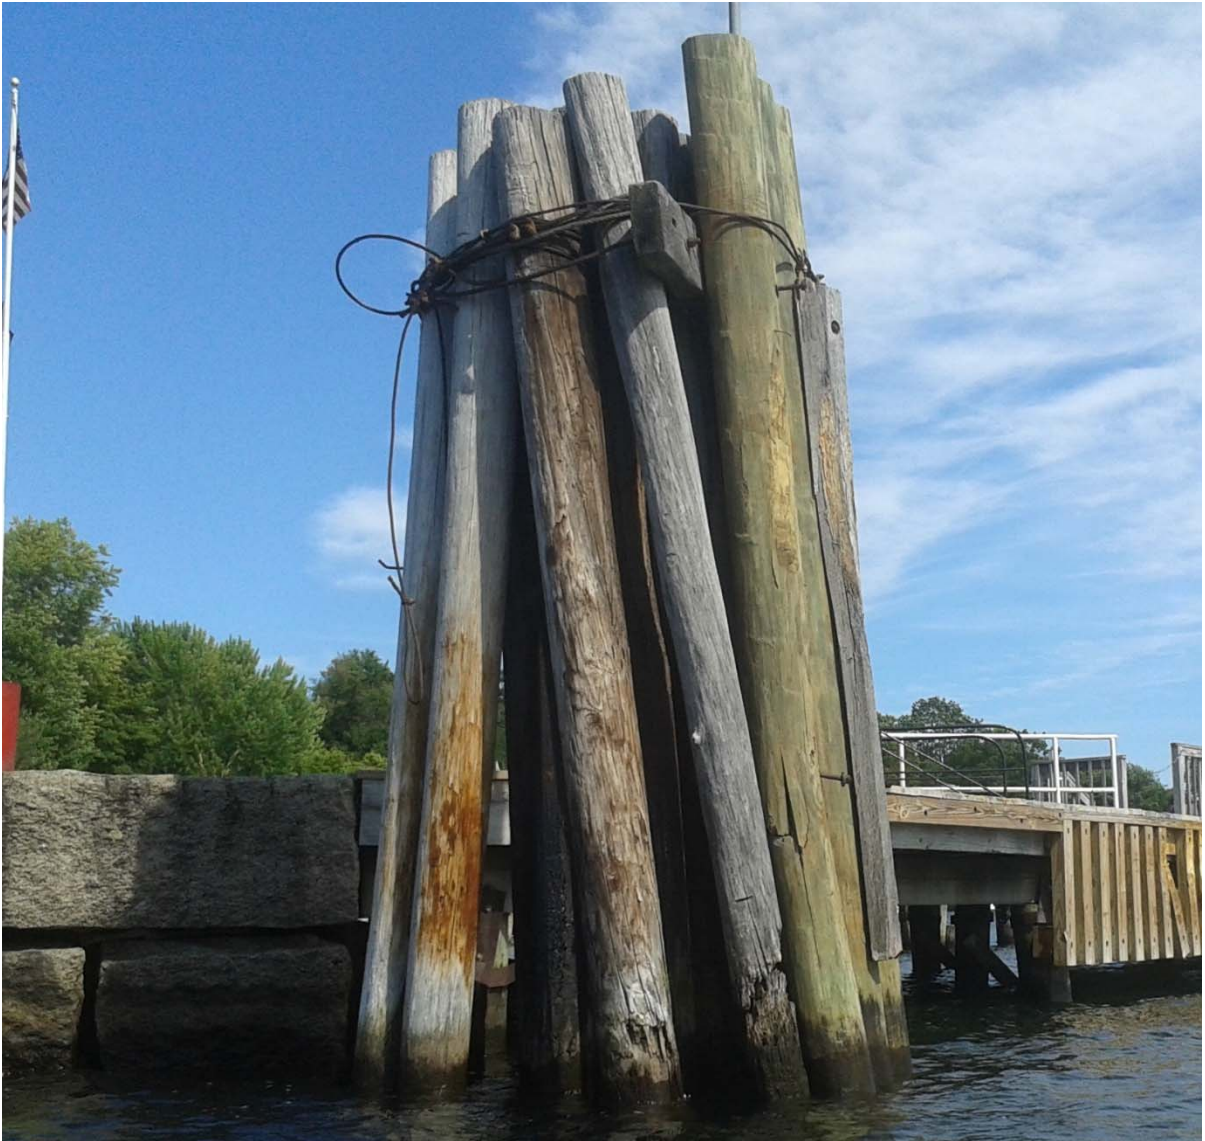
The western dolphin used by the bow of the *Mt Washington*, has approximately 18 piles of different ages and different types of timber. Two oak piles are broken, one pressure treated timber pile is broken, 5 brown (creosote treated?) piles have damaged near the top, and there are 5 cut off timber pile stubs underwater protruding from the lake bed.

Photo 8 West Dolphin, note broken piles

The Main Dock dolphins will be subjected period vessel impact and potentially ice damage, thus have a lower projected remaining service life, in comparison to dock piles. It is recommended that the underwater power cable running to the South Dolphin be secured to the piles down to the lake bed and either be buried or covered with ballast mats where exposed.

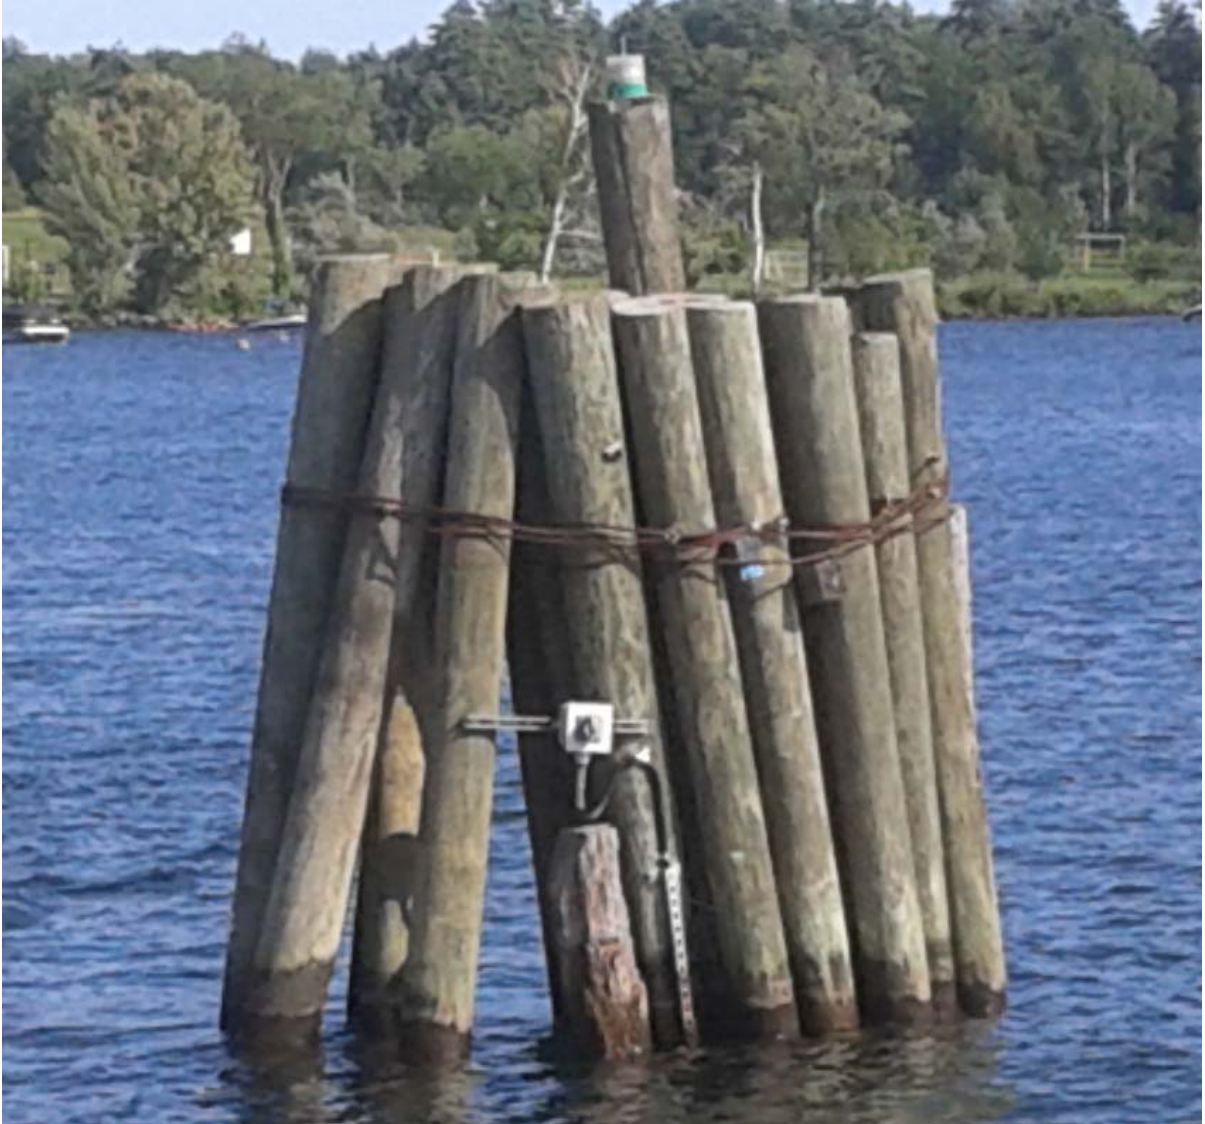
The South Dolphin is a primary berthing dolphin for the *Mt Washington*, comprised of 17 pressure treated pine piles, plus one older oak pile stub, with 6 pressure treated pine piles apparently added to the northeast side as the original 17 piles lean to the northeast (reportedly due to ice forces). Three piles in this dolphin are broken just above the lake bed. It was noted that the underwater power cable running to this dolphin is exposed on the lake bed near the dolphin, in an area clearly scoured by propeller wash with active sediment movement.

Photo 9 South Dolphin, main cluster of piles leaning to left

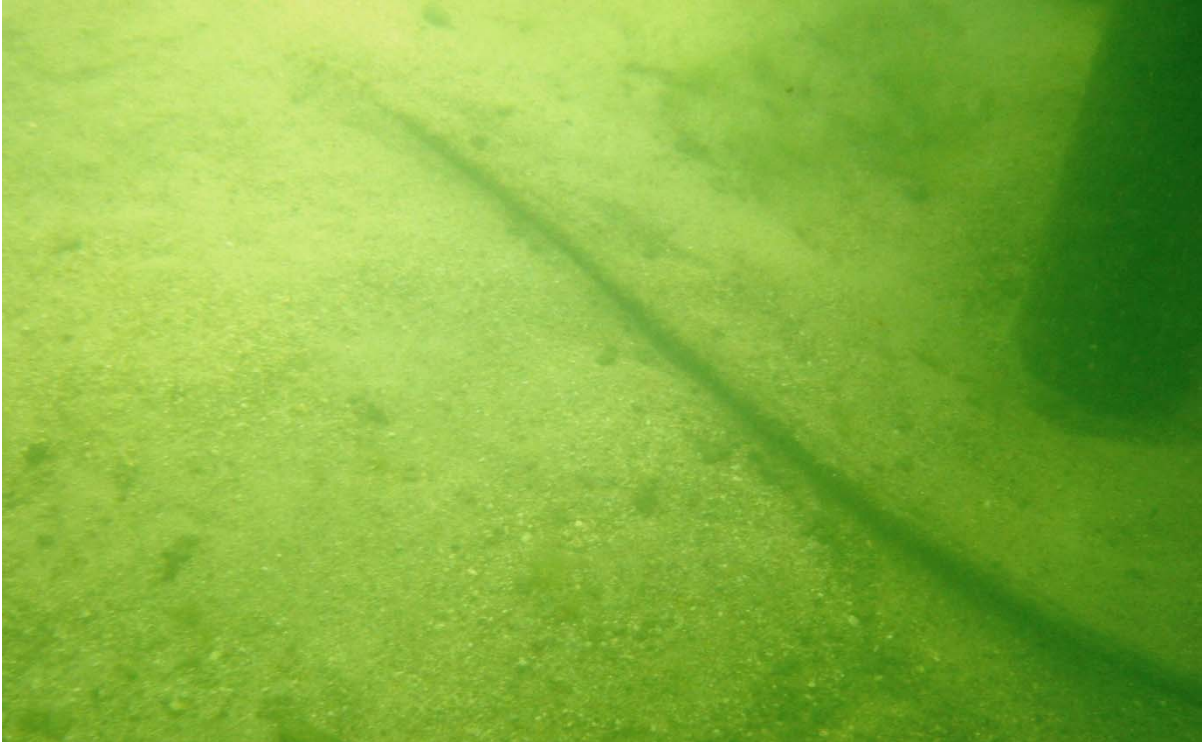
Photo 10 Exposed power cable on the lake bed (prop wash sand ridge) adjacent to South Dolphin

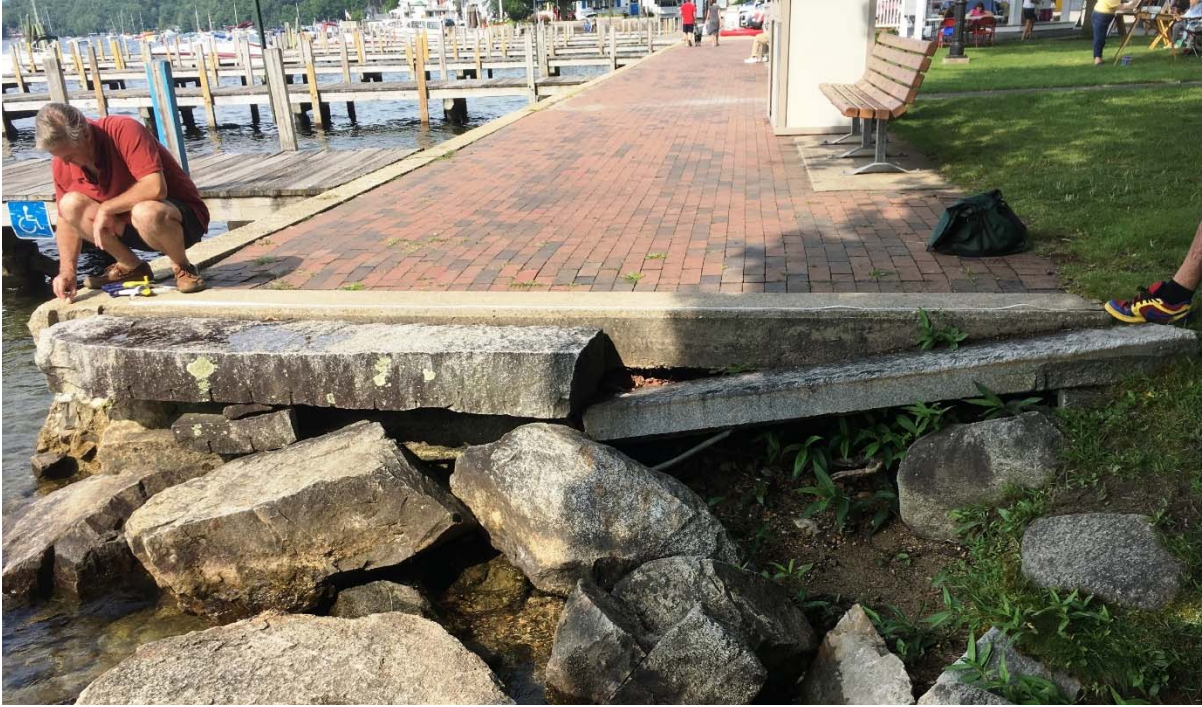
The east seawall is a low concrete shoreline retaining wall in shallow water. The concrete does have some cracking, spalling and surface scaling due to weathering and freeze-thaw winter weather. The most severe surface scaling is just underwater in a zone that would be exposed to freezing during lower lake levels, where the concrete is water saturated following summer submergence. At the corners where spalling has exposed the internal wall concrete, we noted no sign of reinforcing bars and the use of cobbles and boulders within the concrete, suggesting this may be an older wall. The return wall across the eastern end of the paver walkway has minimal depth and wave action has created a scour void, which is starting to collapse the brick pavers.

Photo 11 Scour void under return wall

It appears this cast in place concrete seawall is approaching the end of its service life so we recommend a full replacement of this wall. We anticipate a remaining service life of 5-10 years, during which the wall can be designed and permitted and funding can be secured.

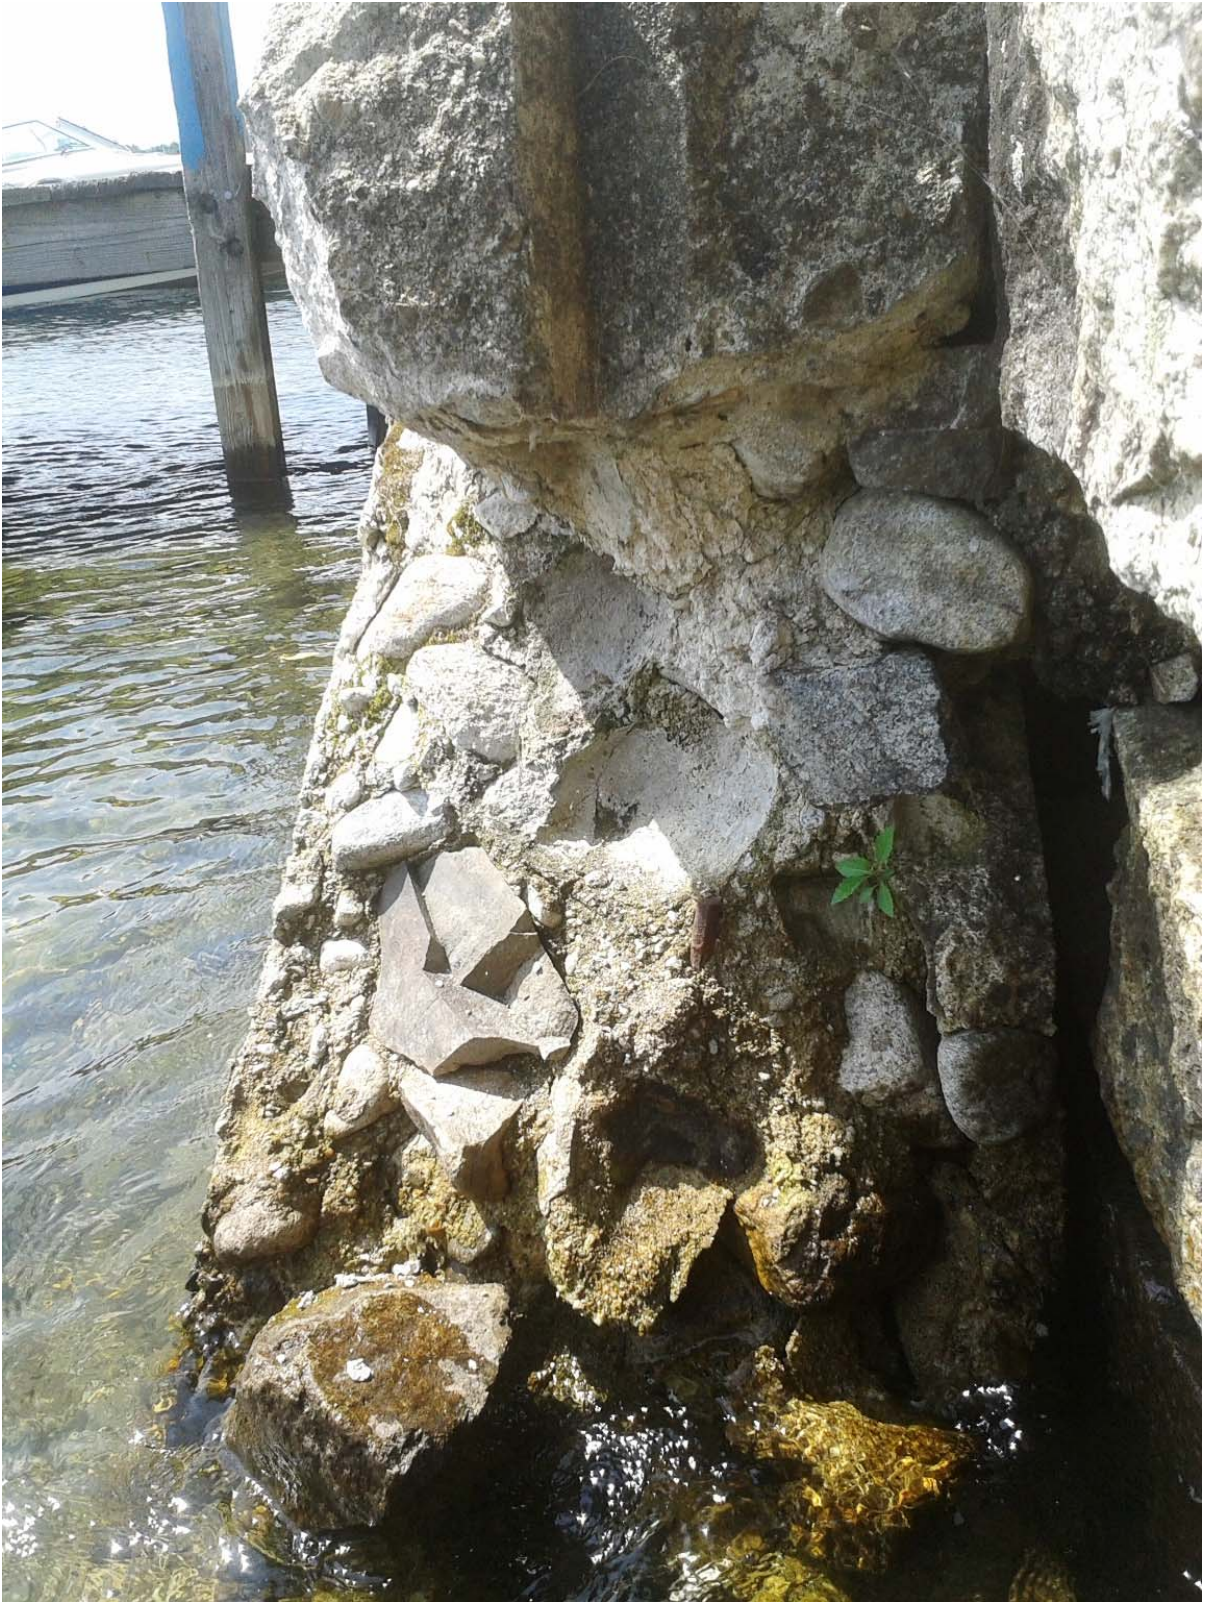
Photo 12 East Seawall deteriorated eastern corner

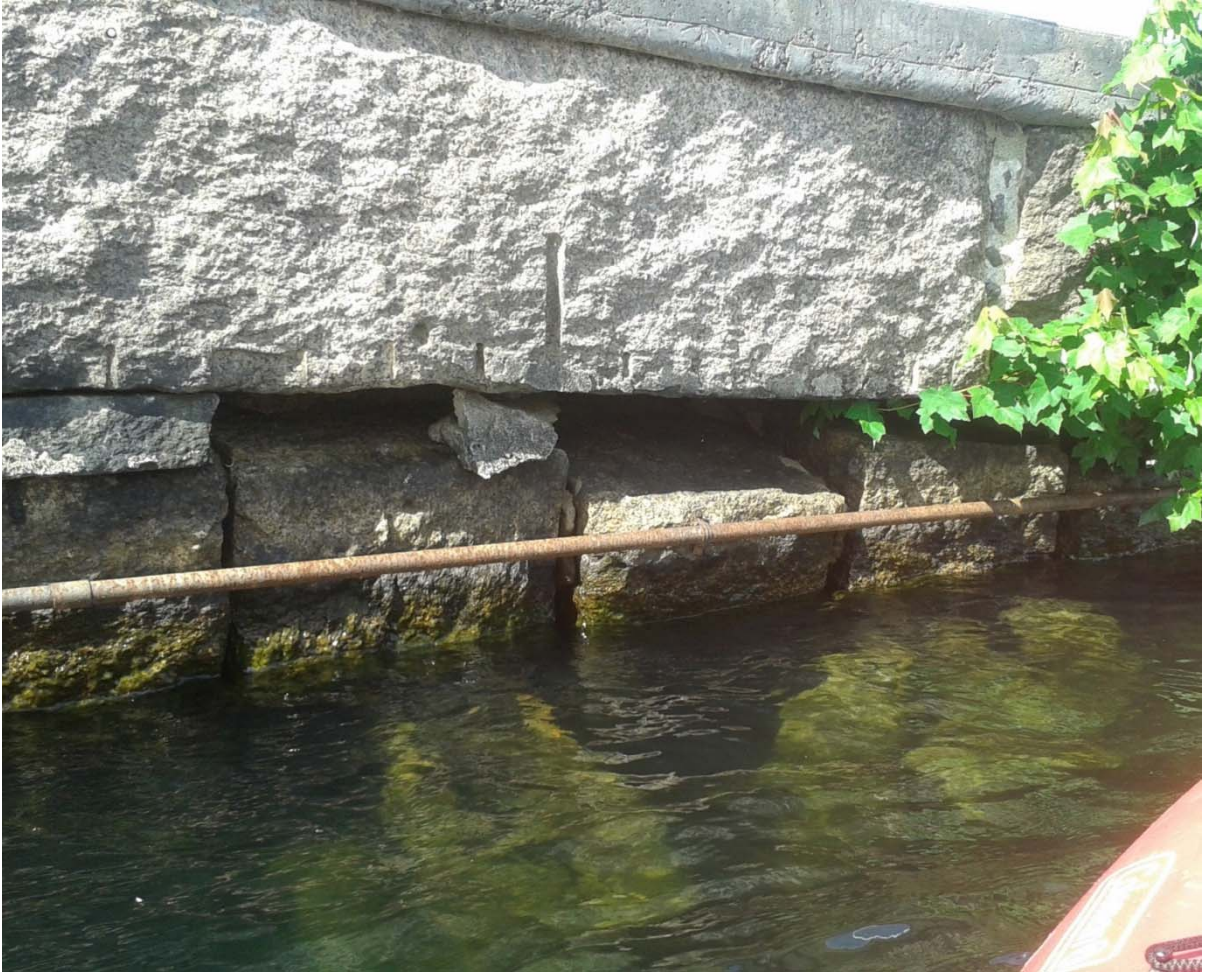
The Main Dock seawall was a surprise when viewed underwater as it is primarily a horizontal sawn timber wall with granite blocks on top, above water level. The underwater timbers do appear to be old having some area, particularly at butt joints and the corner, having some biological deterioration (loss of wood) resulting in wall voids. There are many large cast iron brackets along the south face of this wall, founded on timber pile stubs and bolted to the horizontal timbers, that extend upward to help support the granite wall blocks above. There are several granite blocks along the southern face and the western face that appear to be moving. Along the southern face (station 2+12 to 2+93), the uppermost granite does not appear to have moved, indicating it may be dowel connected to the concrete pavement above (concrete extends over the granite). Along the western face the granite blocks extend up to deck level and a gap between the concrete and the granite, up to an inch wide, indicates the granite blocks are moving offshore. Underwater observation noted a substantial void between timbers at the southwestern corner and some locations with prior grout bag repairs.

Photo 13 South wall face with rotated granite blocks with cast iron bracket visible underwater

The granite blocks that sit on top of the timber wall are generally moving towards the water as the underwater timber and its fasteners deteriorate. To prevent further displacement of the blocks, we recommend constructing a stone revetment in front to shore up the wall. To facilitate environmental permitting of this "fill", it is suggested that the aquatic habitat and reduction in wave reflection values be emphasized, including discussion of this forming a "living shoreline". The revetment would consist of large angular interlocking stones set at a 1.5H:1V slope and the top of the slope would remain near summer lake level to maintain the character of the existing wall. Granite block chinking and cramp irons (rock staples) are recommended to tie the granite blocks together and keep the granite block portion of wall stable.

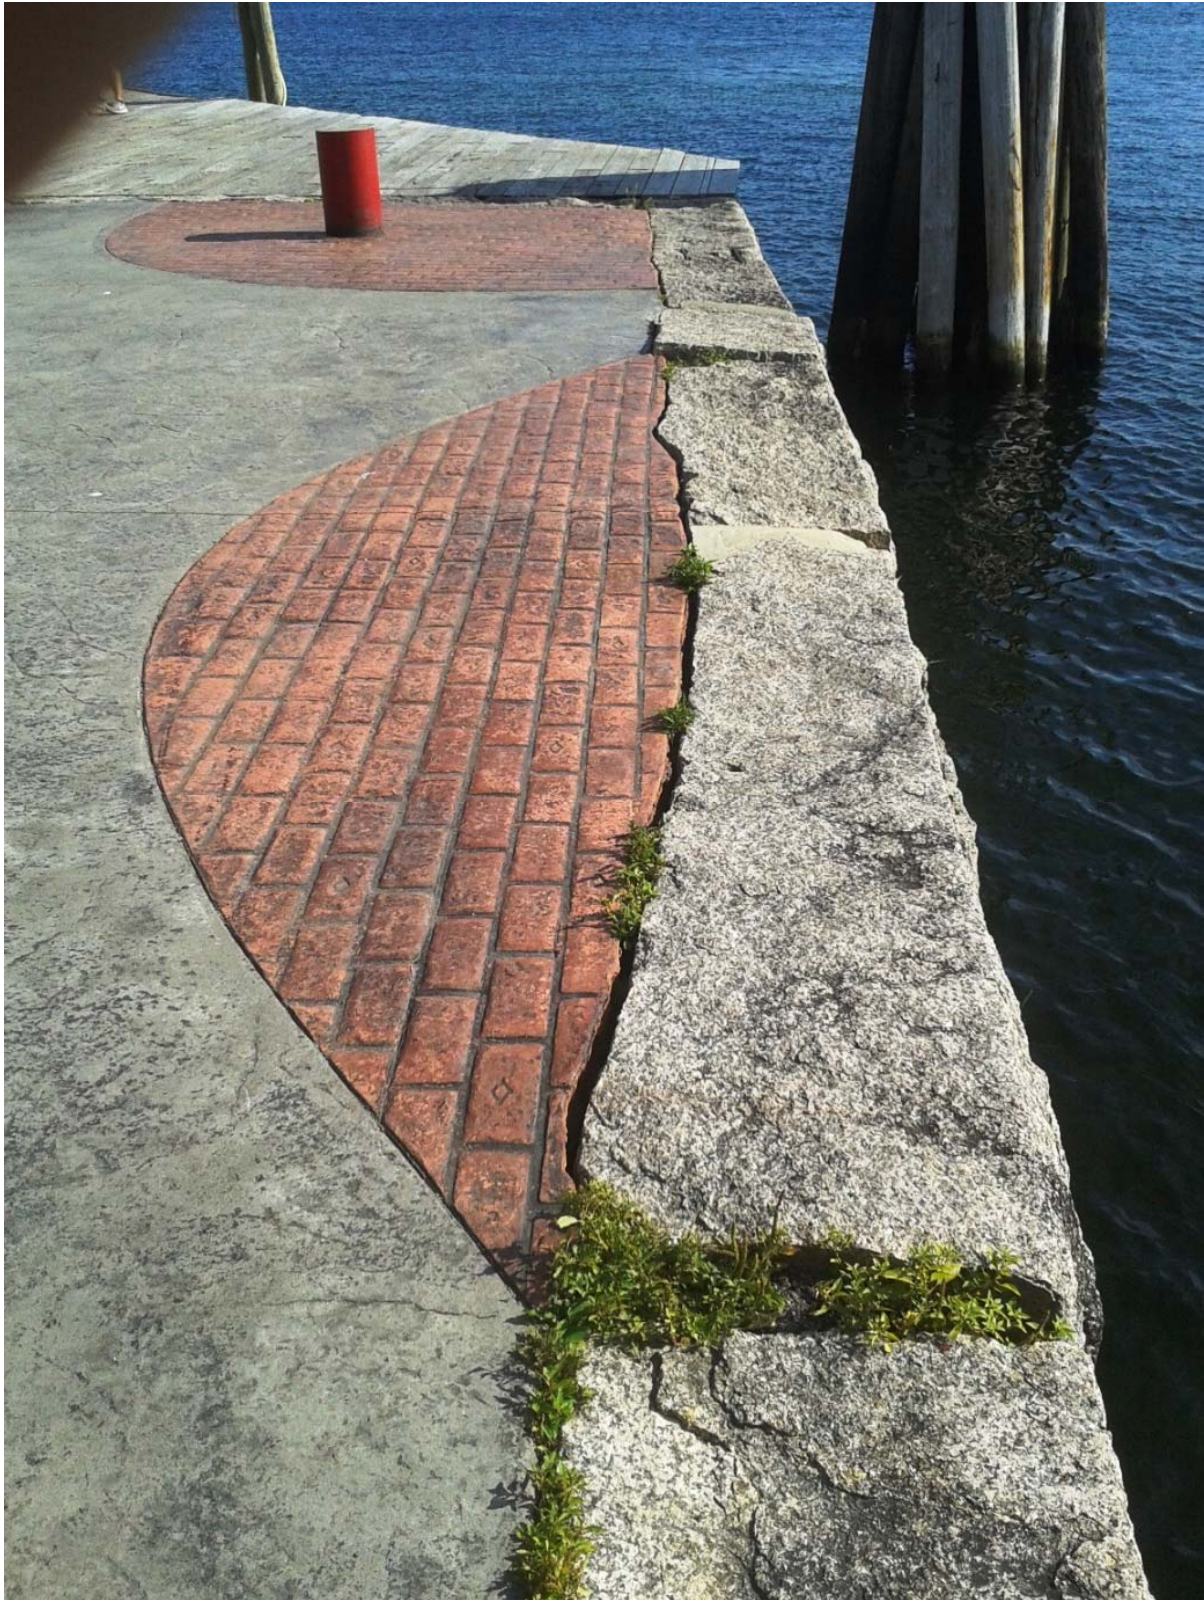
Photo 14 Western face of seawall, note opened gap between the granite blocks and cast in place concrete slab

At the corner of the seawall on the western end of the wall, the timber wall below water have deteriorated away and opened a large void under the granite blocks. This and other voids should be filled with grout bags (prior to revetment placement) to prevent further settlement of the granite blocks above.

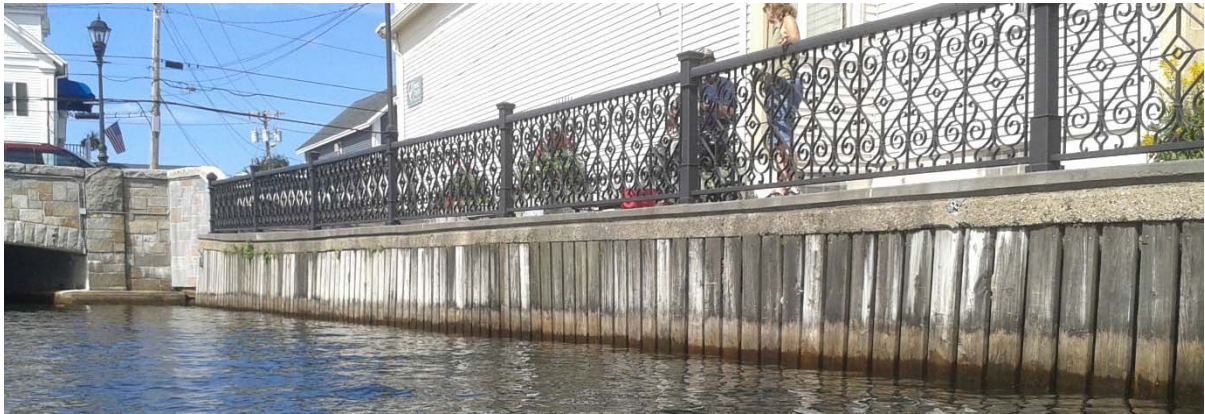
The wall along the river from station 4+01 to 5+18 is comprised of rock filled log cribbing, with a covering a sawn timber facing/fendering above water level. This length of wall does have indications of scour damage and log deterioration above and underwater. There are many large grout bags around station 4+50 that appear to be a prior repair of channel scour along the wall. A loose log end was found at station 4+25 indicating a broken or deteriorated log. A log end at station 4+56 contained decay at about 1.5 feet below the sidewalk. At station 5+16, log ends just below the concrete pavement level have settled about 2 inches from when the pavement concrete was placed. The inshore extent of the log cribs is not known and may be of concern if they extend under and support the adjacent building.

Photo 15 Log crib wall with timber plank covering

Fixing this section of wall is similar to the repairs described under Section 3.6 to the extent a stone slope can be used without restricting the navigation channel and not control river cross section. We recommend constructing an underwater revetment slope to stabilize the wall and prevent further scour and to stabilize the crib wall. This conceptual repair may need to incorporate an above water vertical wall where there are geometric or flow constraints which have not been included in these preliminary construction budget estimates. Prior to setting the revetment, we recommend filling the void with grout bags or stone. As this conceptual repair would not address existing voids under the adjacent building, it may need additional repairs such as void grouting or underpinning.

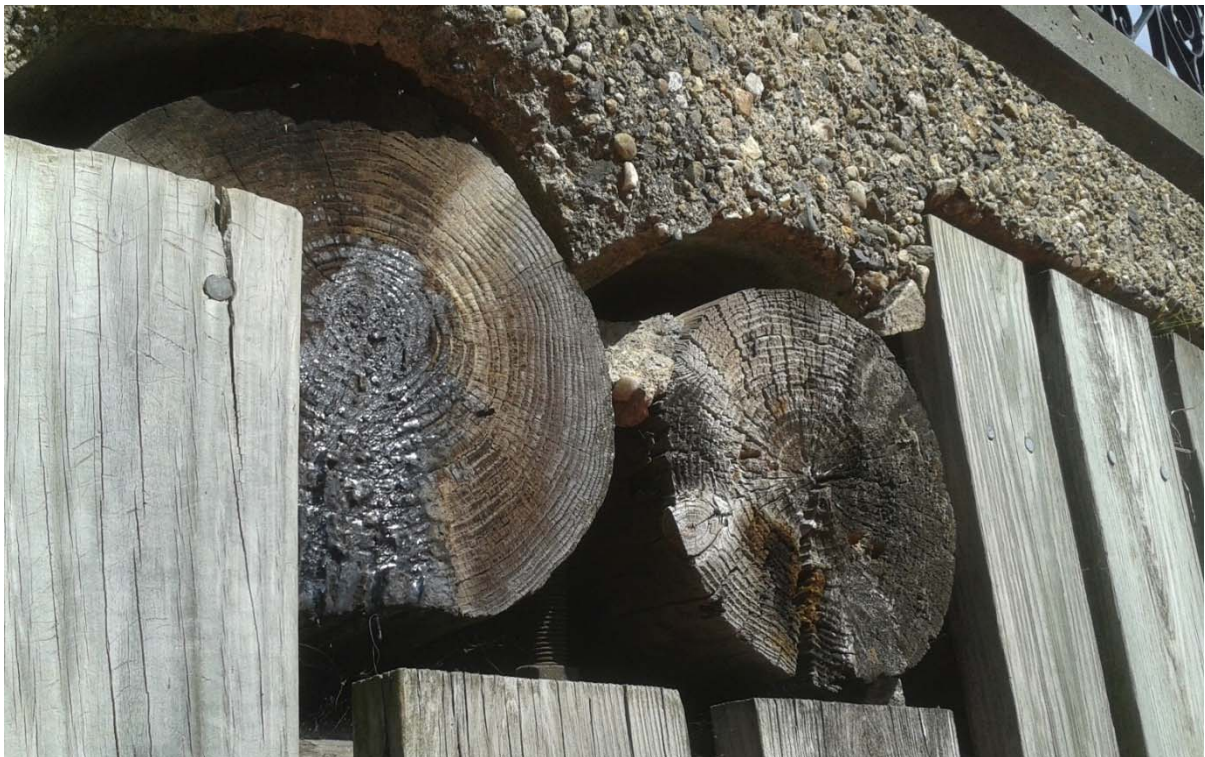
Photo 16 Log ends settled relative to concrete pavement above

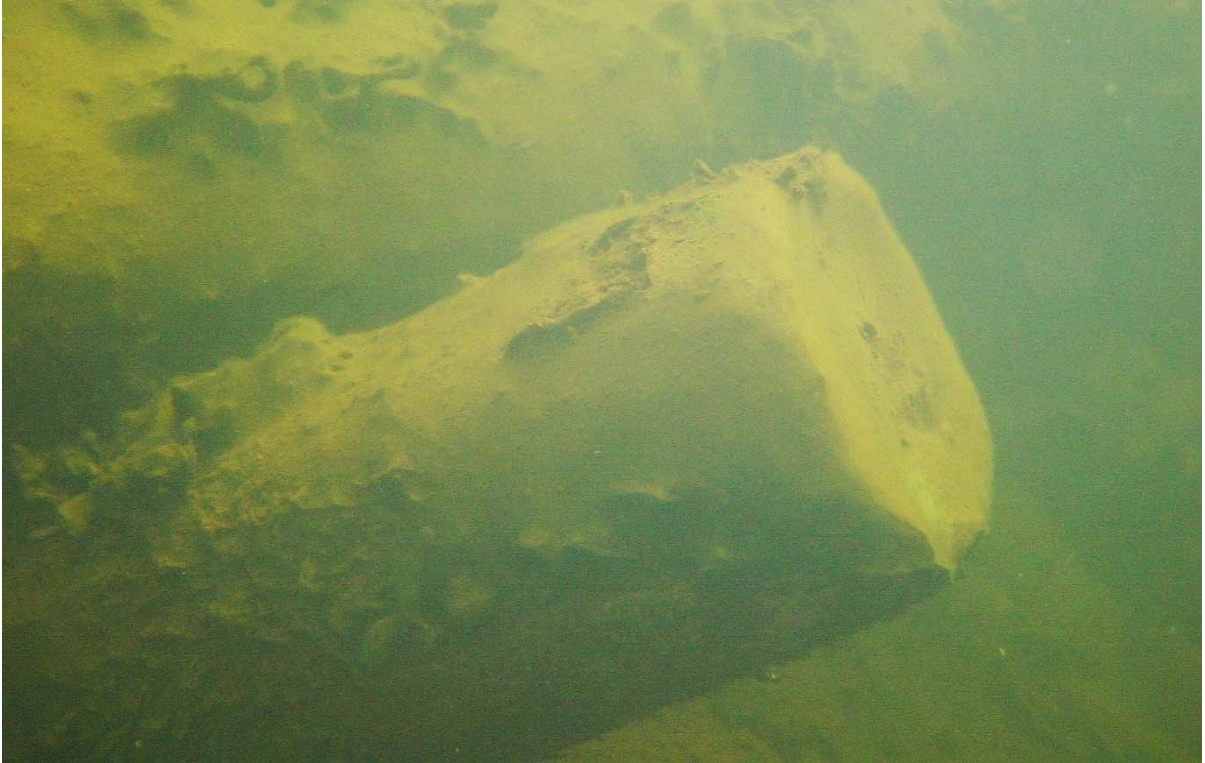
Photo 17 Crib log end angled upward, suggesting scour induced subsidence or a broken log

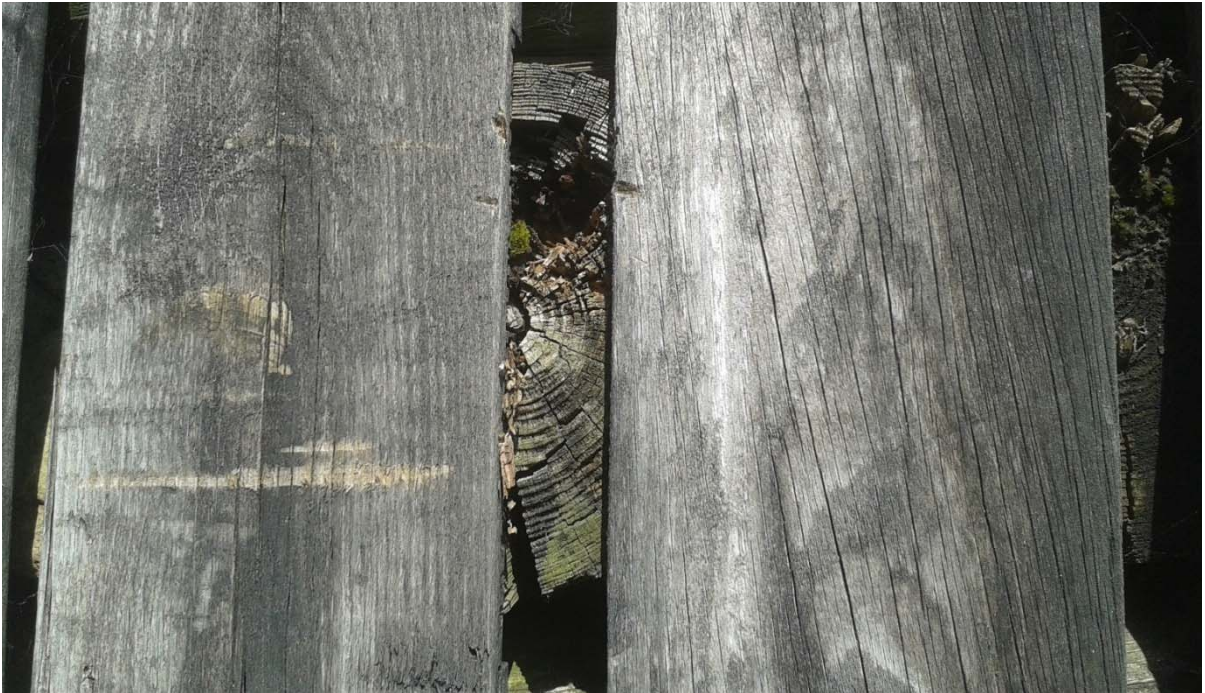
Photo 18 Log end decay visible between planks

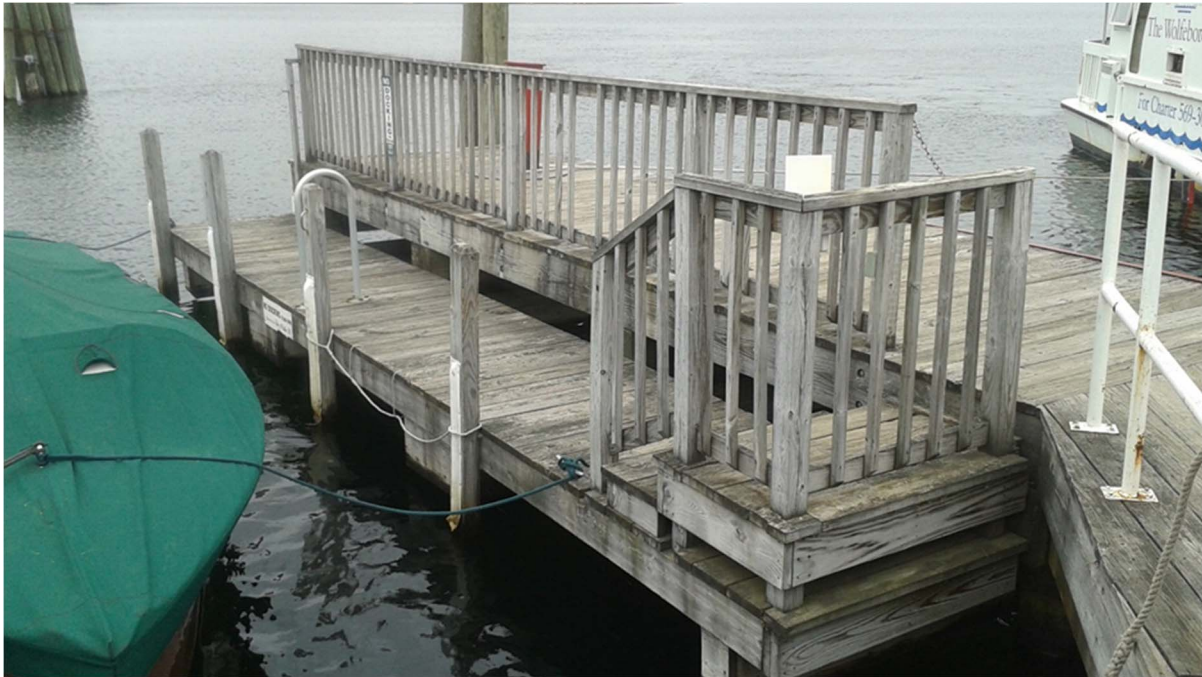
Photo 19 Cantilevered deck
