Town of Wolfeboro

Public Safety Building

Feasibility Study Final Report
August 8, 2018

EXISTING FACILITY CONDITIONS ASSESSMENT

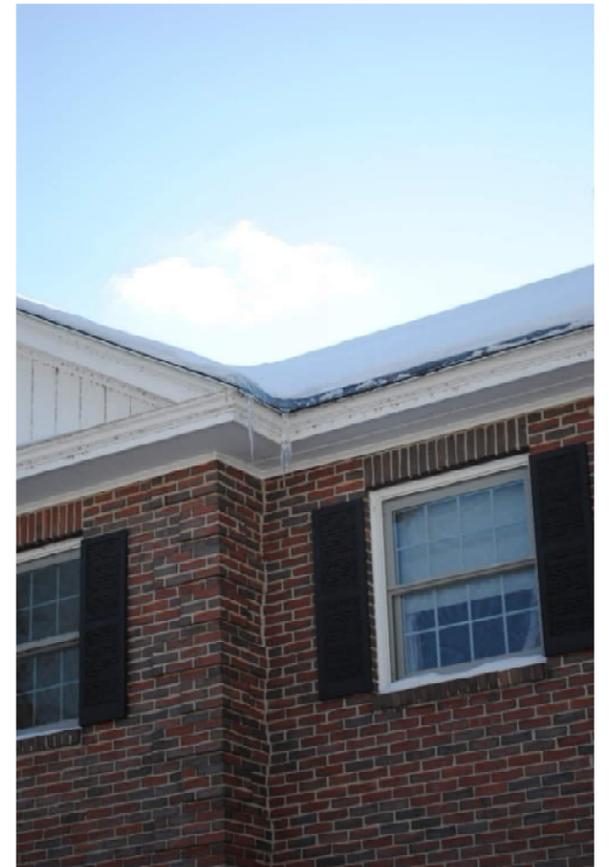
Minor ice damming on the east elevation roof in the small gable roof valleys above the public entry doors was observed. No similar conditions were observed elsewhere. Soffit venting was observed along the main roof and gable ends. Venting in the lower soffit above the masonry exterior wall was missing. In reviewing the construction drawings, the small gable roof section was built over the main roof plywood sheathing and supported by the main trusses. This creates a complex space and potentially difficult to vent. So, it is suspected that this valley ice buildup could be a result of trapped heat loss from below causing melting snow on the roof. Further study of this area might clarify what is causing this issue. Interior damage from water back-up was not apparent from inside the building. Ice damming was not observed on the west facing gable roof.

Minor ice damming at East façade roof

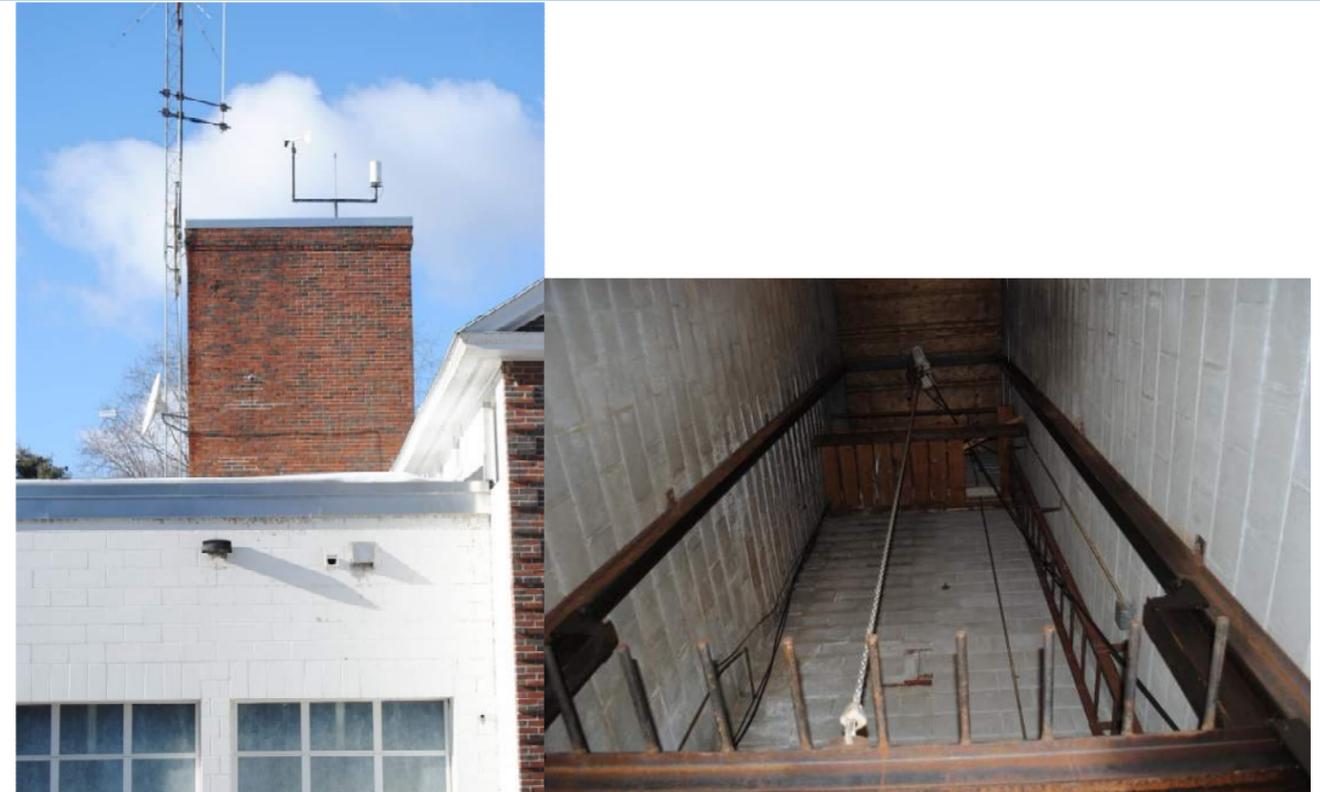
The exterior Hose Tower brick veneer was not accessible from the outside for a close review. They appear to be in good condition. According to the *Bergeron* report, the brick should have been repointed. However, it does not appear to have been repointed recently. The hose drying tower from the interior view appears to have moisture saturation on the interior concrete block surfaces on the south and west walls near the top of the shaft. This moisture could be due to warm air rising from inside the Apparatus Bay and condensing on the walls. However, this shaft is vented at the top with a wall louver on the west elevation and should relieve this possibility. A better possibility could be from a combination of roof and wall conditions. The tower roof pitch drains moisture over the roof edge allowing water to drain down the brick face. This can saturate the veneer surface and travel inside the wall. Similar moisture conditions were identified in the "*Bergeron*" report. Further review of this issue is warranted to resolve the cause of this condition.

Hose tower exterior and interior views of moisture saturation.

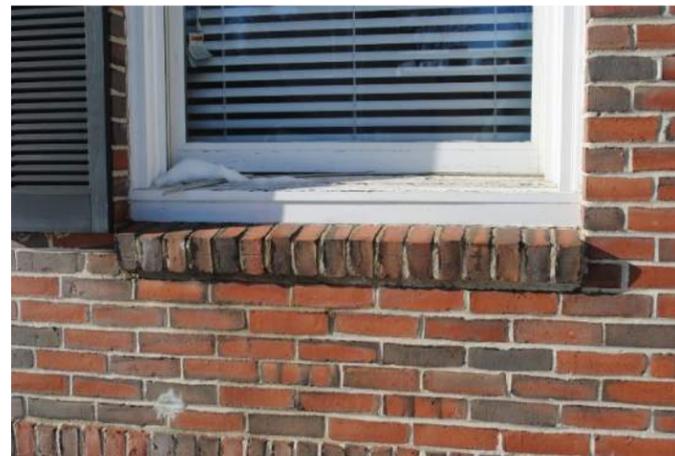
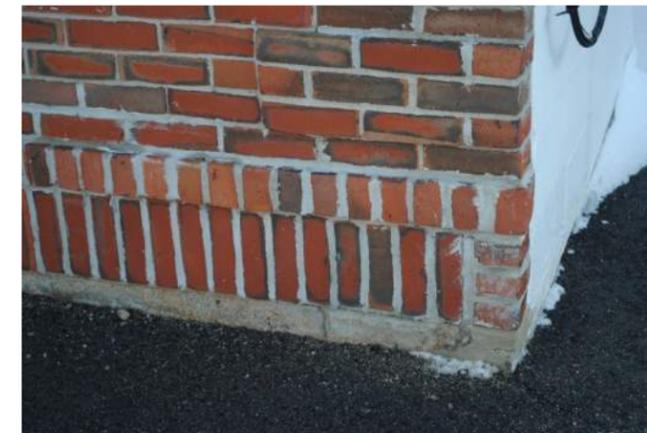
The brick veneer and mortar joints on all elevations appeared to be in good condition. There is evidence that some isolated repointing to wall mortar joints was executed. Brick sills at locations accessible to observe need some repointing where mortar has chipped and eroded. Sills see severe weathering, and should all be reviewed for attention. There is some minor build-up of liken and moss growth along the lower 16”+/- surfaces above grade only on the east elevation wall. This could be resulting of constant wetting of the brick surface from roof rain run-off and splashing up from the adjacent finish grade. This liken should be removed with a proper cleaning method. The *“Bergeron”* report recommended applying a waterproofing to all brick surfaces. If this was executed during the earlier restoration, a reapplication may be recommended following cavity weeps installation and brick cleaning.

Brick masonry previous repointing – no brick weeps

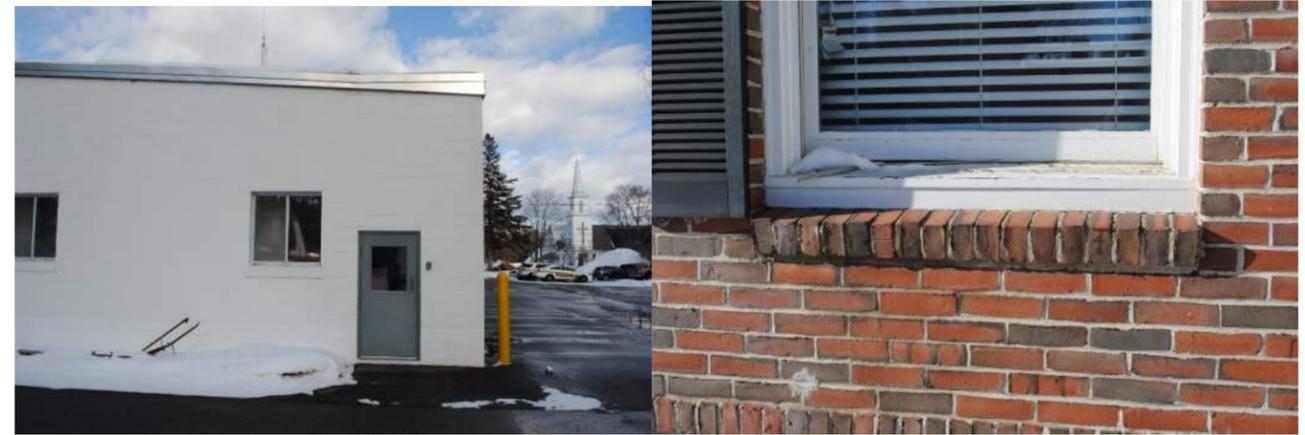
Exterior windows on the west wall of the Apparatus Bay are side-sliding aluminum frame with single pane glass. They appear to be original installed product. They look in good condition but are very poor energy efficiency performing. Considering the poor energy performance of the Apparatus Bay envelope, replacement of these windows may not prove a valued action until further overall envelop improvements are considered.

Apparatus Bay west windows

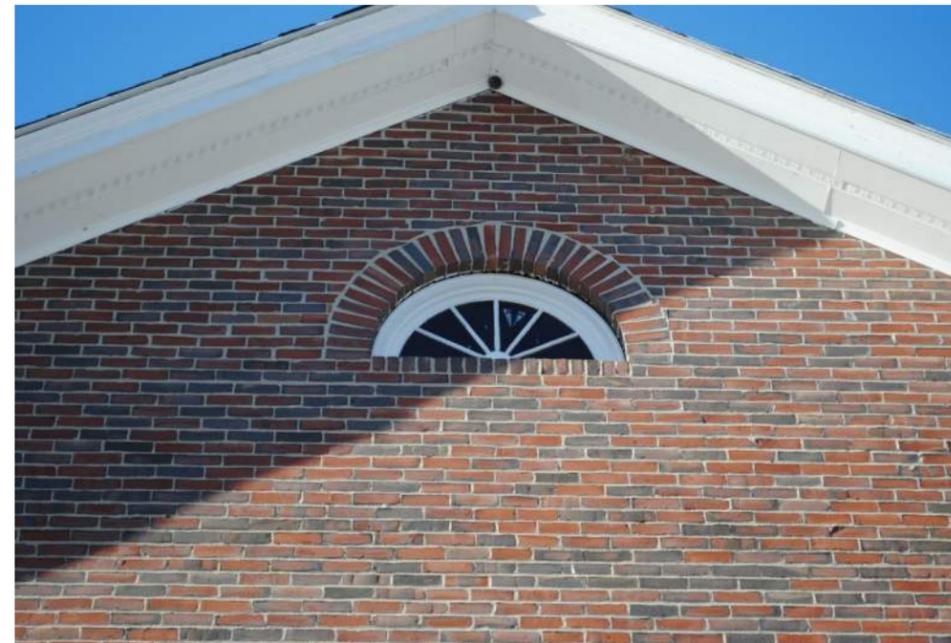
Exterior windows appear in general to be in good condition. They appear to be of a residential level quality product and expect are replacement units since the original building construction. The windows are of a thermal insulating glass and wood frame type with weather-stripping. Some conditions were observed where the bottom weather-stripping on lower sash have come free. It would be our recommendation to review all windows and replace or repair weather-stripping as necessary. Reducing air infiltration through windows is a major step in increasing building energy performance. And, this maintenance is a very cost-effective action to take. Perimeter joints between window frame and brick masonry are very important to maintain building energy efficiency as well in the reduction of air infiltration. These joints should be inspected annually and replaced about every 7+/- years. It was observed from inside the attic and outside that the south attic semi-circular window joint between frame and brick had no sealant. Although the attic is an unheated space, this opening also allows moisture into the building which can then create damage to the interior wall system along with air infiltration. It is unknown when sealant joints were last reviewed. It usually happens when wood trim is repainted. A review of all joint conditions should be scheduled to determine the full extent of repairs necessary.

Office section window weatherstripping repair

Missing sealant around window to brick joint.

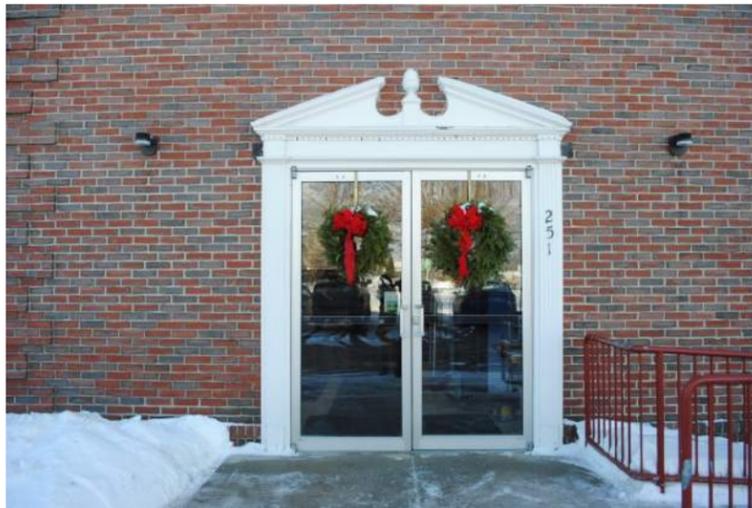
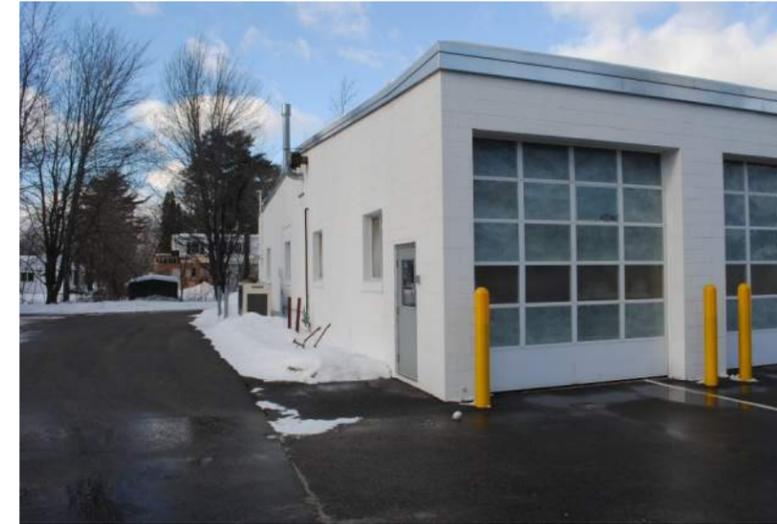
Apparatus Bay south elevation overhead doors (with damage).

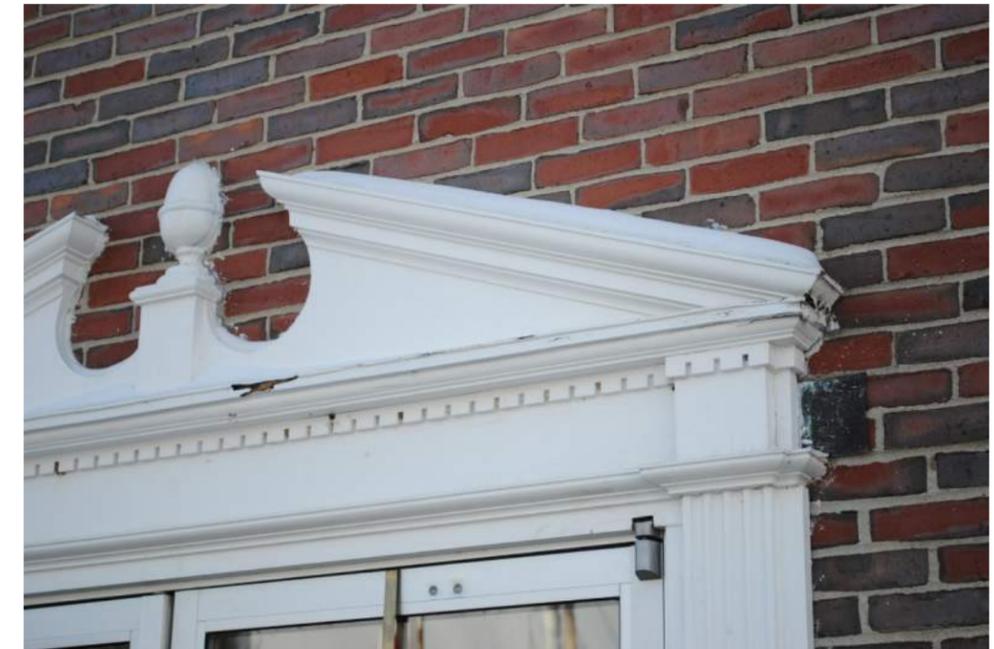
In general, all trim at roof soffits, windows and doors appear to be in good condition with no observed chipping or peeling. There are numerous insect cocoons collected on the wood surfaces. The colonial wood decorative trim over the front entry door is showing some rotting. Considering the advanced condition, it looks like this condition may have been here for a while. Moisture may be gathered on the flat top surface and soaking into the wood. Repair or replacement would be recommended.

Trim rotting above front public entry doorway

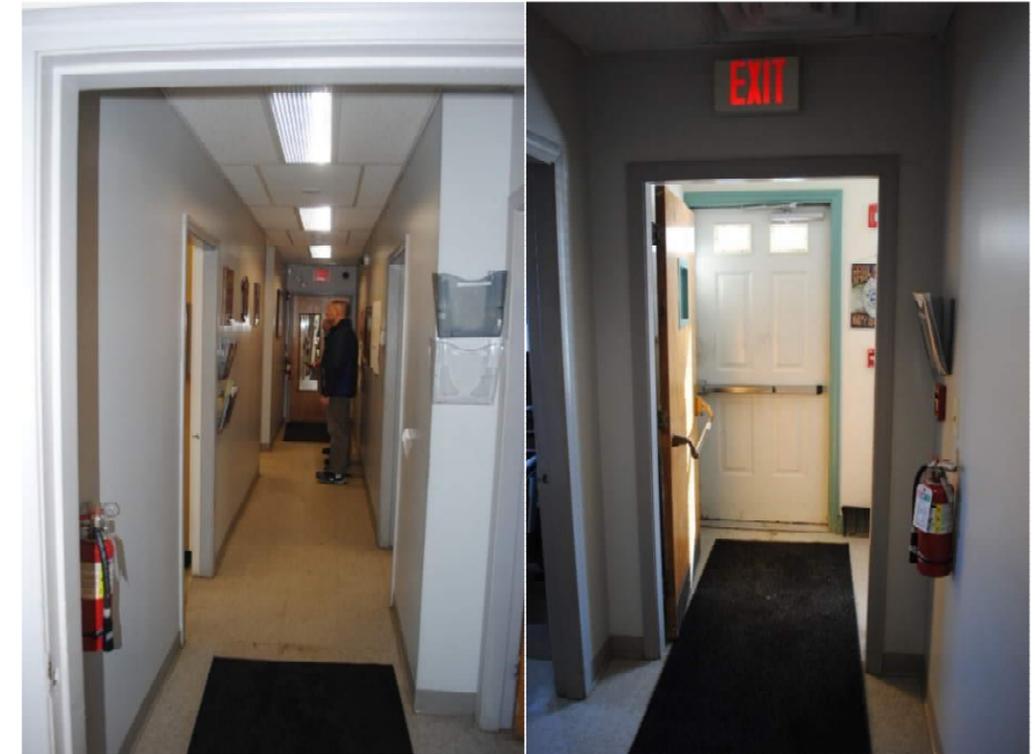
Door opening missing interior closers

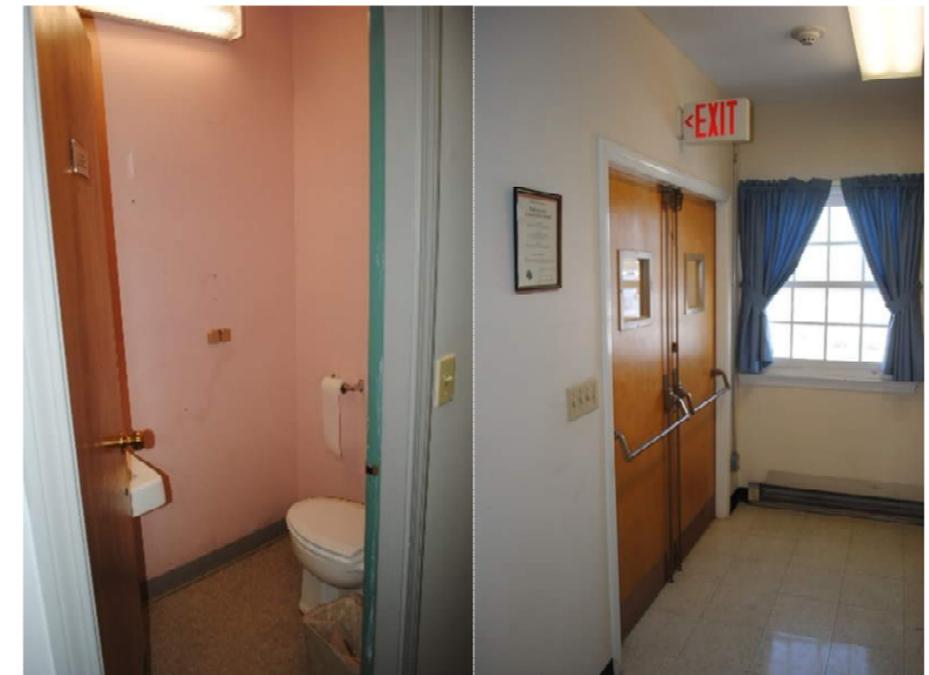
Toilet Room door swing conflict

Missing door closer hardware

- Door closers mechanisms are missing on all fire labeled doors.
- The north Fire Department stairway first floor door was missing a positive latch mechanism.

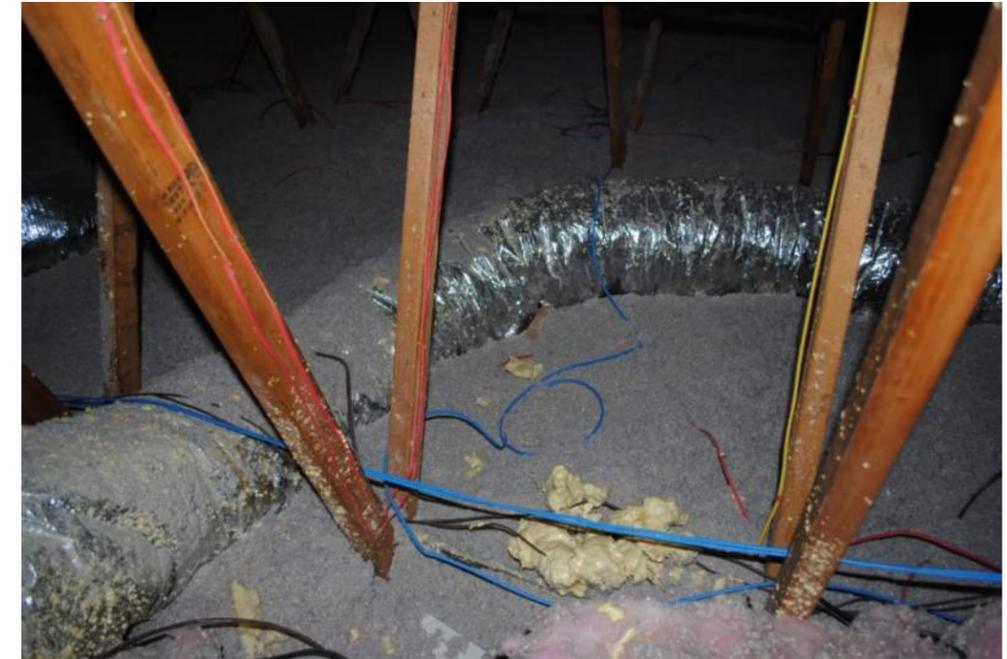
The effective attic insulation layer is between ceiling framing and truss lower cord members. The material appears to be a loose blown-in cellulose product. Thickness was measured at 6”+. Random placement of 6” fiberglass batt insulation was also observed above cellulose but not in any effective placement to add thermal value.

Loose blown-in cellulose insulation - uneven layered.

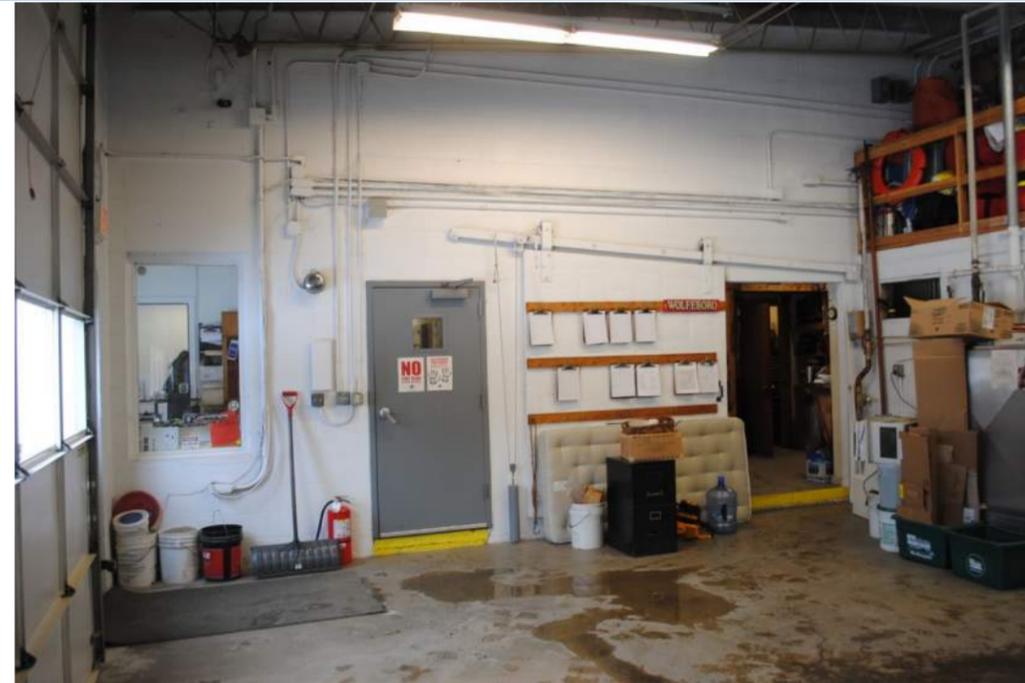
Exit door latching hardware is installed on all doors except the north stairway first floor door Fire Station. This door is missing latching hardware. All doors through protected walls are missing door closer mechanism hardware. It is unknown at this point whether closer hardware was a code requirement at the time of construction. However, by today's code standards, a door closer mechanism is required as an opening protection in stairway rated walls. We would recommend that closers be installed to maintain opening protection of rated wall protection.

Fire Department Apparatus Bay (Storage Use Occupancy) block wall and rated sliding fire door. NOTE: window on left of wall is an unprotected opening through the concrete block separation wall into the Office (Business Use Occupancy)

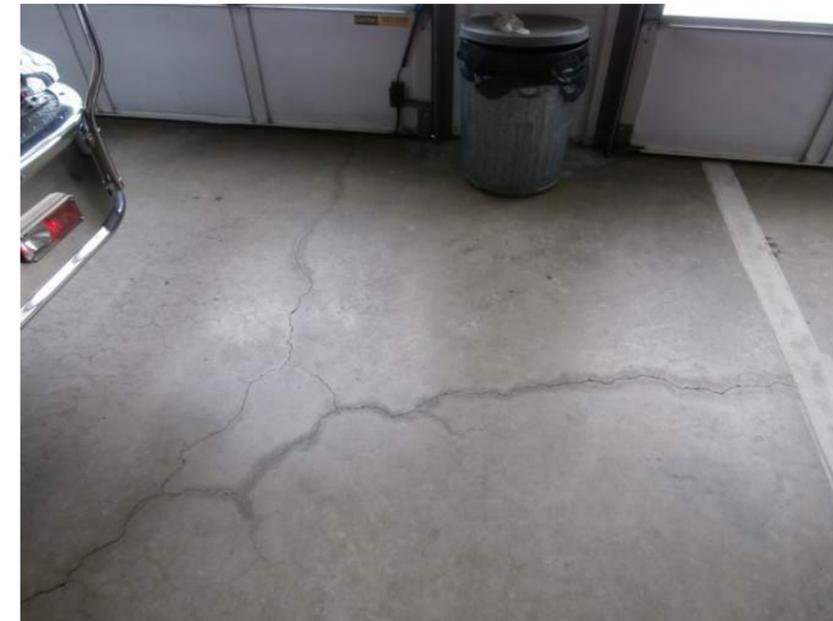
Cracked floor slab, Apparatus Bay

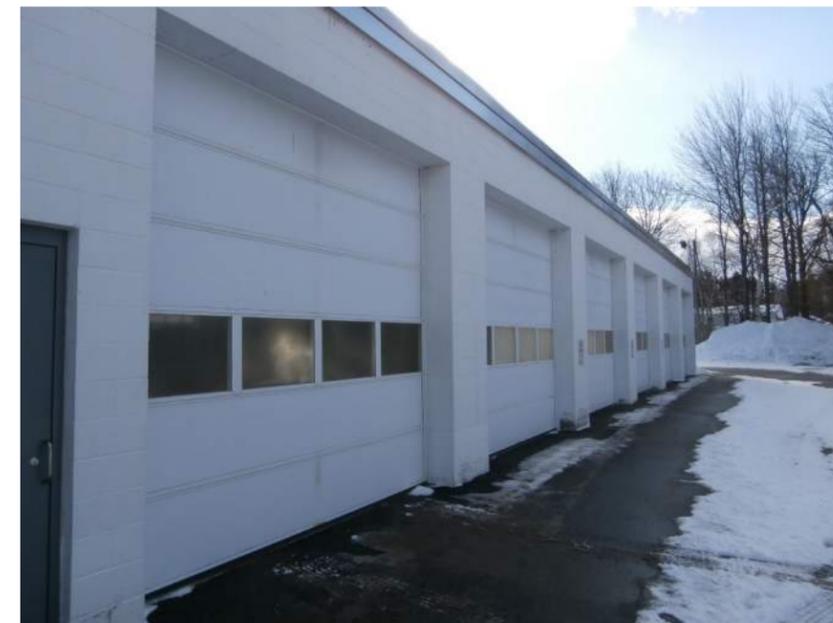
Reconstructed/Repaired masonry bearing walls and door headers, Apparatus Bay

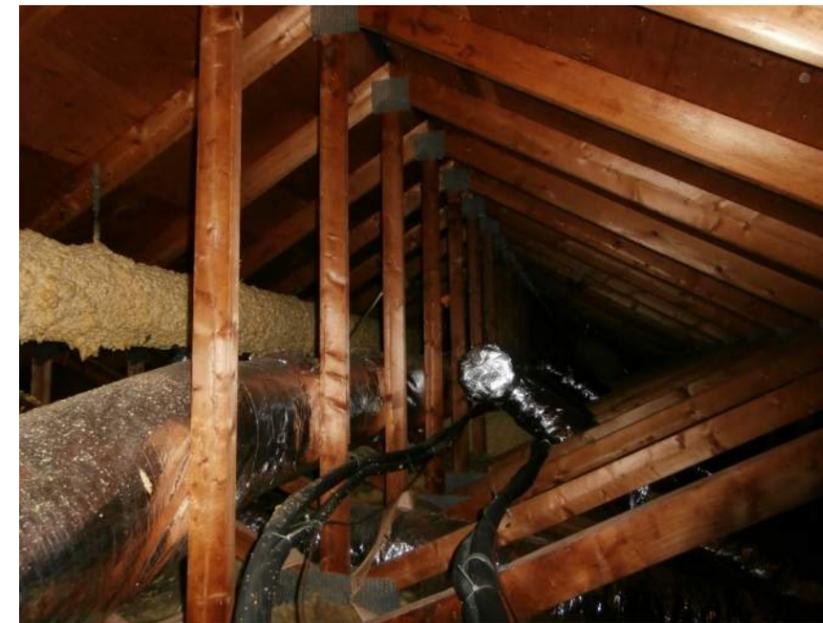
Scissor trusses – no thru-truss bracing

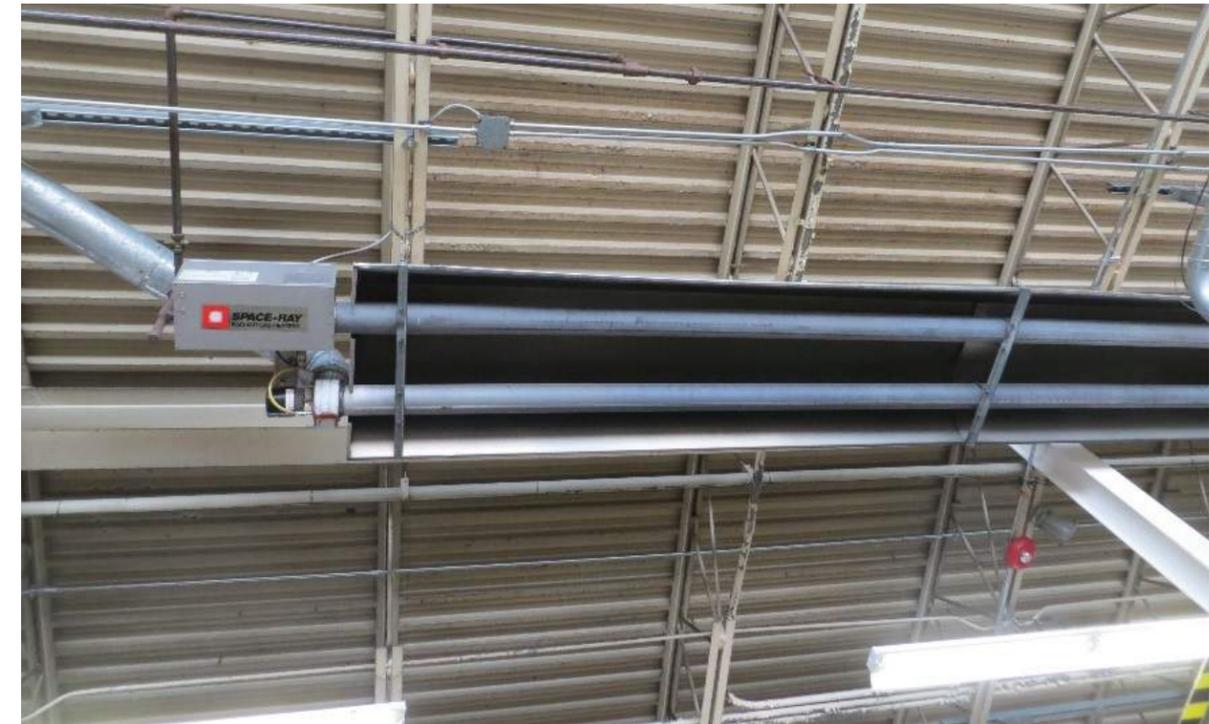
The apparatus bays for the fire and police department are heated by LP gas fired infrared tubes installed high in the bays and power vented through a common pipe out the back of the fire department truck bay. Three Space-Ray heaters rated for 130,000 BTU/hr serve the fire department. One (1) 130,000 BTU/hr heater serves the police department sally port. Heaters are controlled by an electronic wall mounted thermostat, one for each department. All reports indicate that in the 15 plus years the heaters have been installed, no issues have been noticed and the heat output is more than sufficient for the space. The heaters were observed to be in fair condition. At more than 15 years old, small signs of vent deterioration and tube pitting are starting to show. It is estimated the tubes have 5-7 years of useful life remaining before deterioration starts to warrant replacement. Additionally, residue around the vent pipe joints was observed indicating back-pressure may be allowing some products of combustion into the space.

Example of Infrared Tube Heaters

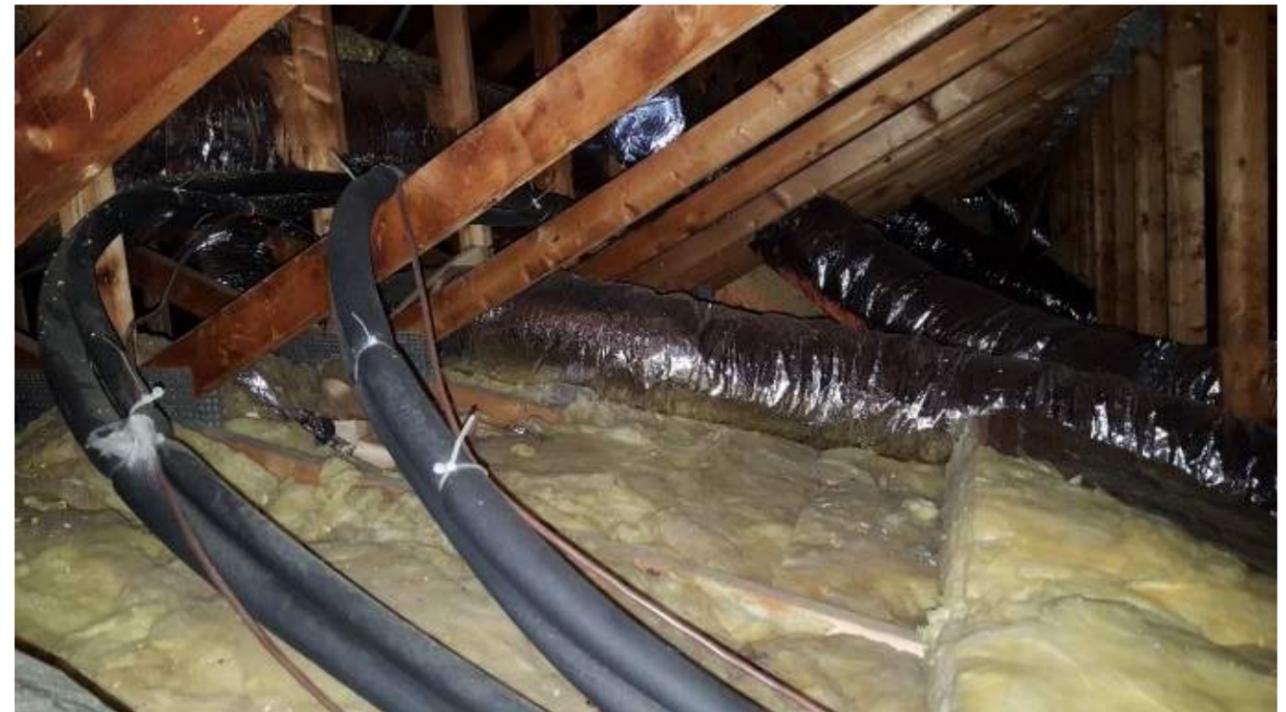
All branch ductwork in the building appeared to be insulated flex ductwork. The flex duct is in good shape, although it is kinked in some areas and most likely restricts airflow from the heat pump to some degree with long twisting runs.

Existing Ductwork in Attic
