HDR

SEWER PUMP STATIONS
CONDITION ASSESSMENT
TECHNICAL MEMORANDUM

June 28, 2021

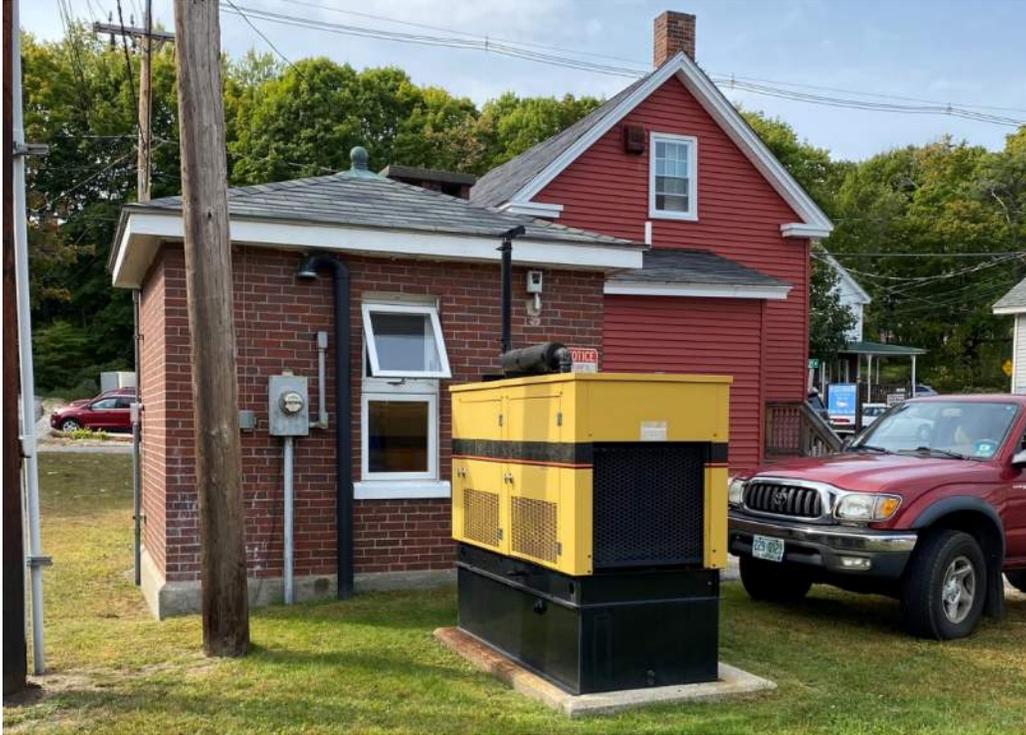
The red building shown in the background of Figure 3-1 is a Town owned building currently used to store valves, spare parts, and equipment.. This building is old and in poor condition. It is reported that this structure does not have a foundation and is not suitable for restoration. The Town is planning relocate the stored materials to a more appropriate facility and demolish the building to allow more room at the pump station site prior to construction. The red building shown in the background of Figure 3-2 is part of Wolfeboro Oil.

Figure 3-1 Lehner St. Pump Station with Emergency Generator

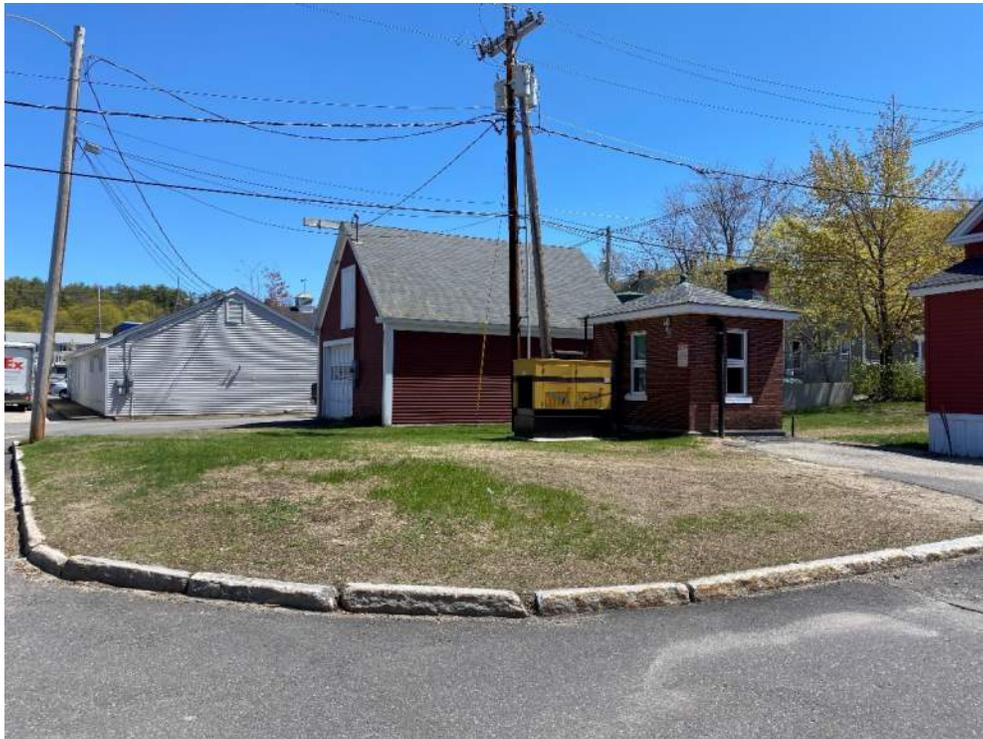
Figure 3-2 Lehner St. Pump Station with Emergency Generator

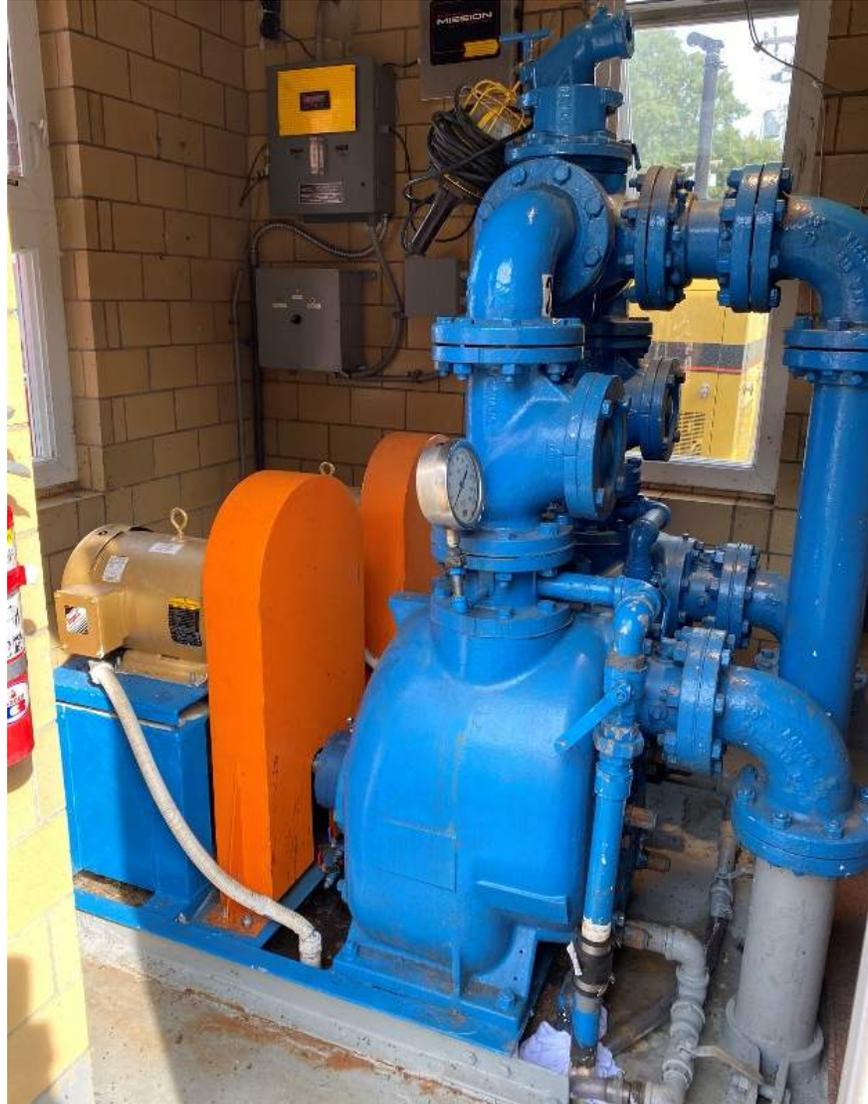
The existing pumps serving this pump station are self-priming pumps manufactured by Gorman-Rupp (Model No. T3A3-B) shown in Figure 3-3. The pumps were last replaced a few years ago and the Town assumes the original design pumping capacity of 320 gpm with one pump running is being achieved. The pumps operate as lead/lag with the lead pump alternating and are connected to a telemetry system to alert the Town to high water levels in the wet well.

- Extremely close working quarters around and between the pumps makes maintenance difficult.
- Safe and adequate access to the wet well areas is not possible with the current wet well and building design.
- Piping within the wet wells are extremely corroded and should be replaced. This includes the discharge forcemain.

Figure 3-3 Lehner St. Raw Wastewater Pumps

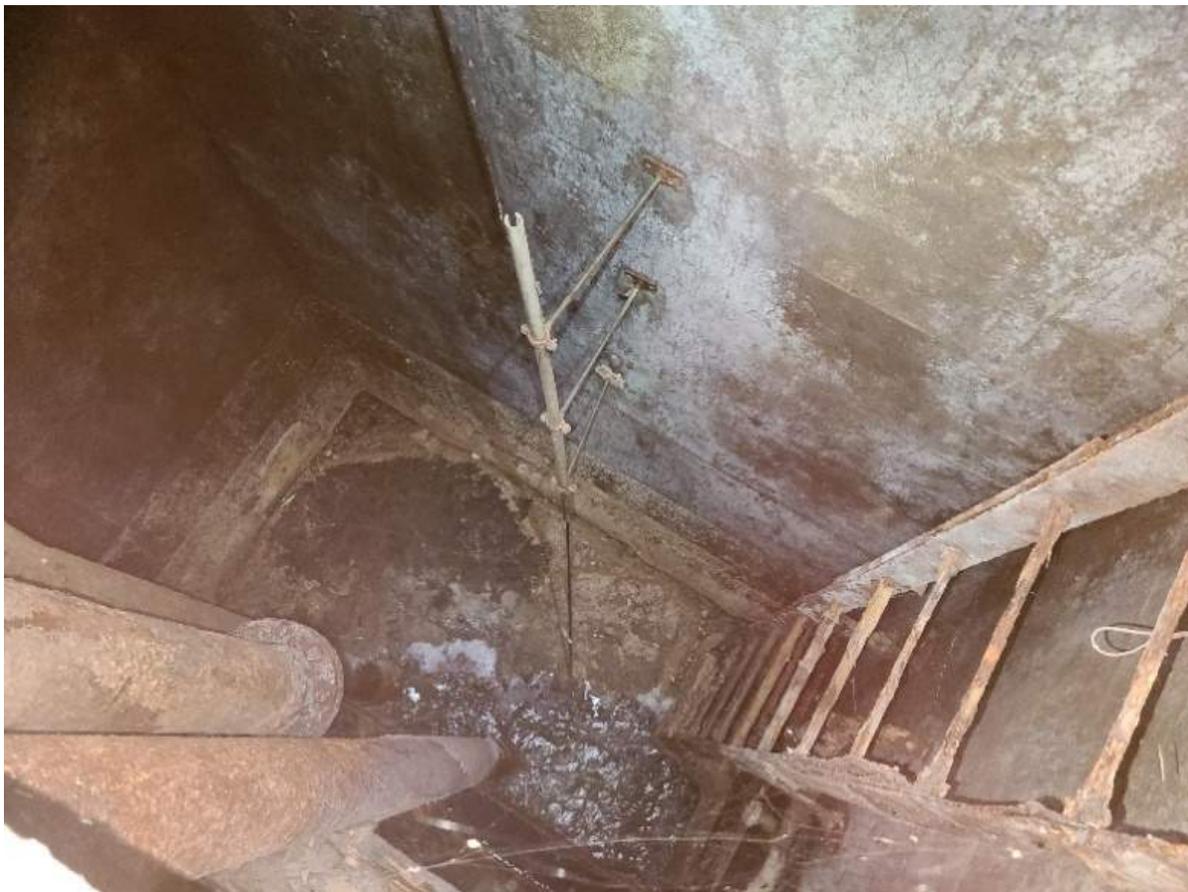
The original 1940's brick pump station building is showing its age even though the Town has done well maintaining it. The pump station has two wet well structures approximately 16-feet deep. One wet well is exterior to the building (exterior wet well) and one wet well is directly under the building and holds a larger volume (main wet well). The exterior wet well is shown in Figure 3-4. Deficiencies noted in this portion of the structure include:

- Minor abrasion to the concrete with minor loss of paste but with no exposed aggregate at the bottom of the wet well.
- The piping and support members exhibit severe corrosion with loss of section.
- Access ladder has heavy corrosion with loss of section and is not currently safe for access.

Figure 3-4 Lehner St. Exterior Wet Well

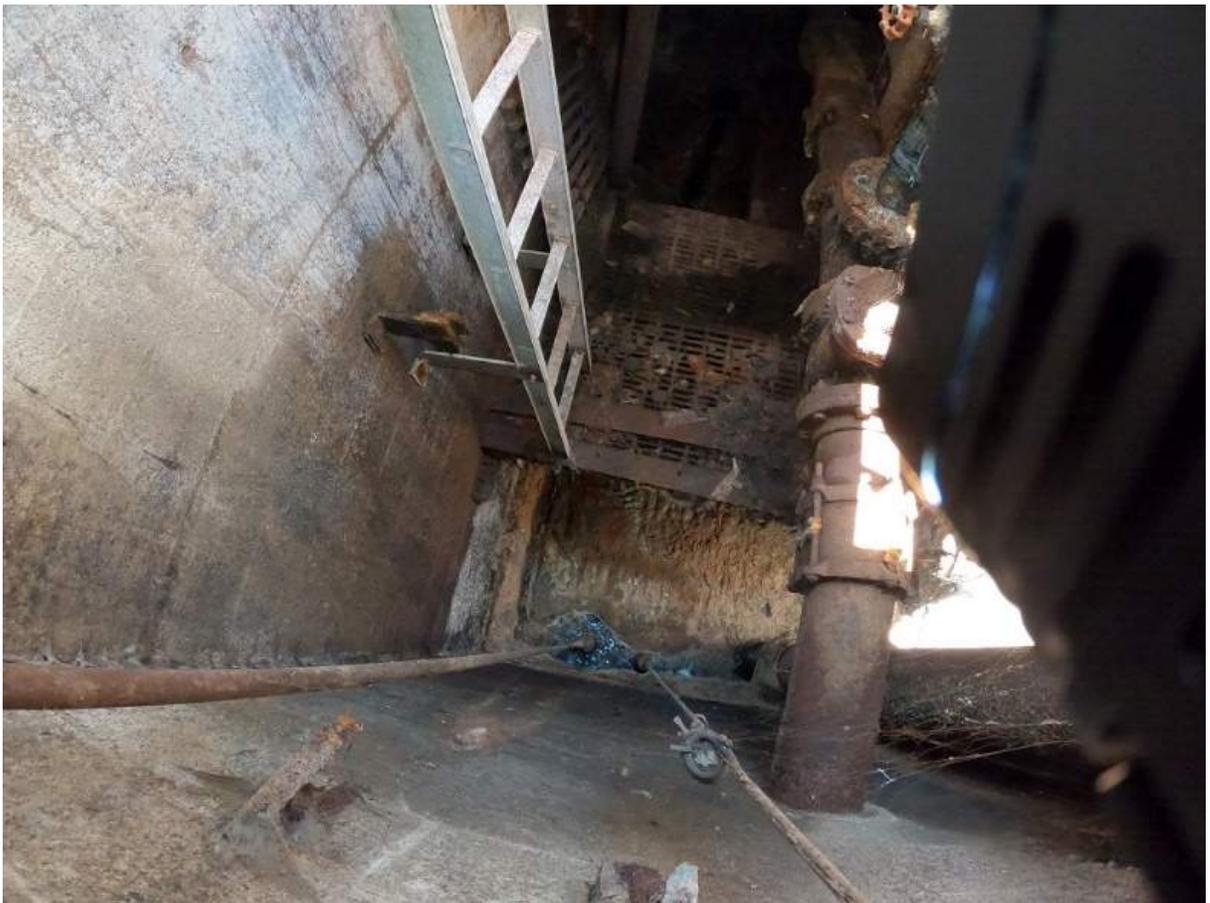
The main wet well is shown in Figure 3-5. Deficiencies noted in the main wet well include:

- Minor abrasion to the concrete with minor loss of paste but with no exposed aggregate at the bottom of the wet well.
- The underside of the overhand has two (2) L-shaped spalls with exposed reinforcement having moderate corrosion as shown in Figure 3-6.
- The piping and support members exhibit moderate to severe corrosion with loss of section along with material building up on the valves as shown in Figure 3-7.
- The grating at the bottom of the wet well exhibits severe corrosion.
- The original access ladder has been replaced with a new aluminum ladder.

Figure 3-5 Lehner St. Main Wet Well

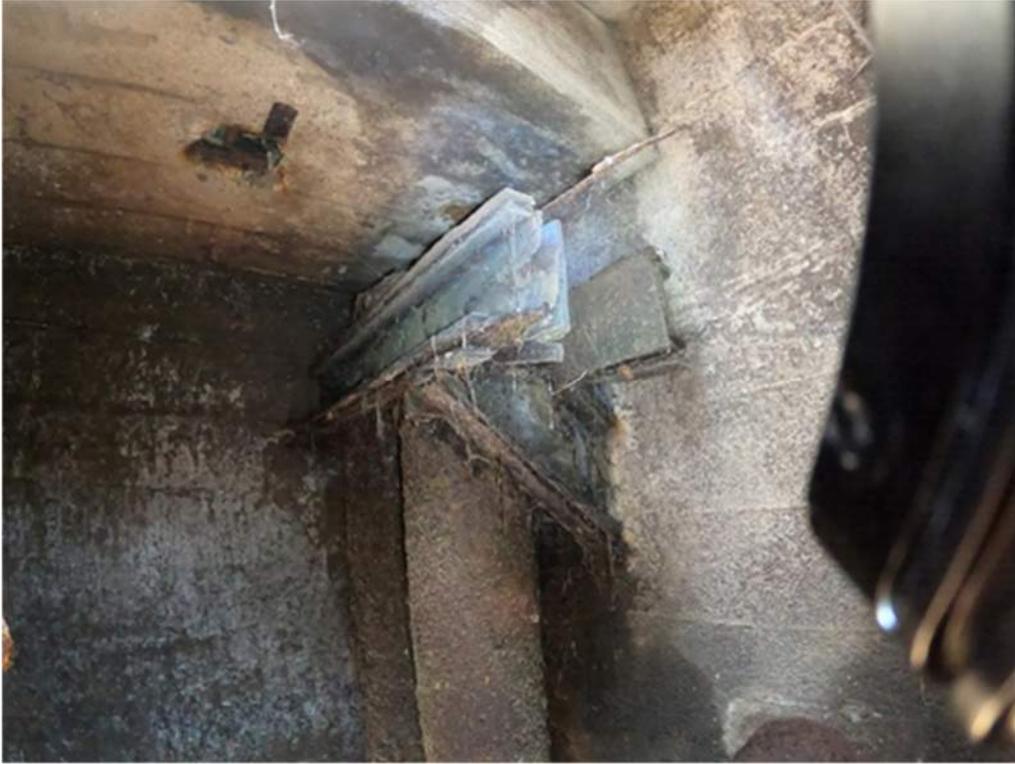
Figure 3-6 Exposed Reinforcement in Main Wet Well

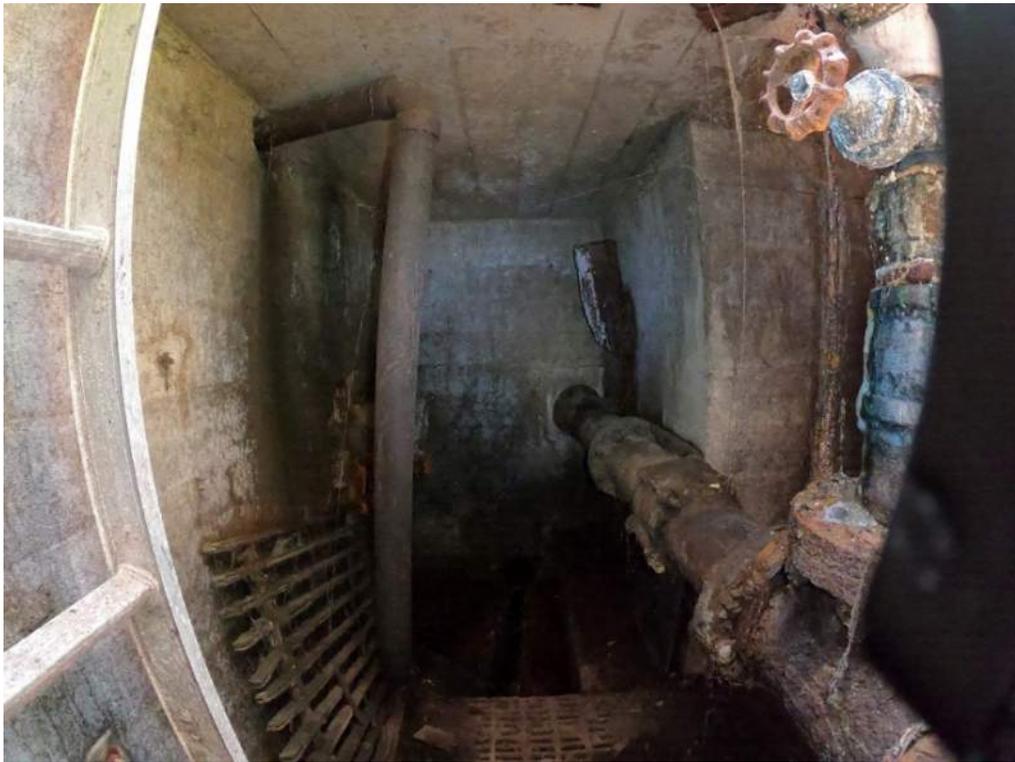
Figure 3-7 Corrosion in Main Wet Well

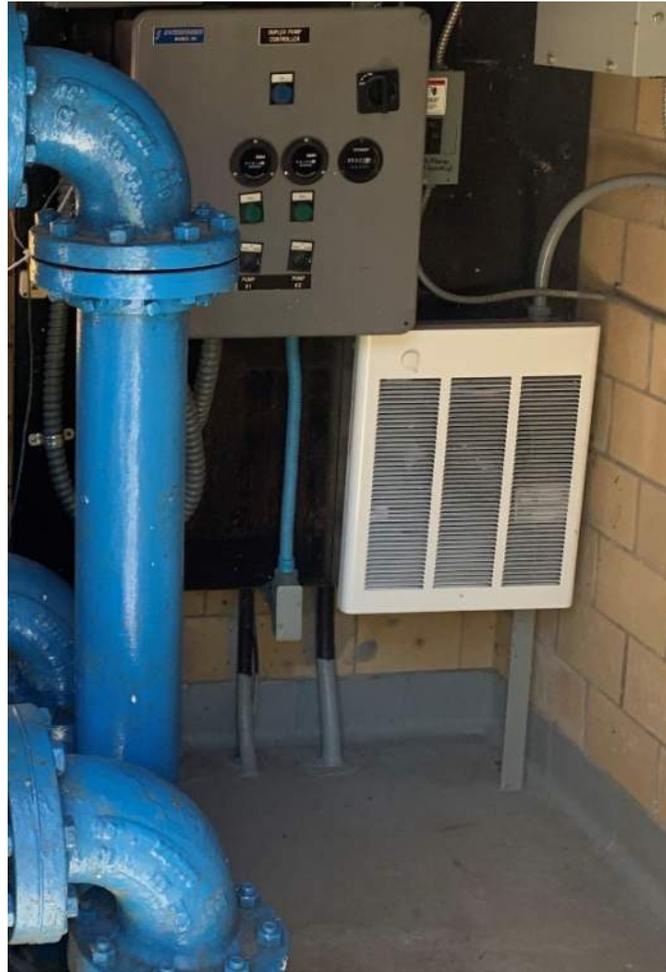
Lehner Street station is currently served by a unit heater with integral thermostat (Figure 3-8). There was no observation of passive or mechanical ventilation within the pump house. Windows are required to be left open to release excess heat in the summer months which does create a security concern for this pump station.

Figure 3-8 Lehner Street Pump Building Unit Heater

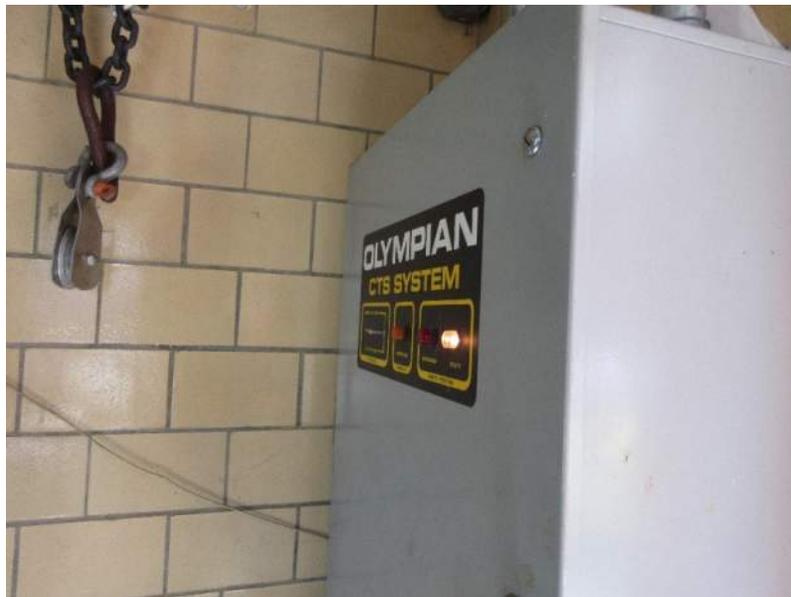
- The wet well is classified as a Class 1 Division 1 space, according to NEC Article 500, and it is not properly sealed off from the electrical equipment. Currently, all the electrical equipment is installed in a Class 1 Division 1 atmosphere, for which it is not properly rated.
- There is not a 3' minimum working space for the electrical equipment and pump motors as required by NEC Article 110.26.
- The ATS and stand-by generator were installed in 1991 and have reached the end of their useful life.

The wet well space not being properly sealed off from the electrical equipment is a significant concern that can lead to failures of the system and regulatory non-compliance. Corrosive gasses will degrade metal in the electrical system including control panels and wiring over time and eventually result in system failures. When failure occurs, the pump station may not operate, and system backups and sanitary sewer overflows may occur causing violations.

Figure 3-9 Automatic Transfer Switch (ATS)

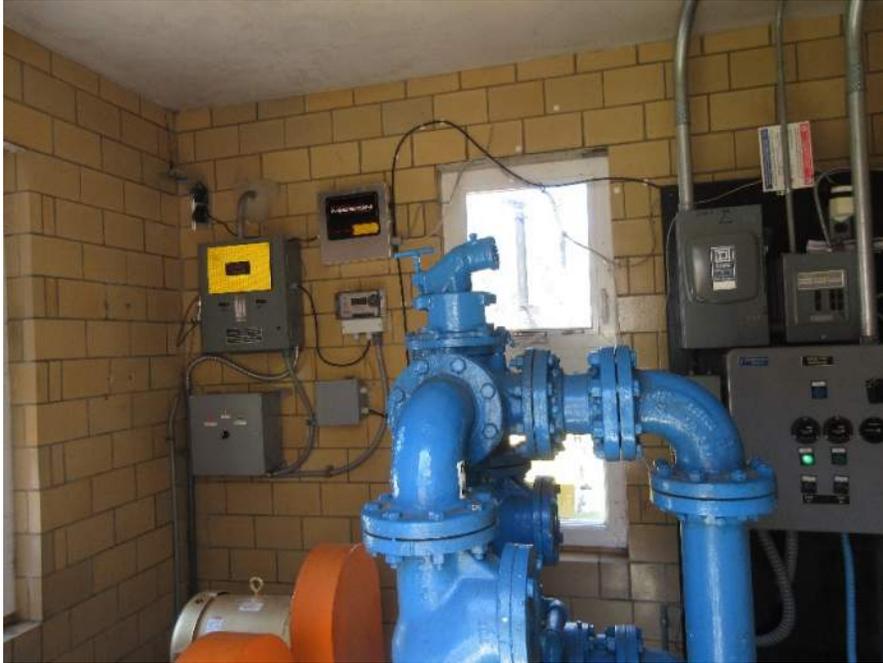
Figure 3-10 Pump Controller and Pump Control Panel

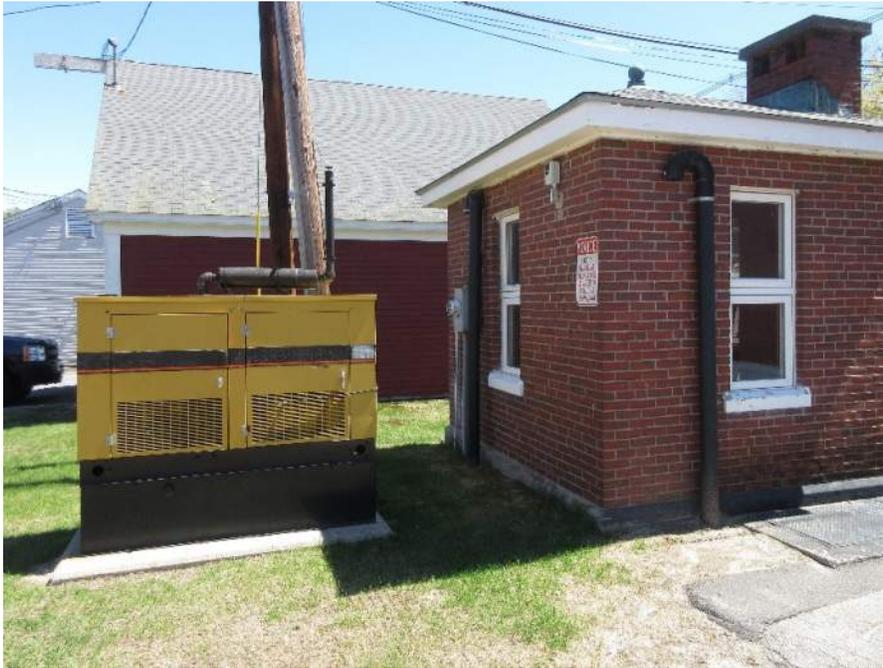
Figure 3-11 Stand-by Generator

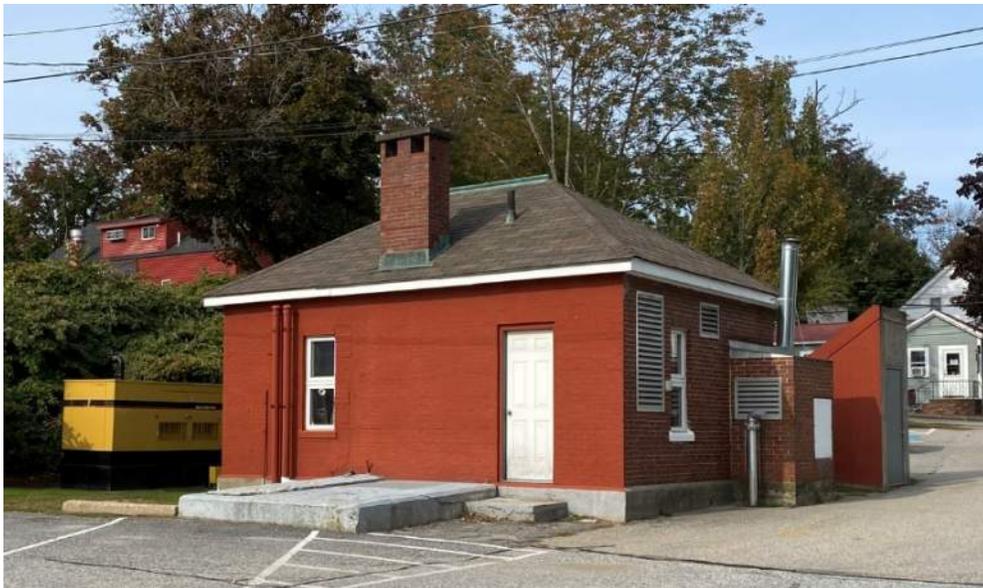
Figure 4-1 Mill St. Pump Station

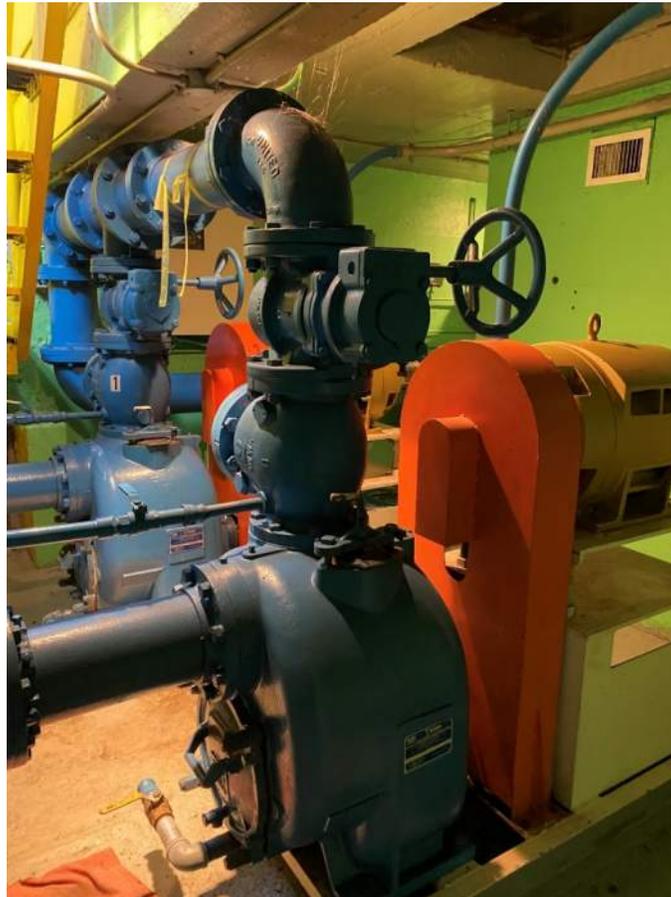
- Safe and adequate access to the wet well areas is important for maintenance and yearly cleaning of the oil and grease build up.
- Pipes within the wet wells are moderately to extremely corroded.

Figure 4-2 Mill St. Pump Station, Pump Level

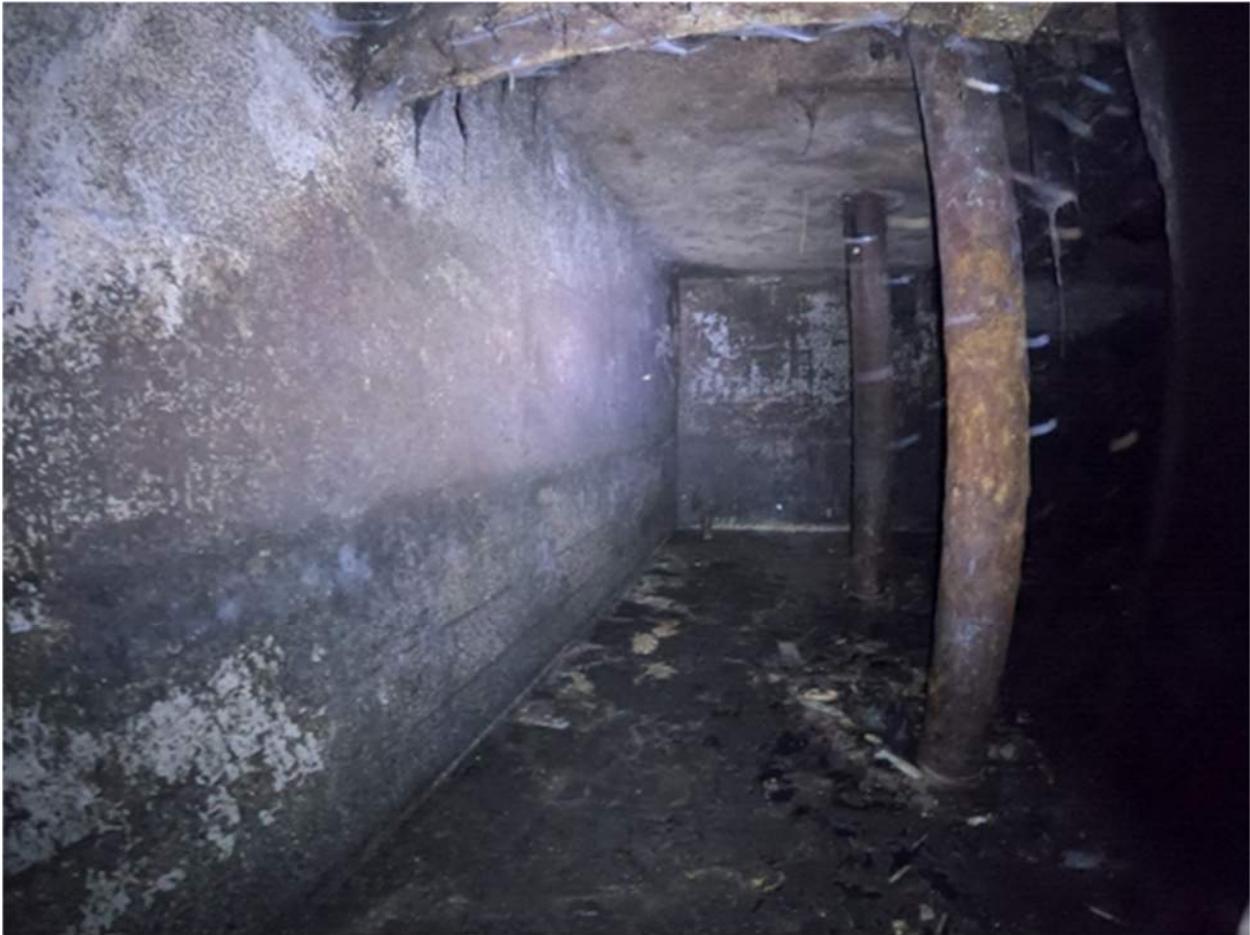
The main pump wet well is located under the building and is shown in Figure 4-3, and is connected to the '72 wet well by means of a small whole cut in the original wall. Deficiencies noted in the main pump wet well include only minor abrasion to the concrete with minor loss of paste but with no exposed aggregate.

Figure 4-3 Mill St. Wet Well

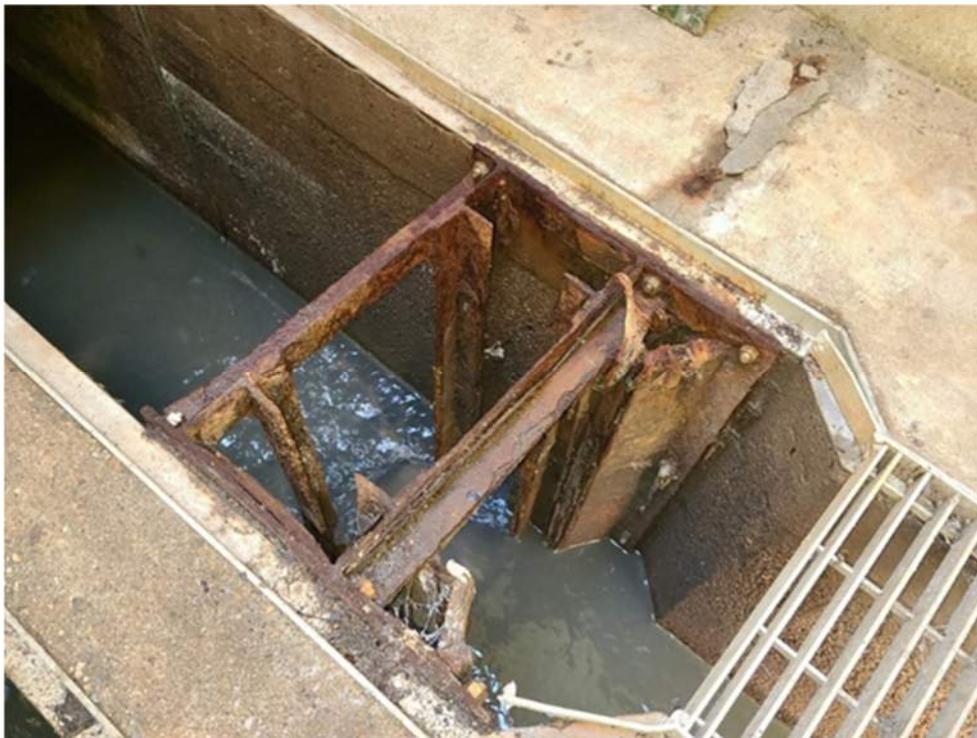
- The west influent channel has a steel structure which is likely the remains of a demolished comminutor (Figure 4-4). This steel is heavily corroded and should be removed in the event it broke loose so as not to damage the pumps.

Figure 4-4 Mill St. '72 Wet Well Influent Channel

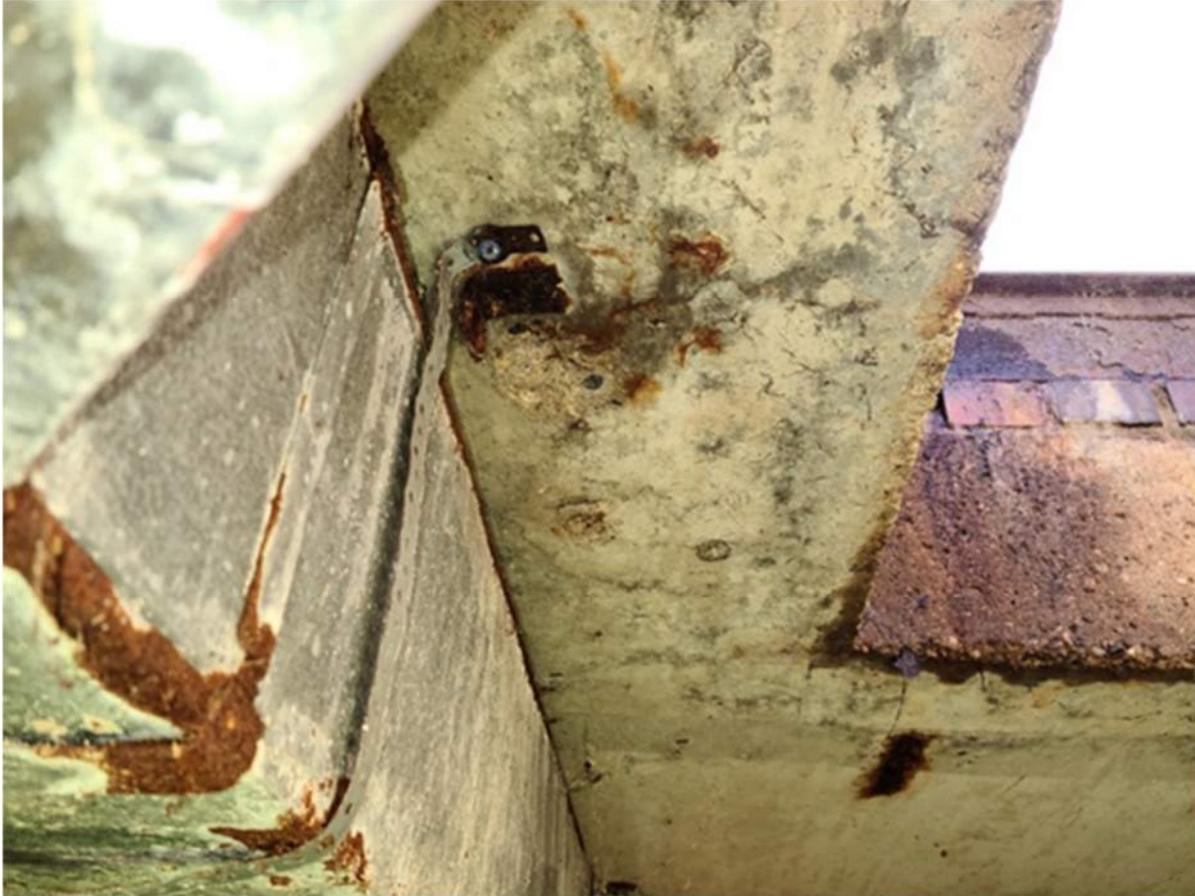
- The bottom of the top slab of the wet well has several locations where the reinforcement was placed during construction such that the bars are exposed. These bars exhibit heavy corrosion with loss of section.

- There is minor spalling ($>10 \text{ in}^2$ at each location) near the supports for the ventilation/AC ducting that corroded away.
- The ductwork is currently support by straps screwed into the slab as shown in Figure 4-5.

Figure 4-5 Mill St. '72 Wet Well Top Slab

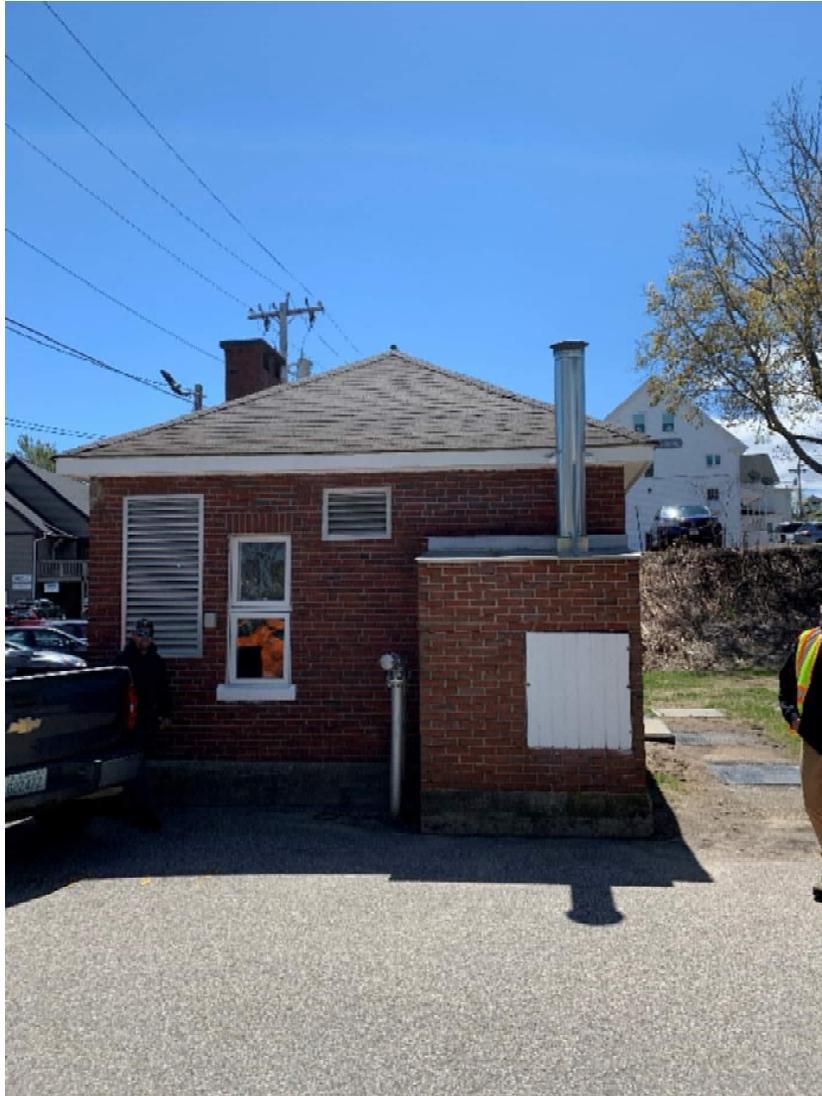
- Exhaust air and supply air louvers were observed to be less than the required 10 feet of distance per 2009 IMC Sections 401.4 and 501.2.1.

The '72 Wet Well is currently ventilated via an exhaust fan mounted inside of a brick chase outside of the pump station (Figure 4-6) and exhaust ductwork routed within the wet well (Figure 4-8). The exhaust fan exhausts air to a chimney vent mounted at the roof of the pump station. Make-up air is brought in passively through the access staircase adjacent to the pump station.

Figure 4-6 Exterior Louvers and Wet Well Ventilation Chase

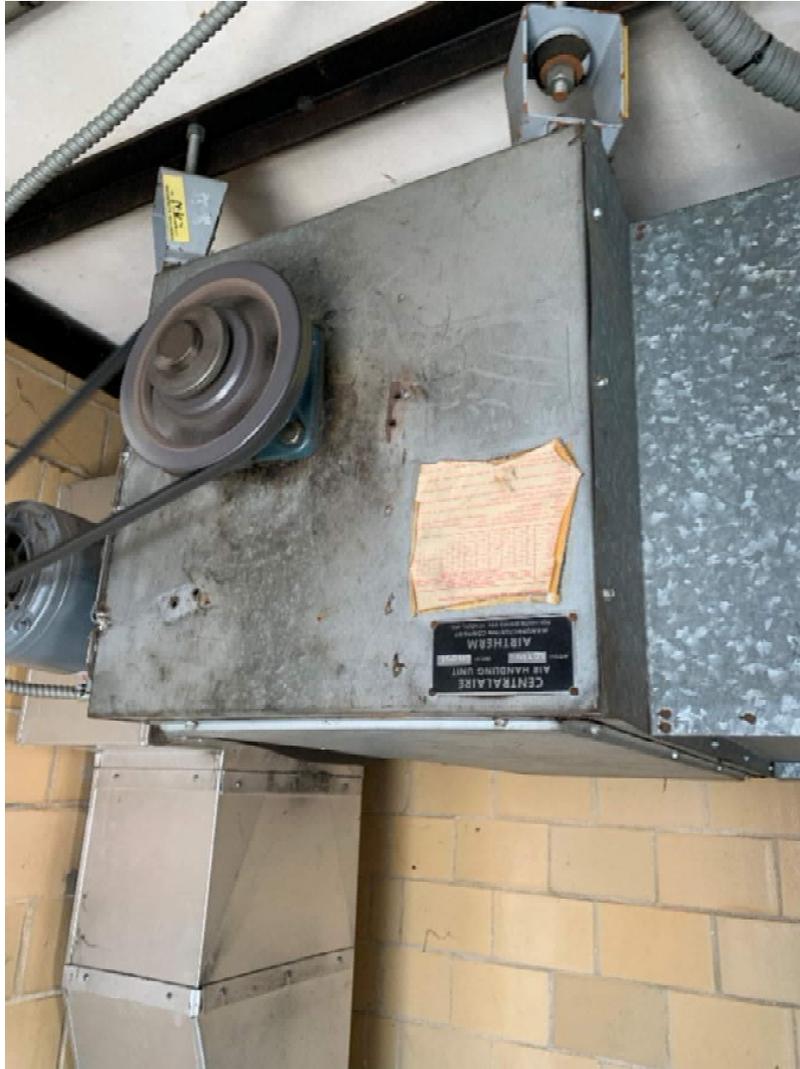
The Mill Street Pump Station electrical room and dry well is currently ventilated by a push-pull ventilation system. Supply air is provided via an exterior louver intaking outside air to an inline electric duct heater and belt driven supply fan with supply ductwork and wall mounted supply registers. Existing louvers can be seen in Figure 4-6 and the supply fan and inline duct heater can be seen in Figure 4-7.

Figure 4-7 Ceiling Mounted Supply Fan with Inline Duct Heater

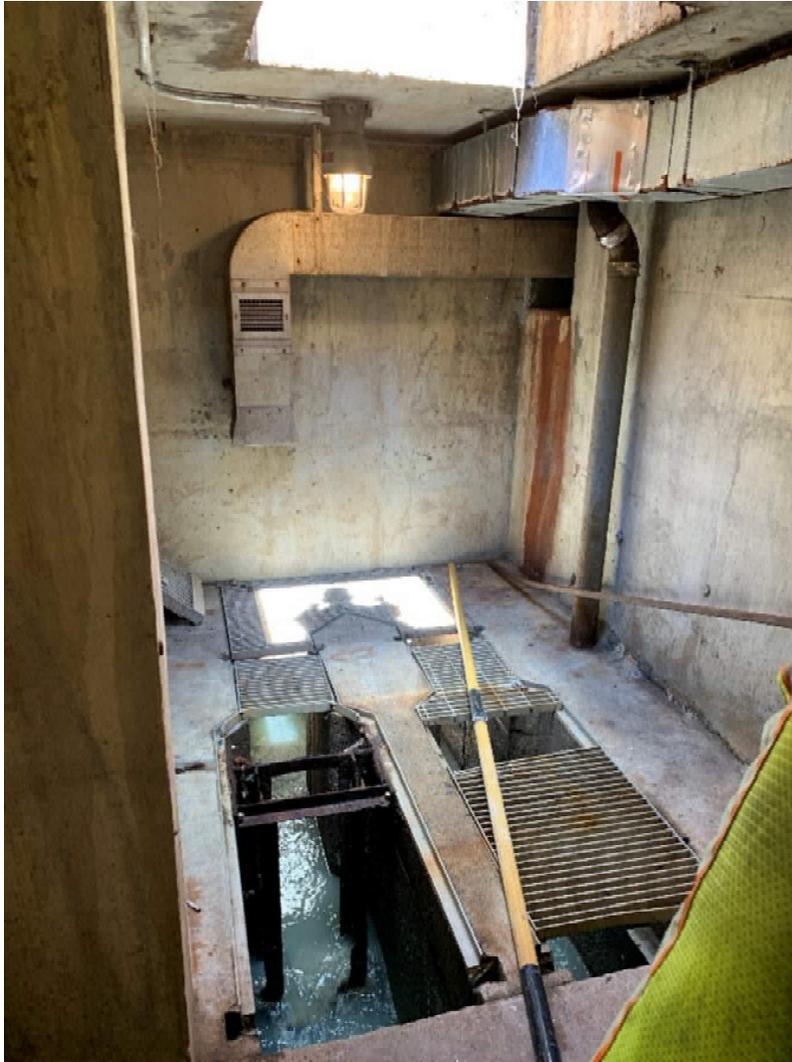
Figure 4-8 Wet Well Exhaust Ductwork

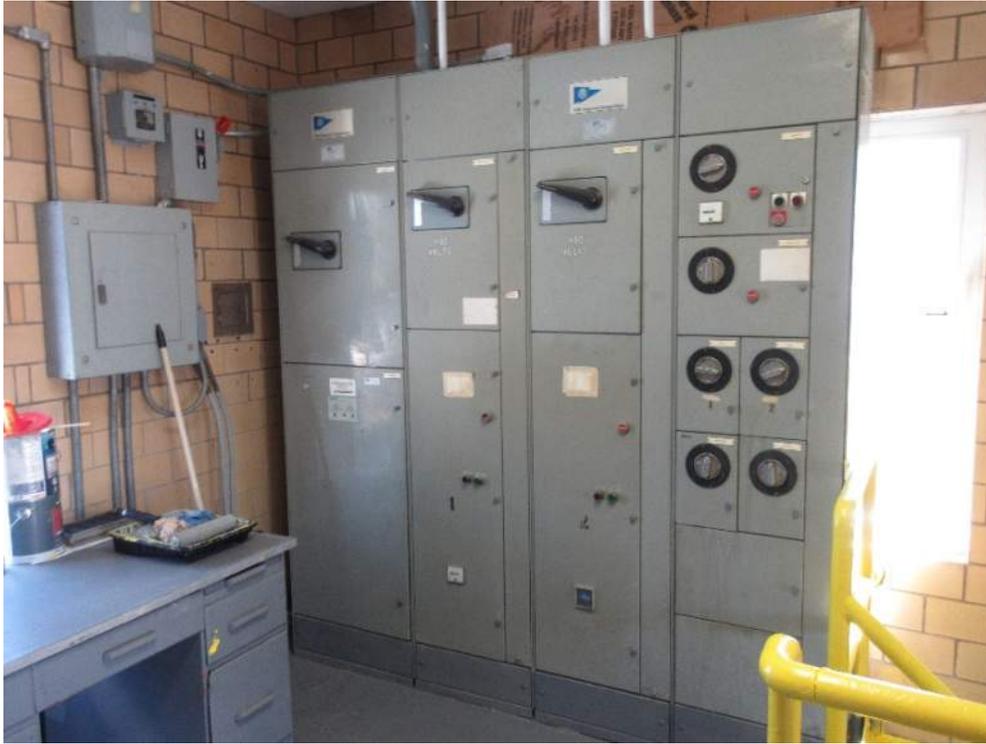
- The wet well is classified as a Class 1 Division 1, according to NEC Article 500, and it is not properly sealed off from the electrical equipment. Currently, all the electrical equipment is installed in a Class 1 Division 1 atmosphere, for which it is not properly rated. The only exception to this is the existing lights and conduits in the '72 wet well.
- Much of the original MCC, and pump control panel are not in operation and should be removed.
- The ATS and stand-by generator were installed in 1991 and have reached the end of their useful life.
- Both pump motors are single speed non-inverter rated motors, but they are controlled by VFDs. Running non-inverter rated motors on VFDs could lead to overheating.

As stated above, the wet well space not being properly sealed off from the electrical equipment is a significant concern that can lead to failures of the system and regulatory non-compliance. Corrosive gasses will degrade metal in the electrical system including control panels and wiring over time. When failure occurs, the pump station may not operate, and system backups and sanitary sewer overflows may occur causing violations.

Figure 4-9 Motor Control Center (MCC)

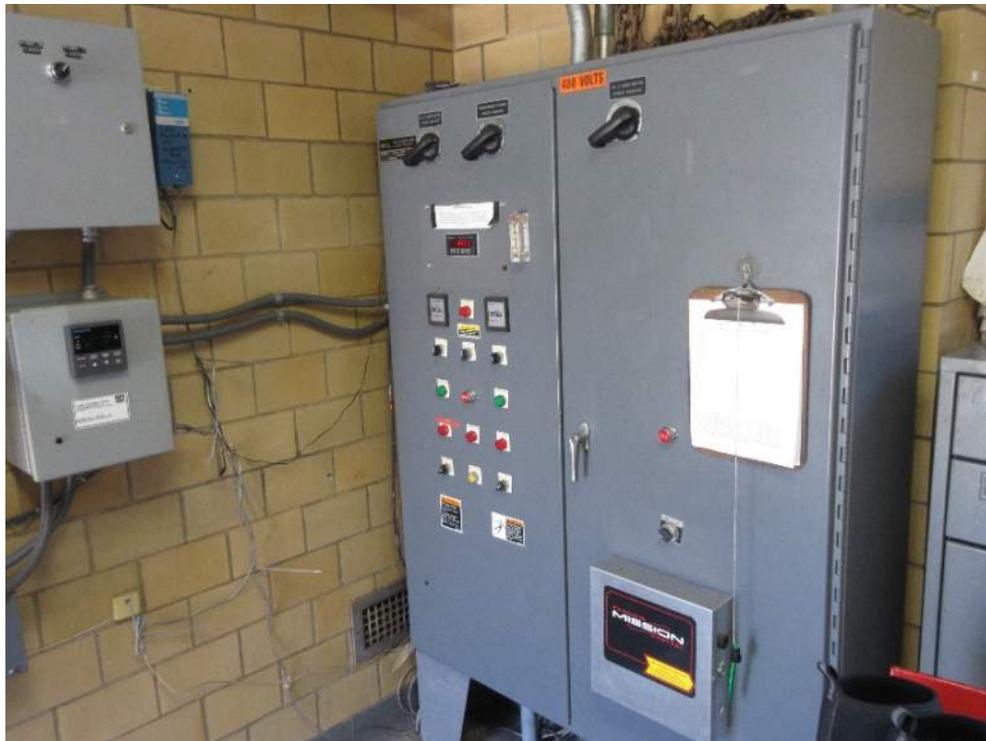
Figure 4-10 Pump Control Panel

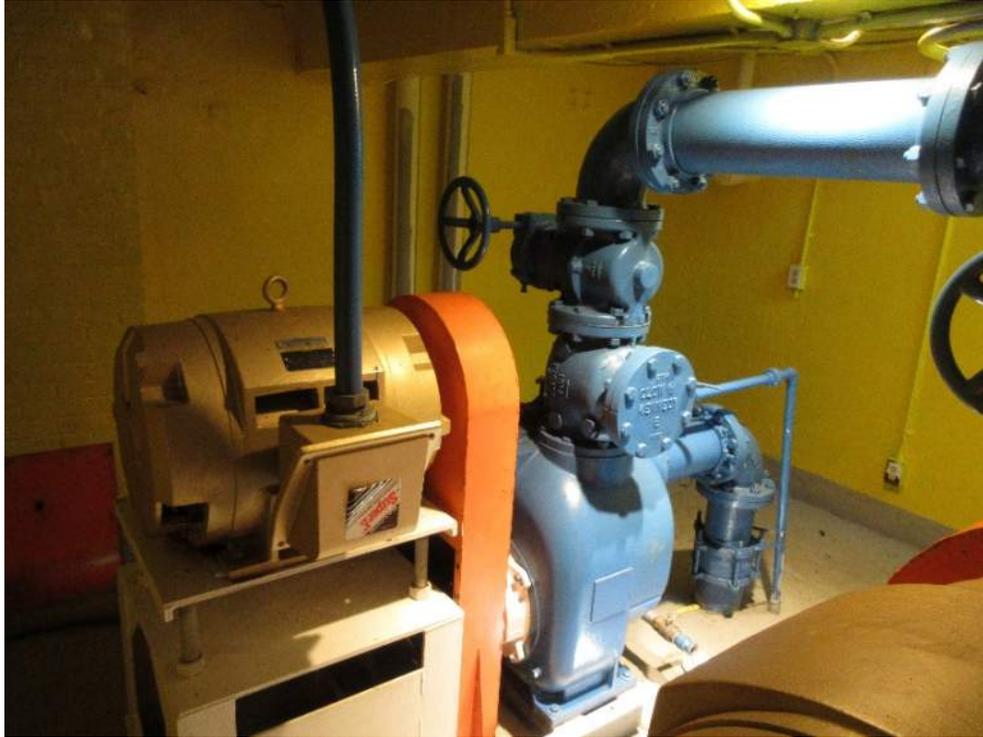
In the 2003 evaluation performed by Woodard & Curran it was noted that the original pumps were provided with two speed motors, but one of the two speed motors had failed and was replaced with a single speed motor. Currently, both motors are single speed motors. It is likely that the remaining two speed motor had failed since the 2003 evaluation.

Figure 4-11 Pump Motor

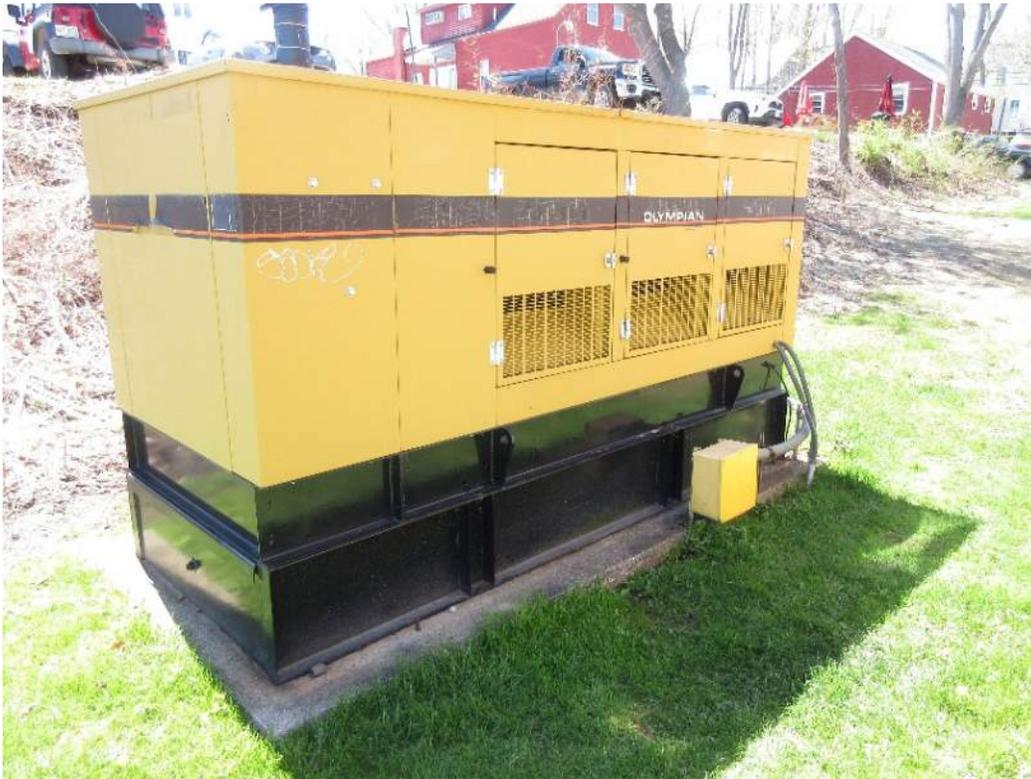
Figure 4-12 Stand-by Generator

The operators noted that the stand-by generator recently experienced issues that resulted in repairs to keep it operable. The ATS and standby generator was installed at Mill St. in 1991. Given its current age and maintenance challenges, it is recommended to be replaced.
