Town of Wolfeboro

Public Safety Building

Feasibility Study Final Report
August 8, 2018

EXISTING FACILITY CONDITIONS ASSESSMENT

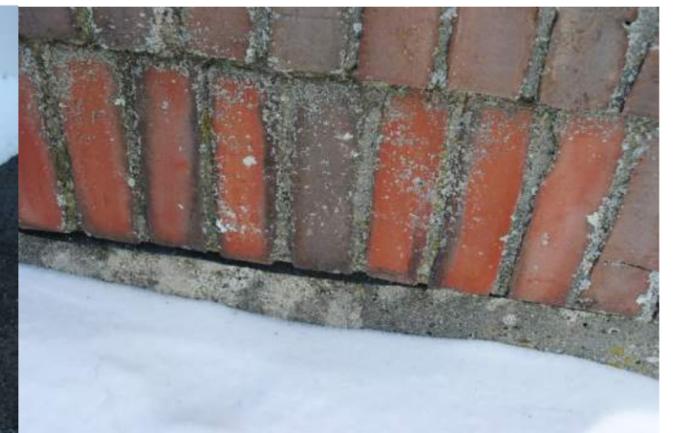
Liken growing on east façade brick.

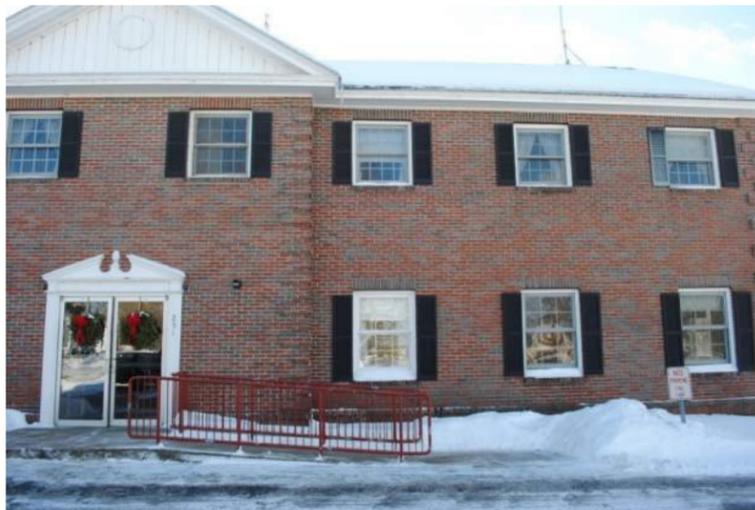
Handicap code accessible is limited to the first floor level Public Lobby. There is no elevator in this facility. Access is limited to the main entry lobby space. Doorways and corridors beyond the Public Lobby do not provide proper side clearances and circulation necessary for access. The facility meeting room and breakroom on the second floor level are inaccessible.

Public entry handicap ramp

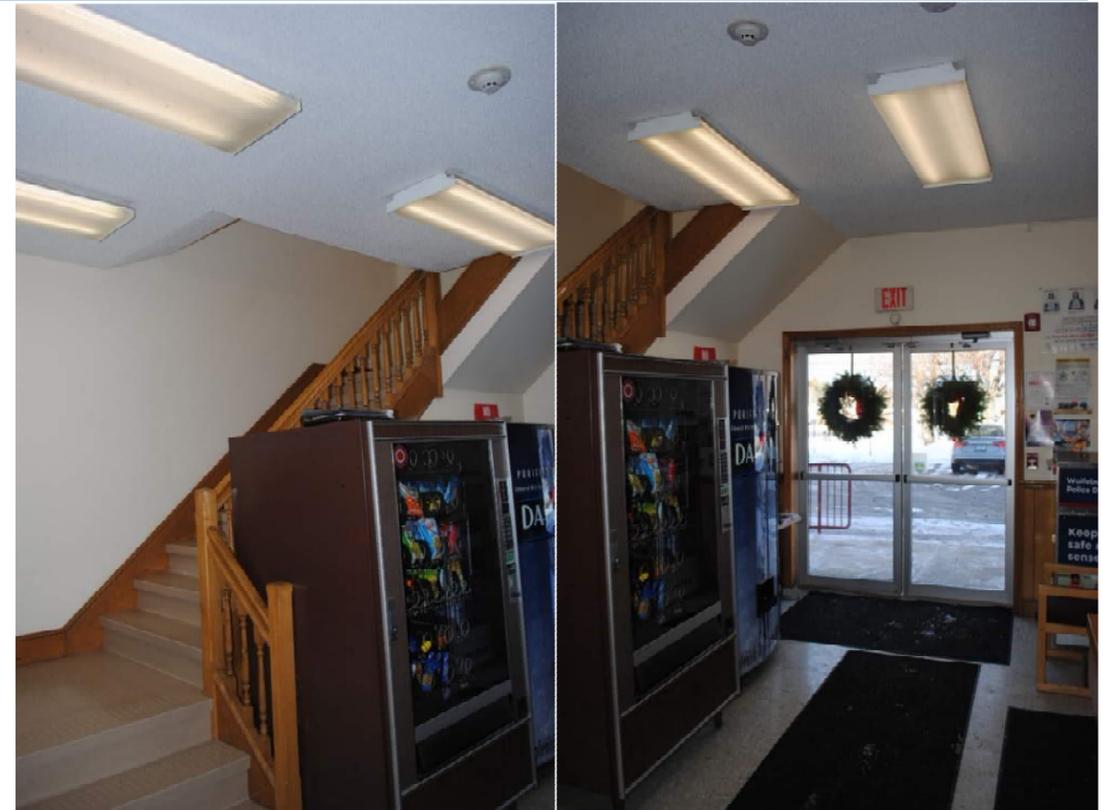
Exit stairway from Second Floor through Public Lobby.

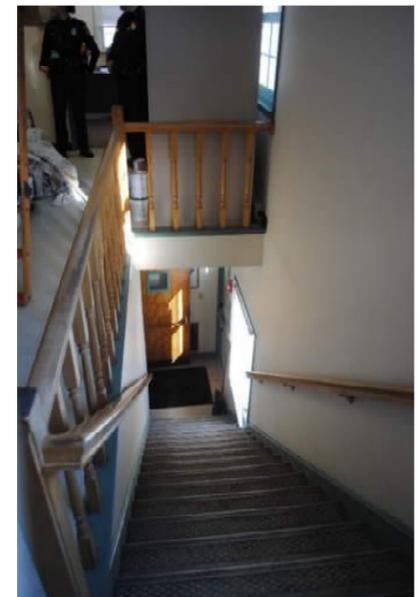
Exit stairway from Second Floor Police Department side

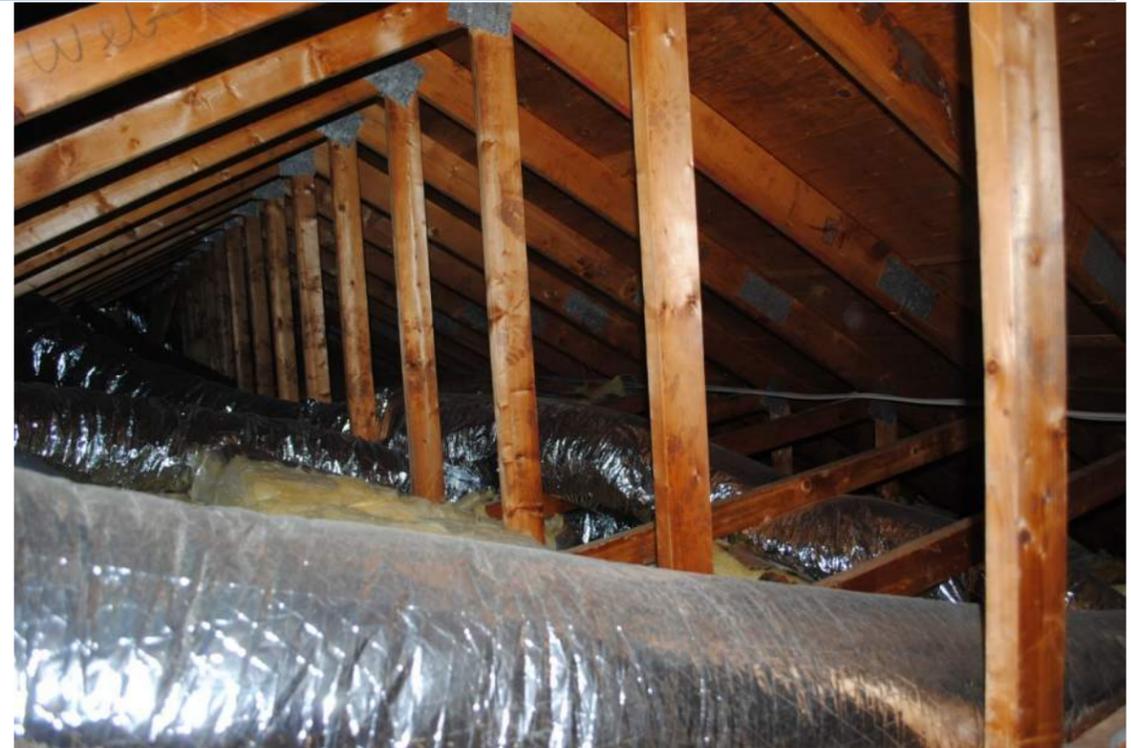
Mechanical systems above second floor ceiling.

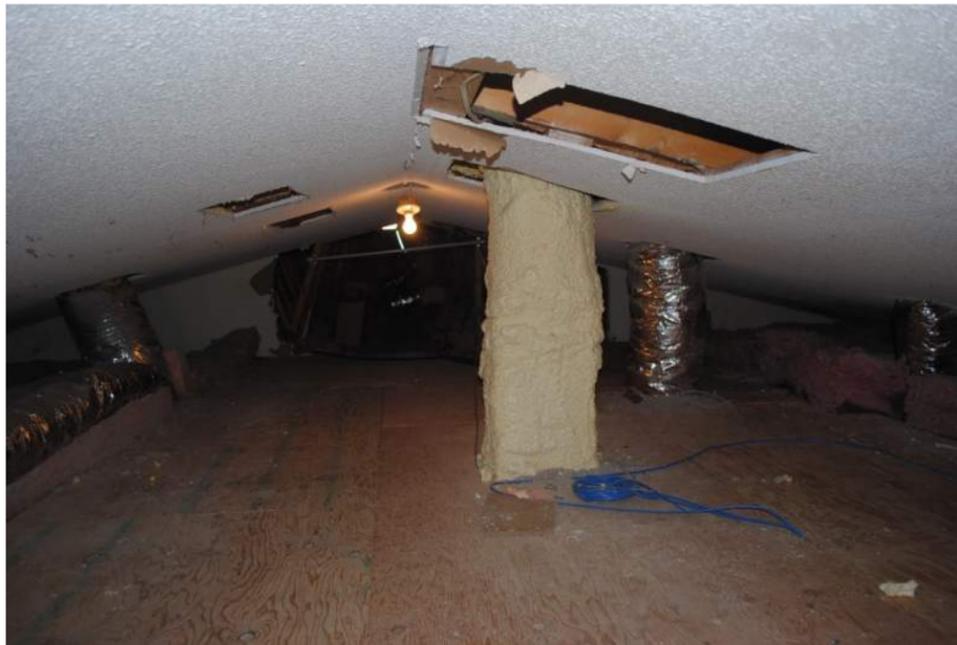
Apparently at some time after occupancy, this second floor area was renovated to create Police Department rooms. A flat ceiling framing was added over top of new stud walls. A sheet plywood deck was added across the top of ceiling joist framing. There was no documentation when this renovation work was completed. The purpose for this deck was documented in the “Bennett” report as being used as storage of files. We observed that this area is clear and not being used for storage. There is only a plywood walkway installed over the midspan of the “Fink” truss bottom cord to access existing mechanical equipment.

Scissor Truss area with plywood decking atop ceiling joists and openings to access H&V equipment controls.

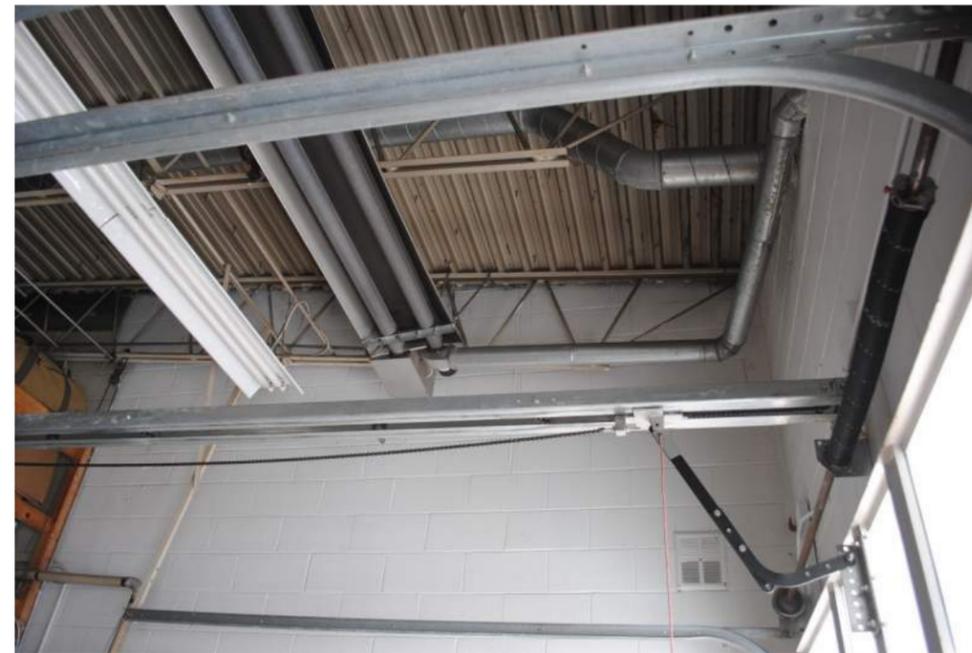
Separation wall in the Police Department Sallyport

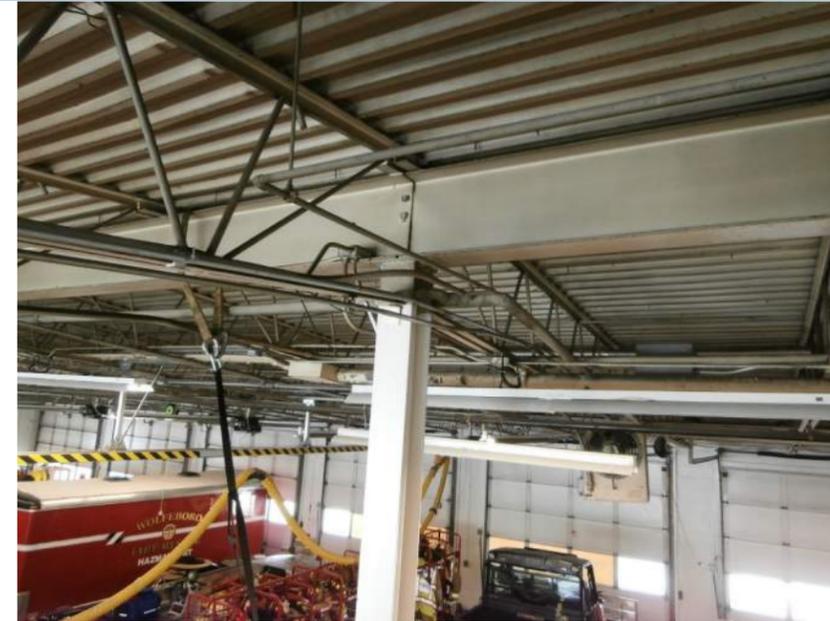
Open web joists and centerline steel framing, Apparatus Bay.

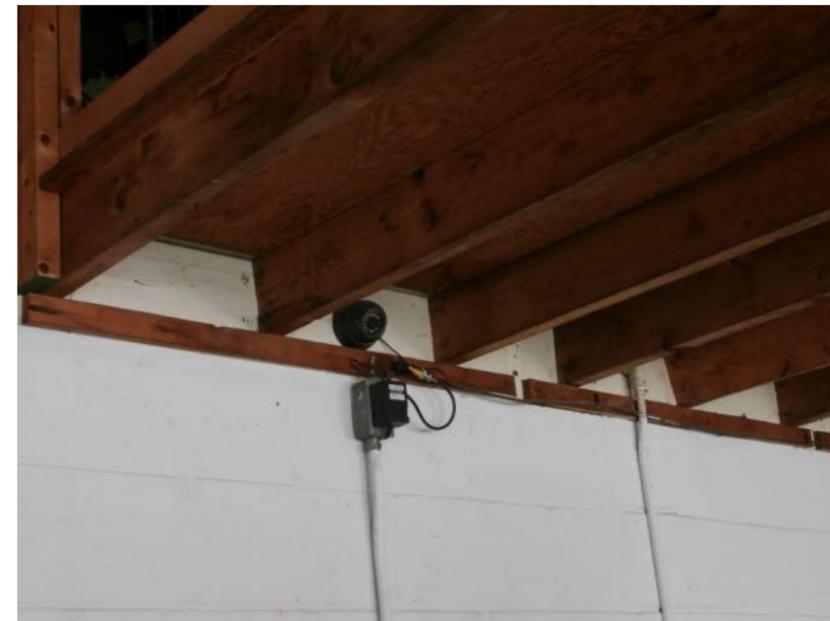
Sally port mezzanine framing ledger.

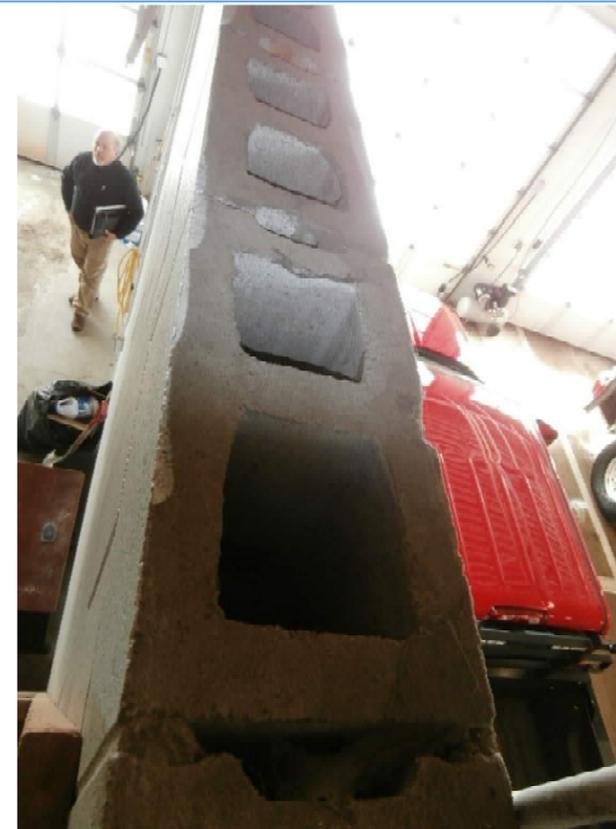
Top: Sally port interior wall, ungrouted and unreinforced / Bottom: South side entry canopy

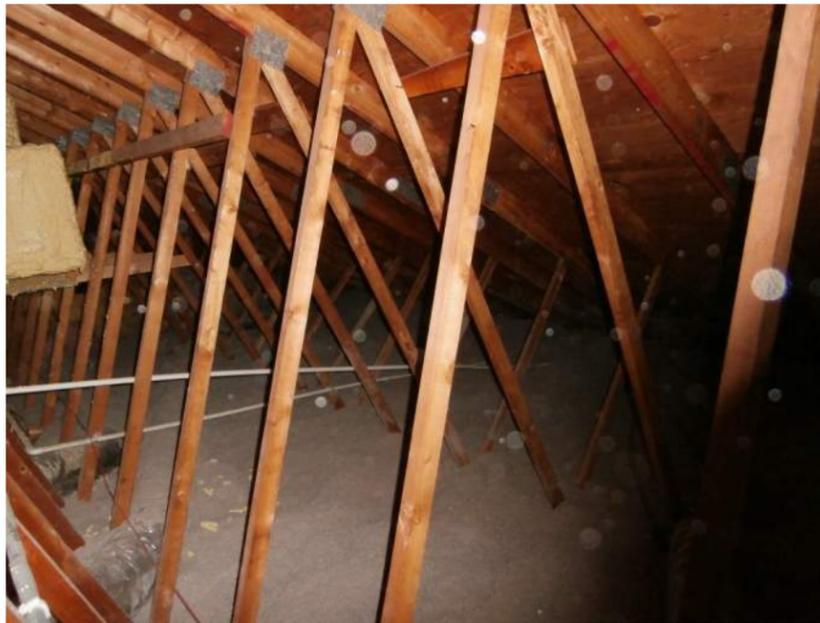
The roof trusses in the northern end of the building are a “Fink” configuration (identified on the original roof framing plan as “Belgian Trusses”). These Fink trusses are notable in that the web members are unusually small member sizes (2x3 lumber).

With regard to all of the 39 foot span roof trusses (Scissor and Fink Trusses) these trusses have no Continuous Lateral Bracing (CLB; also known as through-truss bracing). CLB is commonly required by the truss designer and its purpose is to limit the buckling length of truss web compression members. The complete absence of CLB in this roof structure is a concern. It is possible – but unusual - to design wood trusses of this size so as not to require CLB bracing. Given the member sizes used– especially for the Fink trusses – it is likely that these trusses should have had CLB installed. Determining whether CLB is required in the absence of further information regarding the original truss design and the lumber grades is a complex task.

Fink roof truss 2x3 web members, no thru-truss bracing.

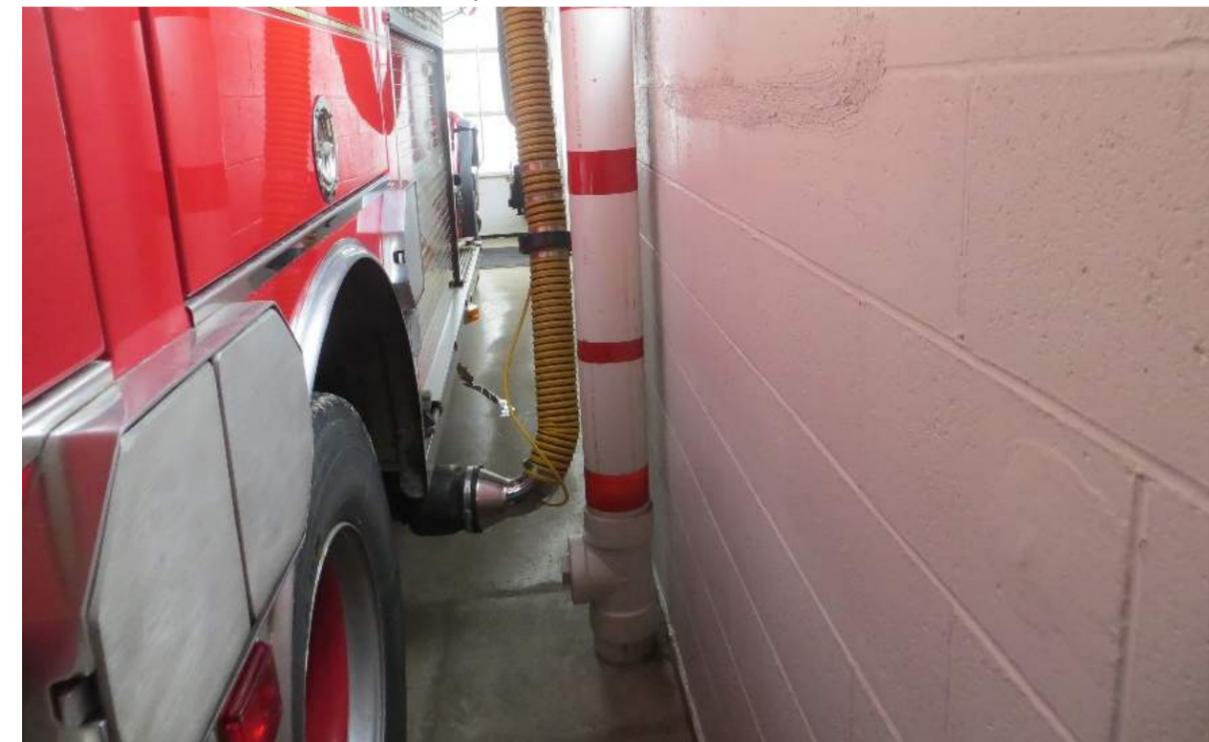
Vehicle Exhaust System Connected to Fire Truck

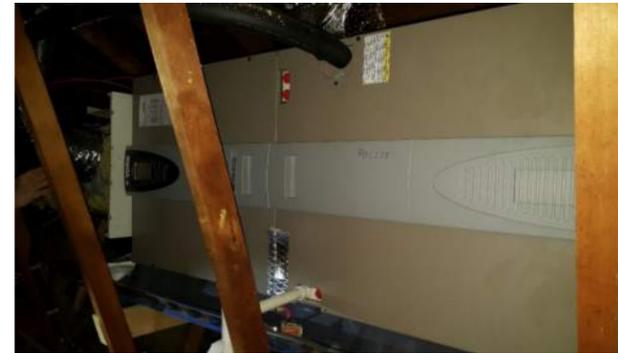
Heating, ventilation and air conditioning in the combination police/fire department is primarily done by two 4-ton York air source heat pumps located in the attic of the building. A heat pump is dedicated to serving the fire department and a heat pump is dedicated to the police department. Perimeter electric baseboard radiators serve as necessary supplemental heat sources in each room with an exterior wall. Installed roughly 7 years ago, both heat pumps blow air through insulated ductwork to all occupiers spaces. It was observed that spray-foam insulation was used to cover galvanized ductwork in the attic. While effective, the spray-on insulation is not even in all spaces and may not provide the code required R-8 thermal resistance required by the 2009 International Energy Conservation Code.

Existing Heat Pump Serving Police Department

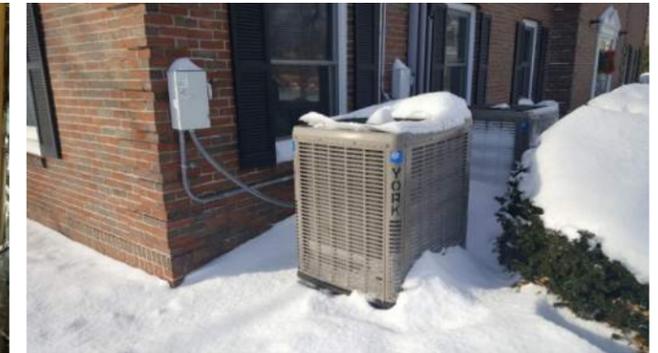
Condensing units located on grade outside run a single circuit of insulated refrigerant lines to the heat pumps. The condensing units are in very good condition, and are expected to have a useful service life of 10-15 more years.

Existing Condensing Units Serving Heat Pumps

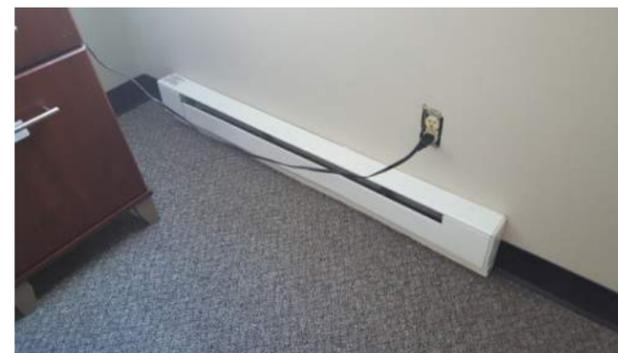
Electric baseboard installed around the perimeter was observed to be in varied condition. Older radiation appeared somewhat dirty and aesthetically out of date. Most of the older radiation is controlled using unit mounted dials, which is functional but is not viewed as convenient. Recently renovated spaces have been upgraded to include new electric baseboard with new wall mounted thermostats. The newly installed radiation is in excellent shape.

Example of Recently Installed Electric Baseboard

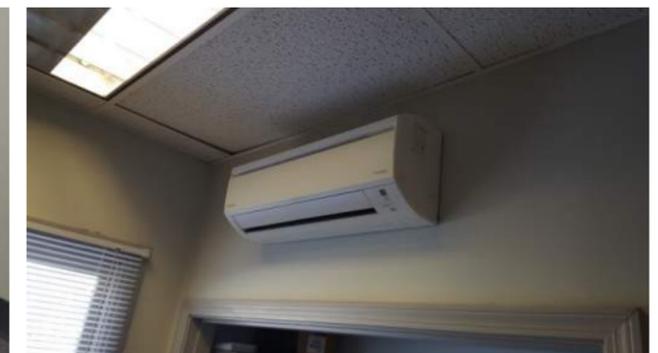
The Dispatch Room of the Police Department is served by a dedicated 1-ton Mitsubishi heat pump split system, with a wall mounted evaporator and on-grade condensing unit. The split system is in good condition and reportedly cools the room and offsets equipment heat loads. The staff did note that condensate, which gravity drains to the exterior wall, drips when the room is especially hot. Insulation is recommended on the piping, and if the problem persists, a drip pan may be considered.

Ductless Split Serving Dispatch Room

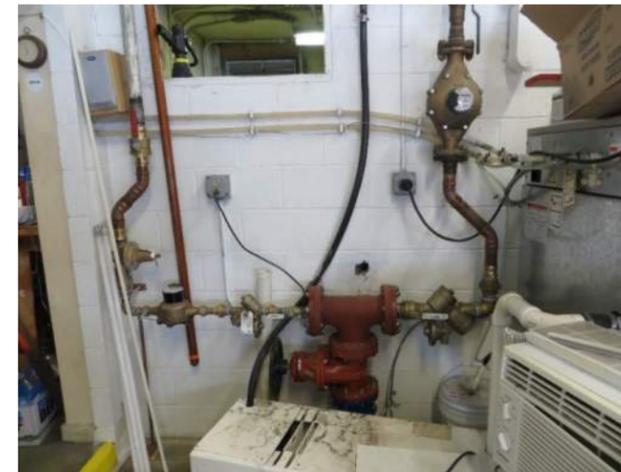
The building water entrance lies in the apparatus bay, and begins with a 4" cast iron entrance thru the slab with a gate valve for isolation. The entrance splits into two separately metered services, a 1" metered service to the police and fire station building, and a 2" dedicated to the apparatus bays. Copper tubing is connected to existing uninsulated system and is in good condition. There is no water pressure boosting system, and the observed water pressure at fixtures was noted to be excellent.

Building Water Entrance

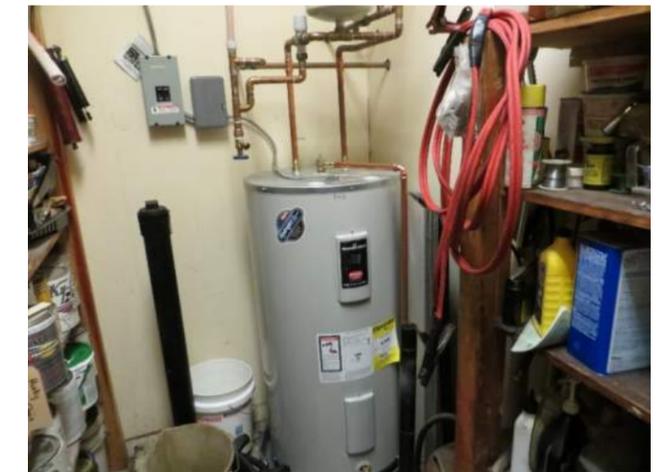
Hot water for the entire facility is heated by a recently installed Bradford White 50 gallon electric hot water heater. Installed in 2017, the heater is in like-new condition and was noted by staff to be of sufficient capacity for the current usage. Along with the new heater, a new mixing valve and new copper tubing has been installed around the heater. The Fire Department Staff reported hot water supply and delivery time was adequate at all fixtures, indicating good pressure and relatively short runs of hot water piping. No hot water recirculation was found to be installed. While not required by the 2009 International Plumbing Code, installation of a recirculation line to fixtures furthest from the heater may further improve hot water delivery times and prevent growth of bacteria in warm stagnant pipes.

Domestic Hot Water Heater

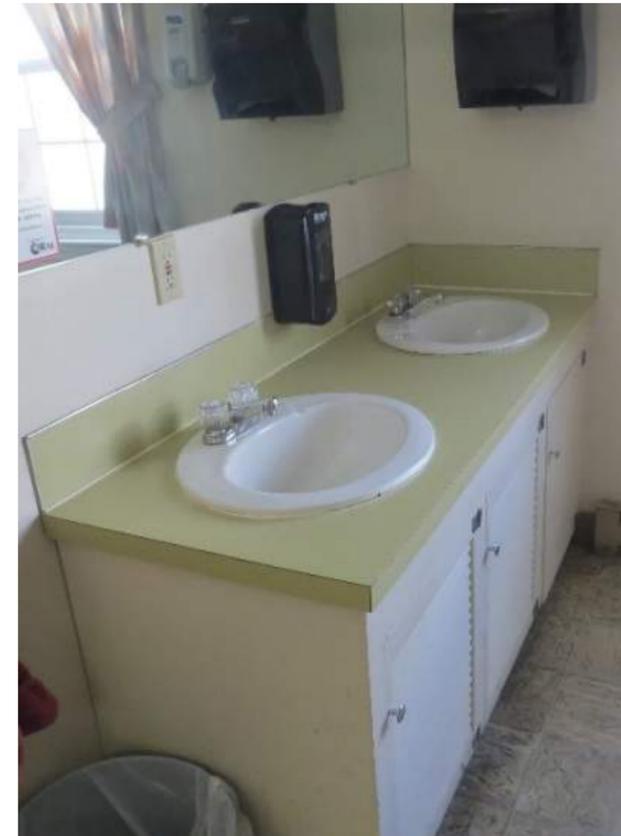
Plumbing fixtures were noted to be manual operation and of varying condition throughout the building. Lavatories are vitreous china construction of the counter or wall mount type and were observed to function properly and without leaks. Toilets are floor mount with manual Sloan Royal flush valves. Urinals are vitreous china with manual Sloan Royal flush valves. Showers were of the plastic insert type, with manual valves and non-adjustable heads. Fixtures did not appear to meet ADA standards, and are generally dated in appearance. It is recommended that all fixtures be replaced should a renovation encompass any restrooms.

Example of Existing Plumbing Fixtures

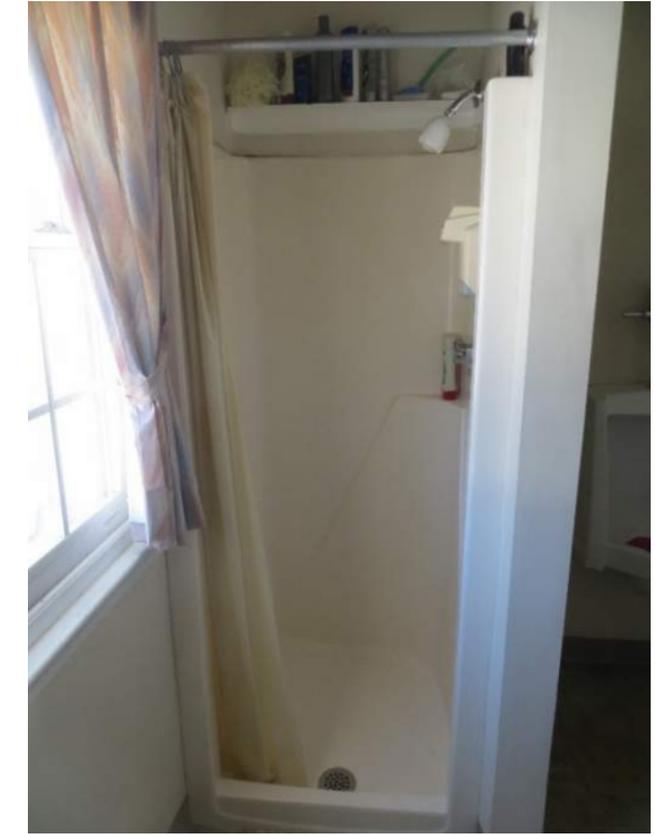
Example of Existing Shower Stall

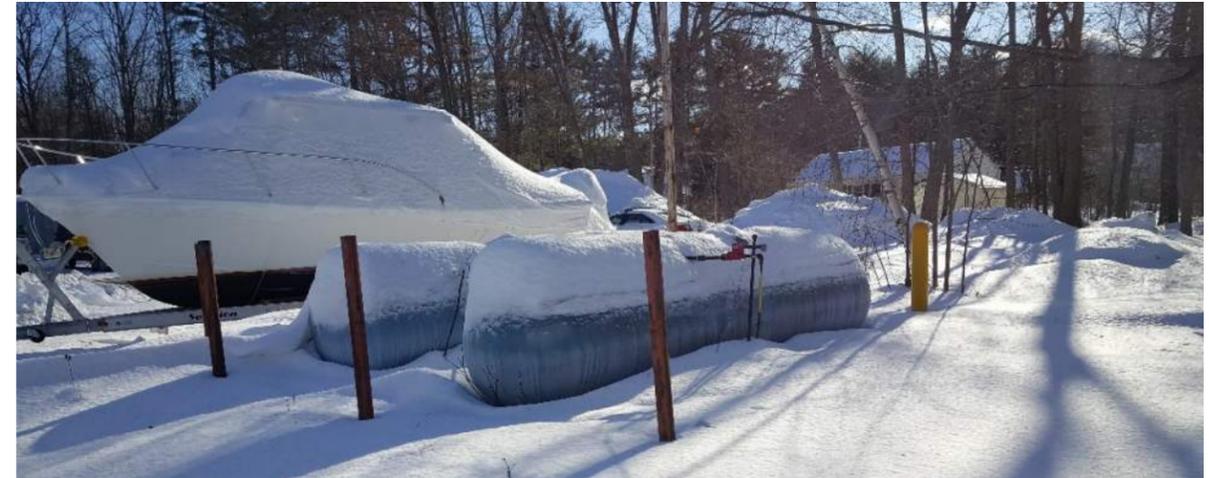
LP Gas fired equipment in the building includes infrared tube heaters in the apparatus bay and the generator. An existing 1 ½" line formerly serving the fire and police department is capped and no longer in use. Two above grade, 1,000 gallon tanks located to the back of the site provide LP gas to all equipment. Two wall mounted regulators provide separate and dedicated low pressure LP gas to the generator and building interior. Gas piping within the building is schedule 40 steel with screwed fittings. The piping, tanks, and regulator all appear to be in good condition and no signs of deterioration were observed.

Existing LP Gas Tanks

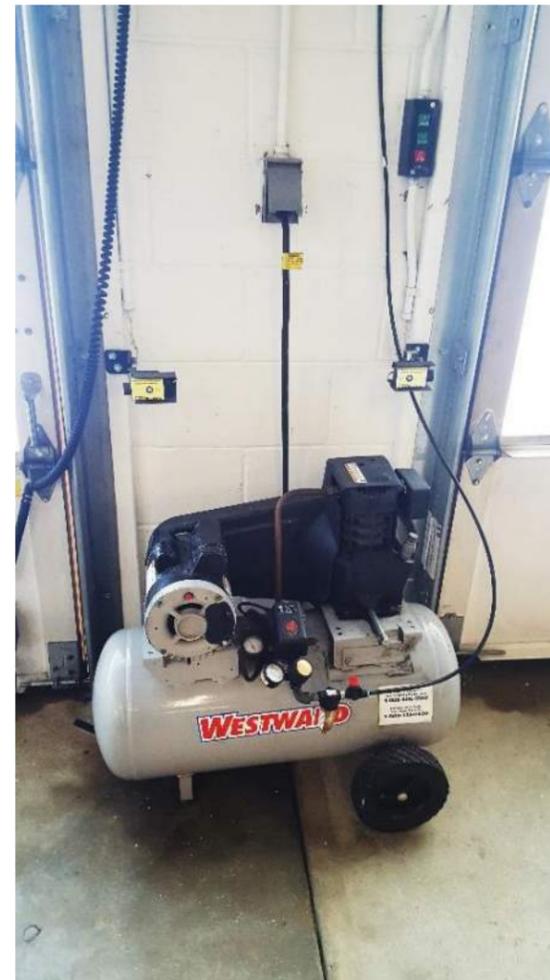
There are two air compressors located in the Fire Department Apparatus Bay. A 21 CFM, 60 gallon Ingersoll Rand compressor is located at the far end of the Apparatus Bay and serves the spaces general compressed air needs including filling tires. The system was reported to be sufficient for the needs of the apparatus bay and is in good condition. Given its condition and capacity the reuse of this compressor should be sufficient to handle a renovation or added space. A second compressor is located between tow overhead doors in the Fire Department Apparatus Bay and is dedicated to the Plymovent Vehicle exhaust system. The compressor is in excellent condition, and was observed to be functioning properly. The compressor is recommended to be reused if the apparatus bay is renovated.

Existing Air Compressor

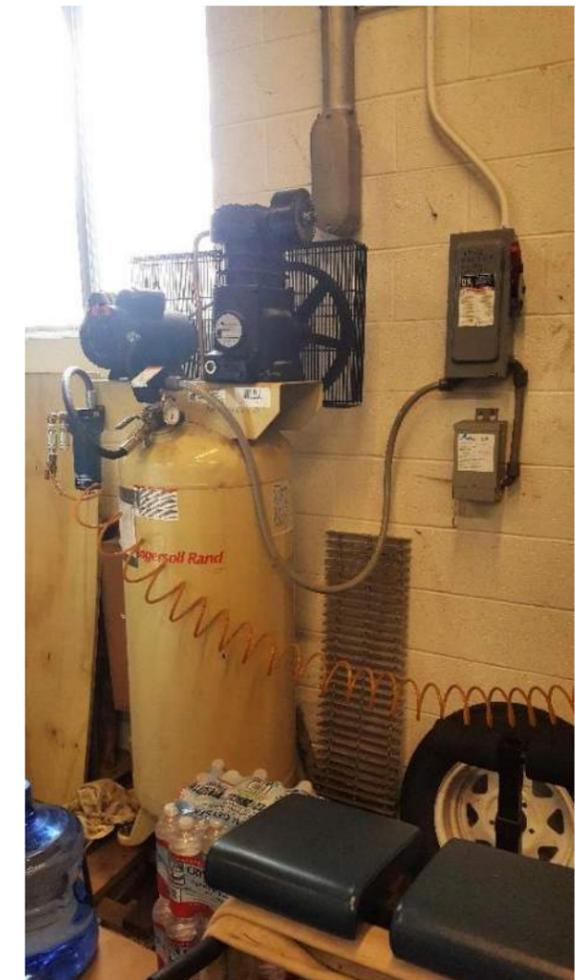
Existing Compressor Serving Plymovent Systems

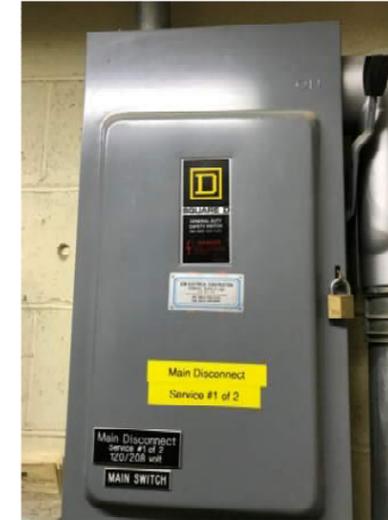
Building Electrical Service #1

It should be noted that utility demand readings are not available for evaluation, as this utility does not bill demand charges. Yeaton is unable to assess the actual service capacity without costly third party testing and chart recording metering. We feel comfortable with our recommendation for a new single three phase service upgrade as noted.

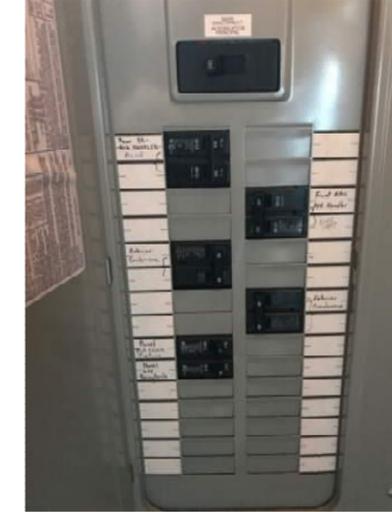
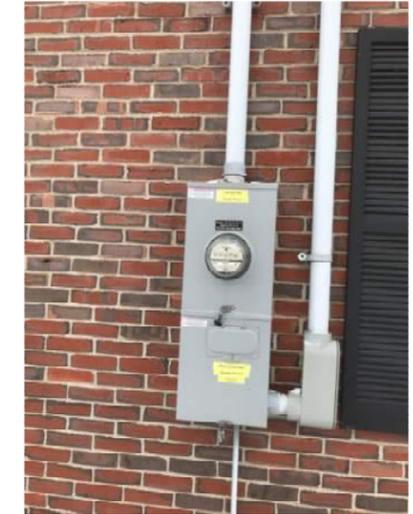
Building Electrical Service #2 is the fairly new overhead electrical service which terminates in the building attic to serve heating and air conditioning equipment. This service is installed as a 200 ampere, single phase at 120/240 volts, fed with overhead utility conductors to an outdoor meter/disconnect. The service disconnecting means is clearly labeled. From this service meter/disconnect, it travels vertically up the outside of the building to a panelboard in the attic. As part of any major renovations to the building, we would recommend removing this single phase service and combining the two electrical services as one, as described in the previous paragraph.

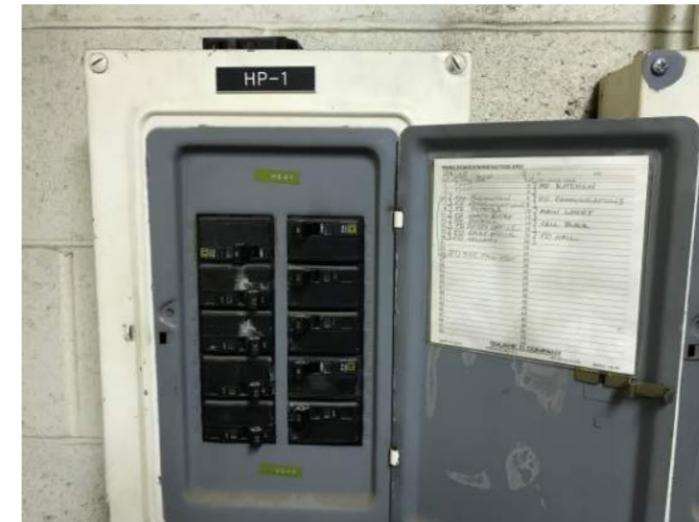
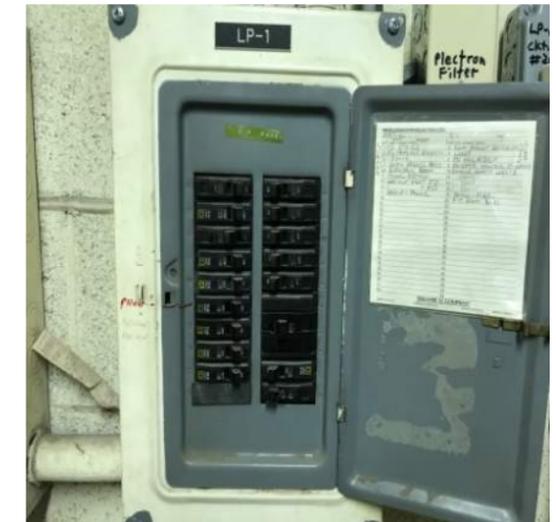
Circuit Breaker Panelboards appear to be original and are installed as residential style load centers, fed from the main distribution panel described in the Building Electrical Service #1. There appears to be five lighting and plug load panels, and two heating panels. As part of any major renovations to the building, we would recommend replacing all of these residential load centers with new commercial rated panelboards.

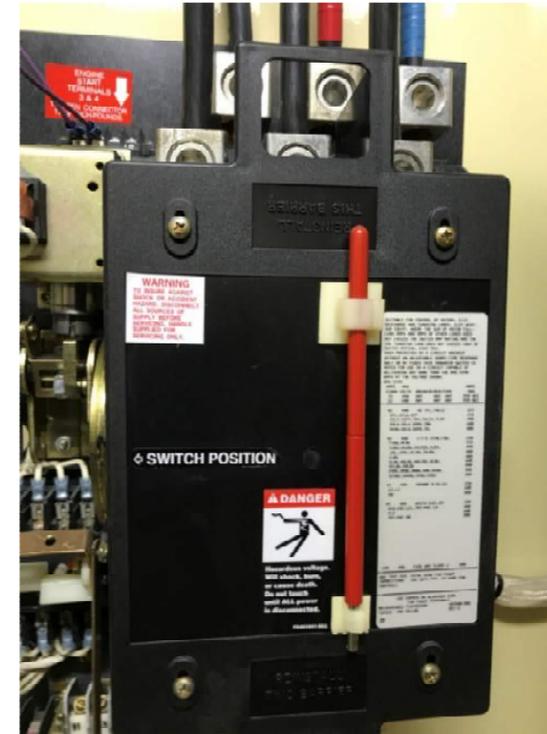
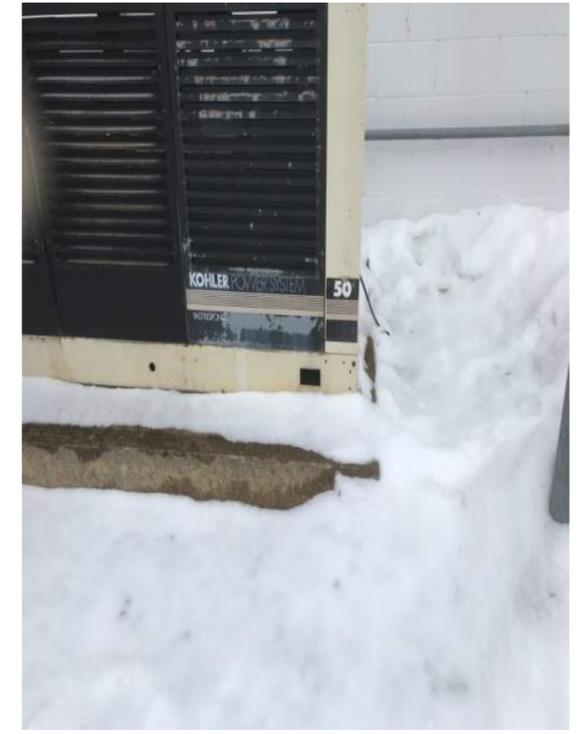
Standby Power Systems

The existing three phase electrical service #1 is supported by a propane fueled emergency generator and 200 ampere transfer switch. The existing outdoor rated generator is a Kohler 50 KW machine, which is good for 173 amperes at 208 volt three phase. This generator size compliments the existing 200 ampere service and present demand. We would recommend no changes to this system, short of reconfiguration of the non-code compliant emergency lighting system wiring down-stream of the transfer switch. If the owners desire addition standby power to support air conditioning systems, then consideration should be given to replacing this generator and transfer switch to a 100 KW machine to compliment a 400 ampere building service solution.

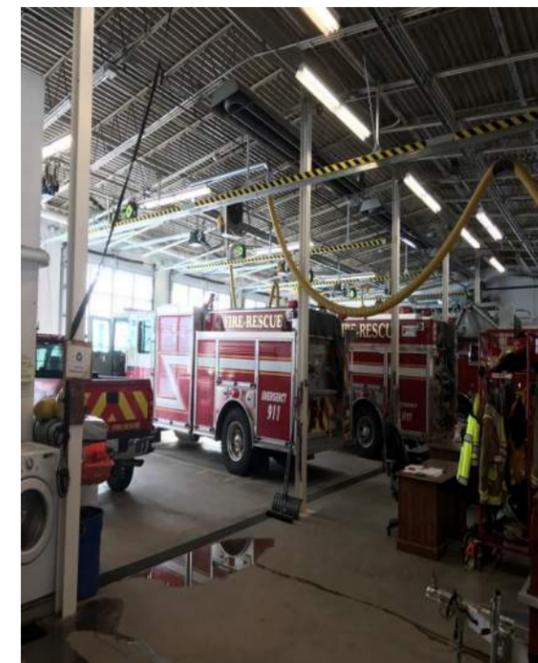
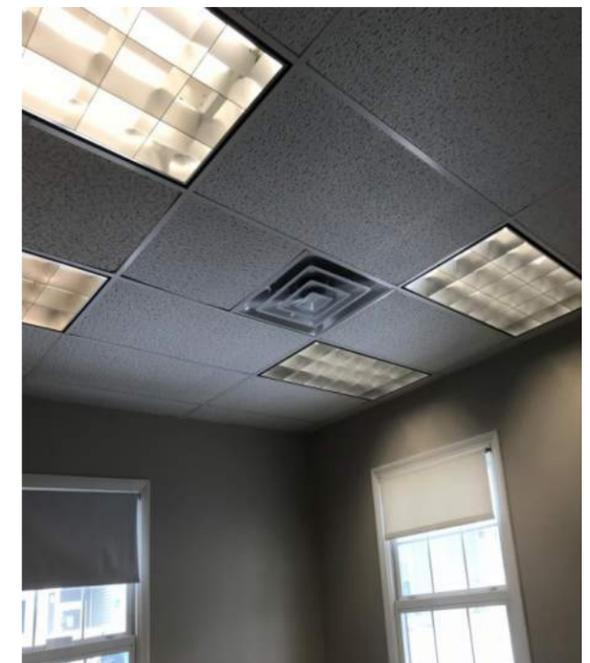
Lighting and Emergency Light

The building lighting systems are a mix of compact and linear T8 fluorescent, incandescent and some recently installed LED. Recessed lighting is linear fluorescent parabolic louver product with T5 HO linear strip lights in the apparatus bay. As part of any major renovations to the building, we would recommend changing all of the lighting to LED product to gain performance, energy savings and eliminate lamp changes. Consideration could be given to keeping the more recently installed apparatus bay lighting intact and adding like product to accommodate any bump out addition to the truck bays.

Code Compliant Emergency Lighting for the building is non-existent and is provided basically from normally powered lighting products and exit signs, wired and powered thru the standby generator power system and its transfer switch. The existing standby generator picks up the entire Building Electrical Service #1 thru this transfer switch. NFPA 70 and 101 require UL 1008 and UL 924 listed transfer equipment and shunt devices, in order to allow connection to a standby generator source. As part of any major renovations to the building we would recommend the installation of Code Compliant UL 1008 devices and distribution to pick up those lighting systems needed to provide illumination of the path of egress, exit access and to the exit public way. An alternate means to provide code compliant emergency lighting would be to install self-contained, battery powered emergency lighting units and exit signage, wired to the unswitched lighting circuits serving the paths of egress. The building is presently in violation of NFPA 70 and NFPA 101 from a life safety standpoint as the lighting system wiring is shared with other non-life safety circuits, and not separated or controlled in terms of UL 1008 and UL 924.

Technology what it is today would suggest that LED lighting be installed to replace existing, where substantial renovations are programmed. There are value added rebates and incentives from the electric utility, to defray some of the cost associated with these upgrades. The LED upgrades are recommended to eliminate the need for replacement lamp stock and the labor to install them as they burn-out. The LED lighting systems have no lamps to replace, and have expected life beyond 60,000 hours, which equates to 15 years at 4000 hours per year. Even after 15 years the lighting will still be operating, but only producing 90% of the initial rated lumens. There is energy savings and maintenance savings associated with replacing the existing fluorescent lighting systems with LED.

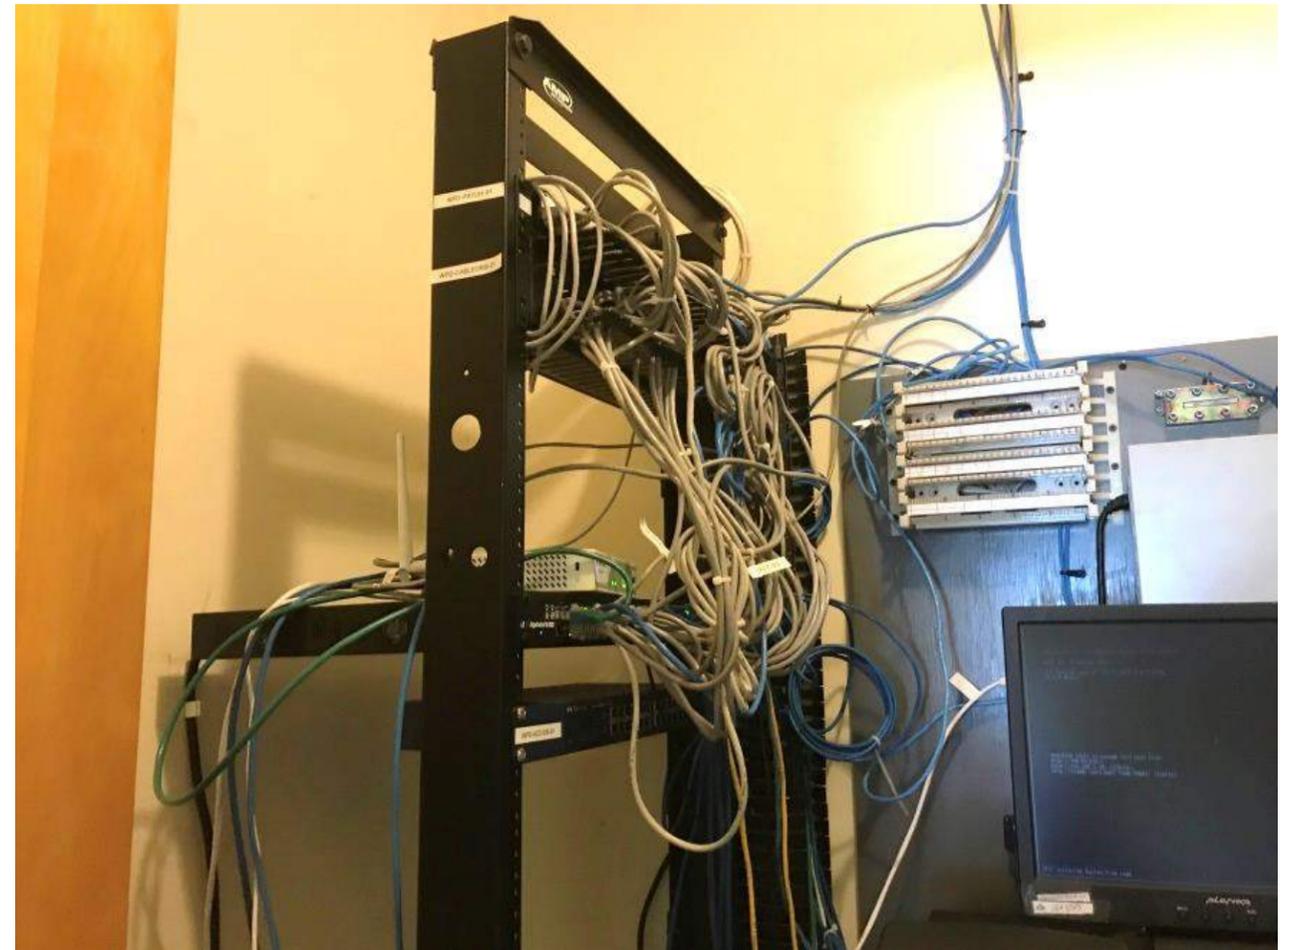
Connectivity Systems – Voice/Data

Existing connectivity appears to be in good shape. We would suggest that review of these elements is subjective, as tenants traditionally make changes to their spaces to accommodate their needs, associated with technology, internet speeds and overall support of their spaces. In general, there is access to the outside world thru existing conduit systems. We recommend no changes to this system, short of expansion and cabling associated with renovations and additions.

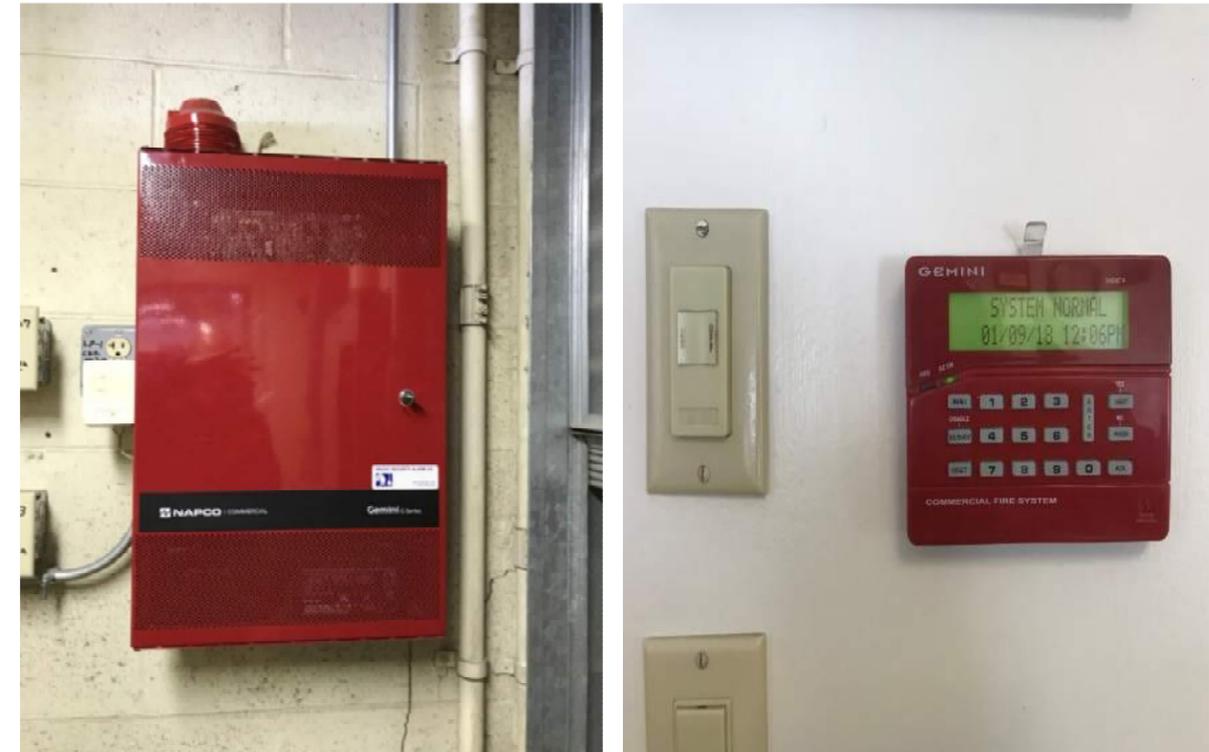
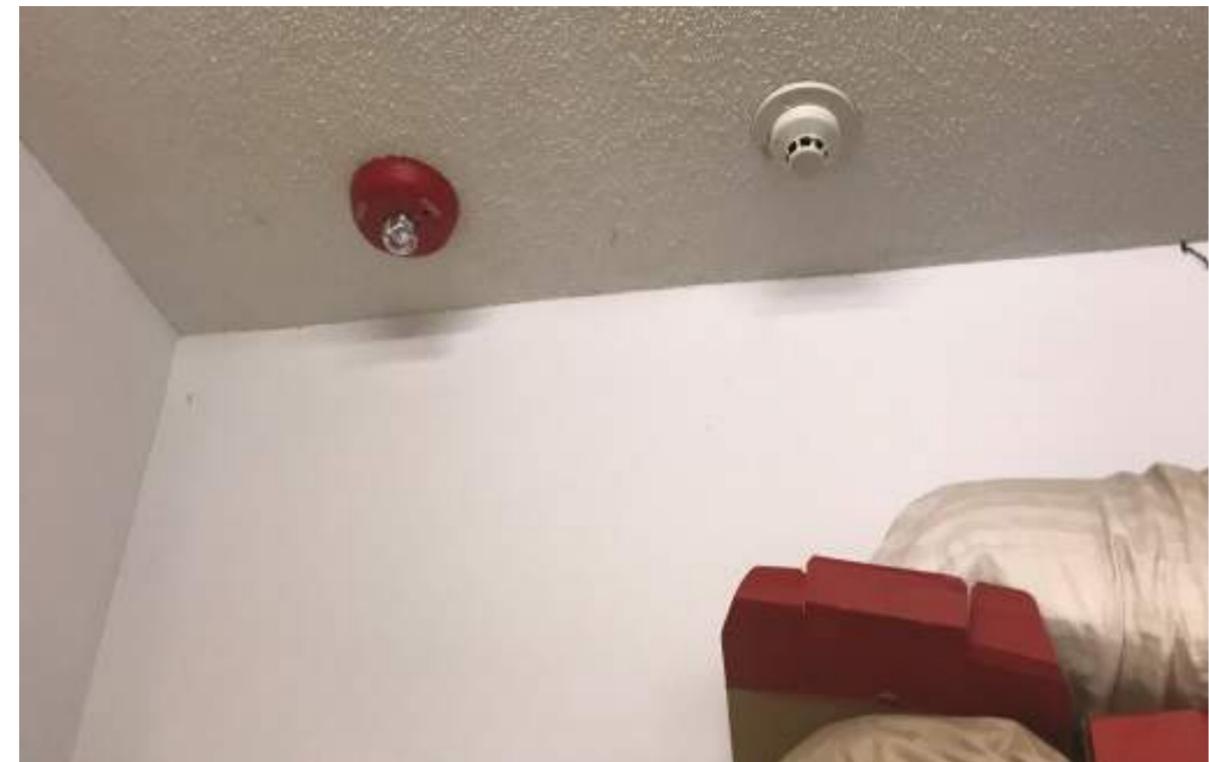
Fire Alarm Systems

The existing Fire Alarm System is presently supported by a recent vintage, addressable Napco Fire Wolf Fire Alarm Control Panel, with two indoor remote annunciators located in each of the fire and police dispatch rooms. The system has Horn/Strobe notification with full detection as the building is not sprinklered. There are a mixture of spot smoke and heat sensors to provide full coverage. The system appears to be monitoring conventional, non-addressable initiation devices which were installed from a previous system. The system is fully expandable. We recommend no changes to this system, short of expansion associated with renovations and additions.

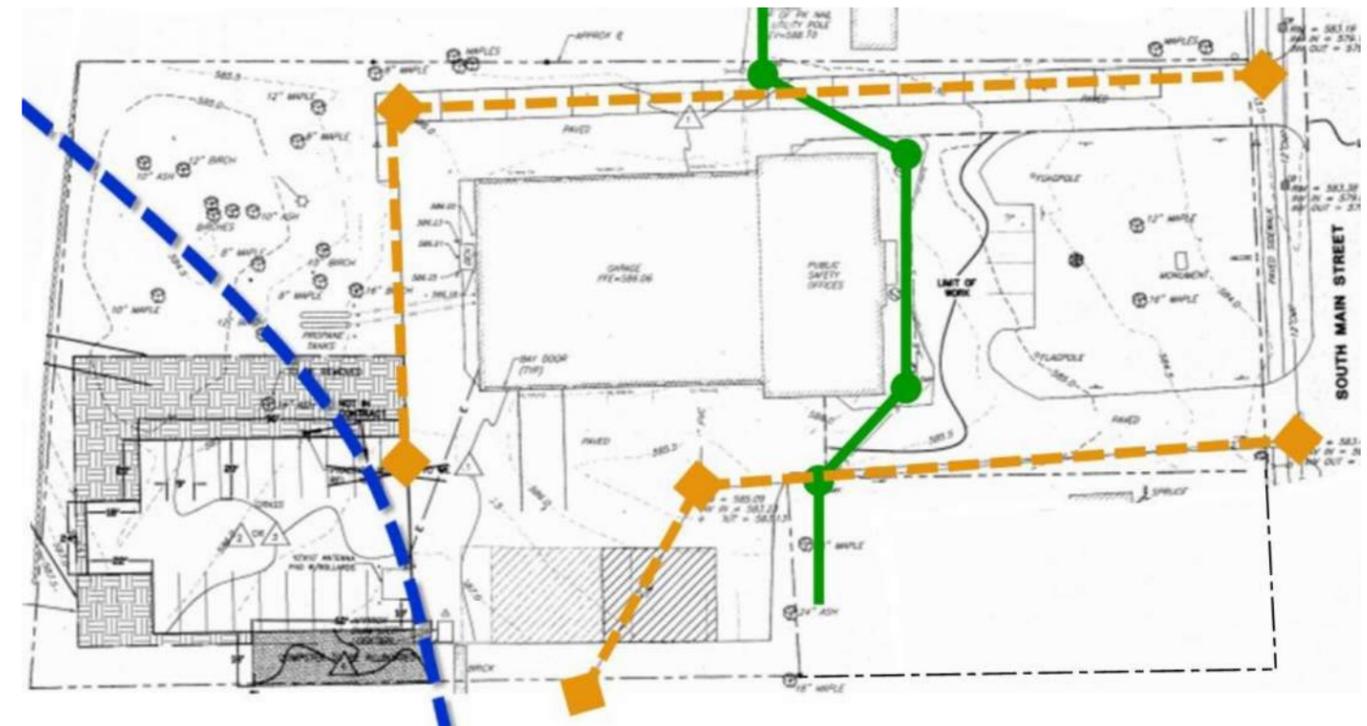
The Town's sewer main runs through the property just a few feet off the face of the building entrance. The building sewer service is located of the northwest corner of the main building.

Existing Conditions Site Plan (Green = Sewer Line, Orange = Drain Lines, Blue = Drainage High Point)
